Schoharie Creek Management Unit 1

Town of Hunter - Prediger Rd. (Station 159225) to Dale Lane (Station 151439)

This management unit begins at Prediger Road, continuing approximately 7,786 ft. downstream to Dale Lane in the Town of Hunter.

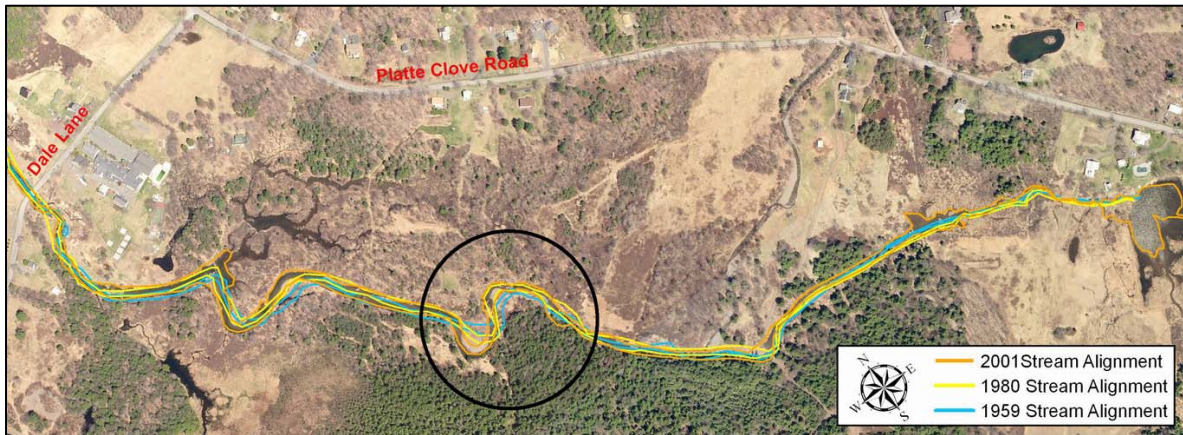
As seen from the historical stream channel alignments (below), with the exception of the *meander* bend in the middle of this management unit, the channel alignment has not changed significantly over the years.

Historic stream channel alignments beginning at Station 157400 overlaid with 2006 aerial photograph

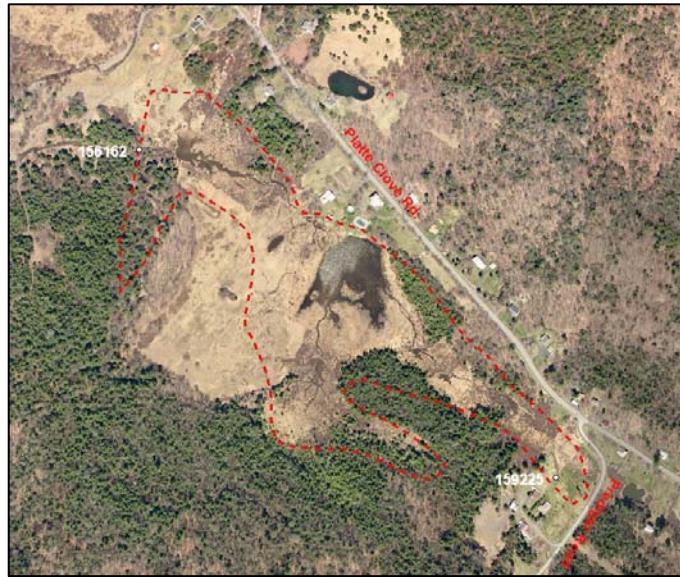
The upstream half of this management unit was dominated by a large palustrine wetland (Station 159225 – 156162). Wetlands are important features in the landscape that provide numerous beneficial functions including protecting and

improving water quality, providing fish and wildlife habitats, storing floodwaters, and maintaining surface water flow during dry periods. This palustrine wetland was approximately 34 acres with forested, shrub-scrub, and emergent vegetation, as well as areas of open water (see Section 2.6 for detailed wetland type descriptions).

*Palustrine wetland (Station 159225 – 156162)
Approximate wetland boundary delineated by NYSDEC*

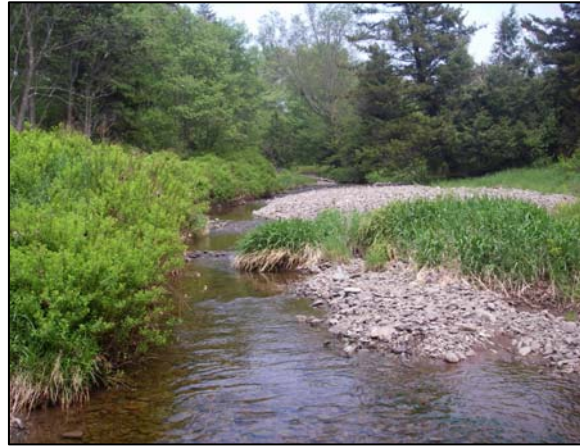
Downstream, a sizable unnamed tributary entered from the right streambank (Station 155270). This tributary is classified as C(t) by the NYS DEC, indicating that the best uses for this stream are the support of fisheries, including trout, and other non-contact activities (NYSDEC, 1994).

Tributary at Station 155270 – looking upstream

Originating on steep mountainous slopes, this stream drains parts of Roundtop and High Peak Mountains before crossing under

Platte Clove Road where the topography flattens before it enters the Schoharie Creek. As a result of this change in stream slope, the tributary loses its ability to transport sediment gathered from the mountain slopes, and begins to deposit sediment.

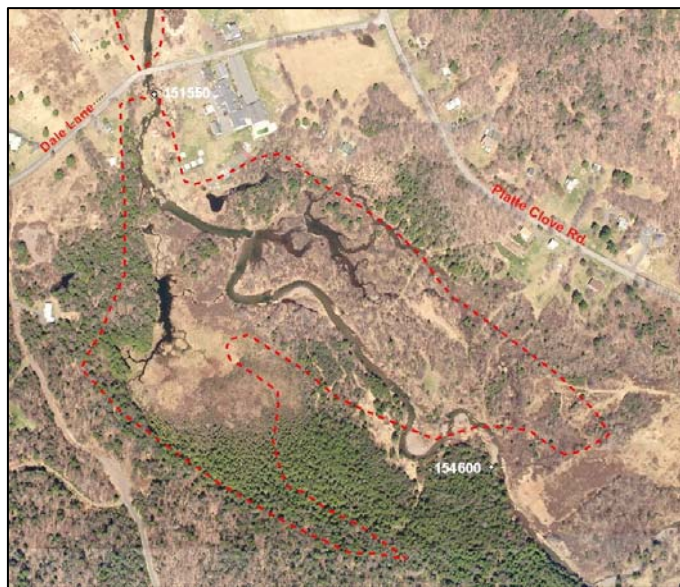
*Palustrine wetland (Station 154600 – 151550)
Approximate wetland boundary delineated by NYSDEC*

Another large wetland encompassed the lower half of this management unit (Station 154600 – 151550). This palustrine wetland was approximately 40 acres with forested, shrub-scrub, and emergent vegetation as well as areas of open water (see Section 2.6 for detailed wetland type descriptions). In 2006, there were three beaver dams documented in this area.
