Schoharie Creek Management Unit 2

Town of Hunter – Dale Lane (Station 151439) to Bunny Lane (Station 148641)

Figure 4.2.1 Management Unit 2 - 2006 aerial photography with stream feature inventory

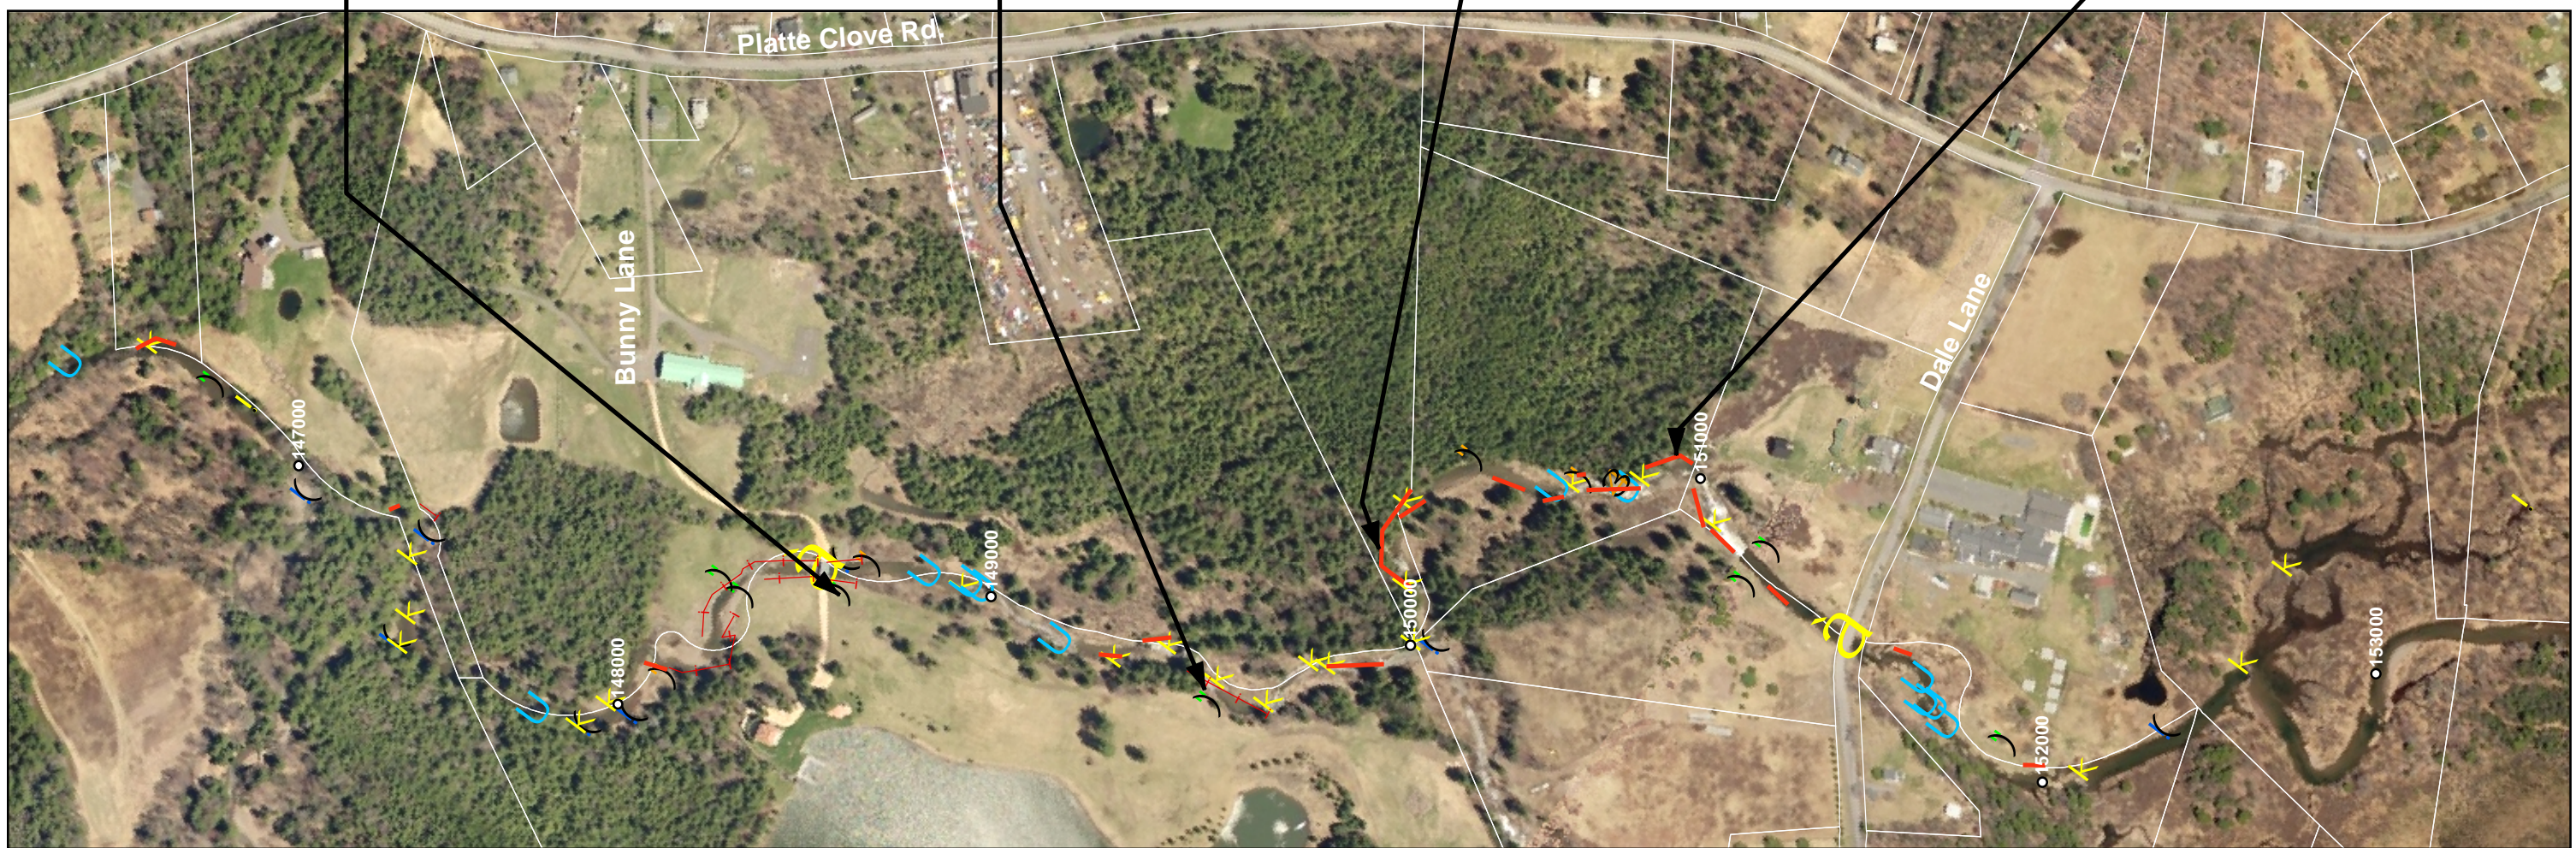
The 2006 stream feature inventory revealed that 19.5% (1093 ft.) of the streambanks exhibited signs of active erosion along the 5,597 ft. of total channel length in the unit (Fig. 4.2.1). The total surface area of active erosion totaled approximately 6,456 ft². *Revetment*

has been installed on 5.6% (315 ft.) of the streambanks. No berms were identified in this management unit at the time of the stream feature inventory.

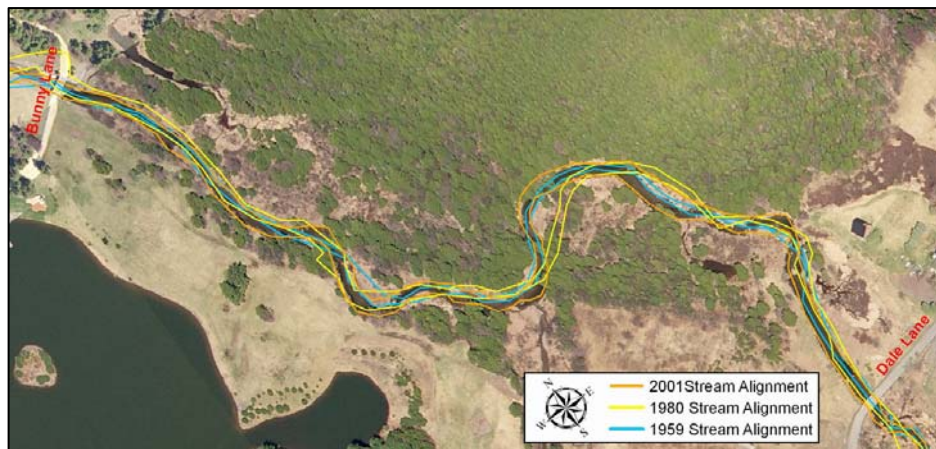
Historic stream channel alignments overlaid with 2006 aerial photograph

As seen from the historical stream alignments (below), the *planform* of the channel has remained fairly stable since 1959. There were remnants of many fish habitat structures throughout this unit in various states of functionality. Due to its rural nature and headwater location in the watershed, the unit had a lot of beaver activity. While beaver impoundments can sometimes be a nuisance, beavers have historically played a beneficial and ecologically important role in the stream system. Beaver activity adds organic debris (trees, leaves, etc. which provide the base of the food chain), reduces water velocities and flood-related hazards downstream, and creates wetland areas that filter sediment and release water to the stream and groundwater slowly throughout the year.
