Schoharie Creek Management Unit 3

Town of Hunter – Bunny Lane (Station 148641) to Station 138610

This management unit begins at Bunny Lane, continuing approximately 10,031 ft. to Station 138610 in the Town of Hunter.

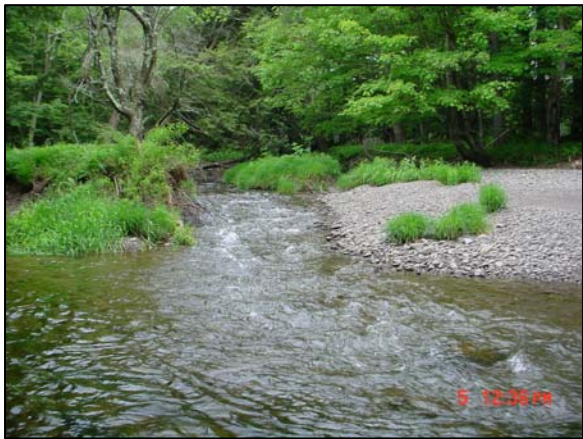
Roaring Brook at Station 147040 - looking upstream

Downstream, Roaring Brook entered from the left streambank (Station 147040). This *tributary* was moderately sloped running along the valley between Sugarloaf and Spruce Top Mountains before entering the Schoharie Creek. The New York State Department of Environmental Conservation classifies streams and rivers based on their “best use” (NYSDEC, 1994). This tributary was classified as C(t), indicating that the best

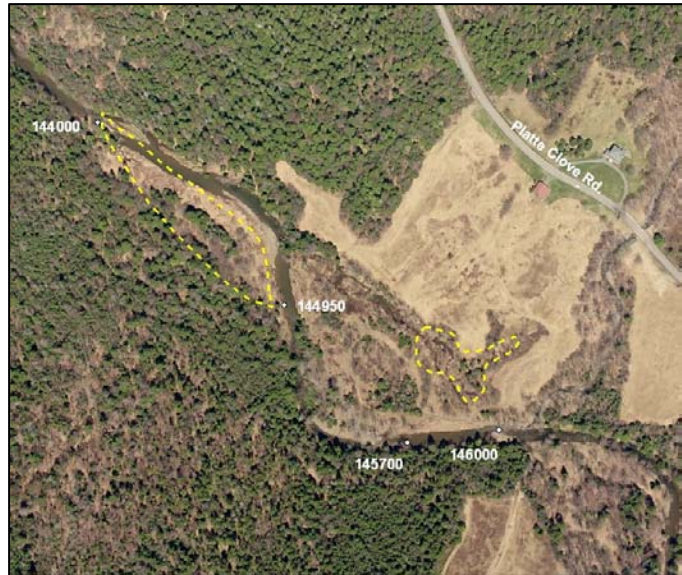
*Wetland (Station 146000-145700 and 144950-144000)
Approximate wetland boundary delineated by NWI*

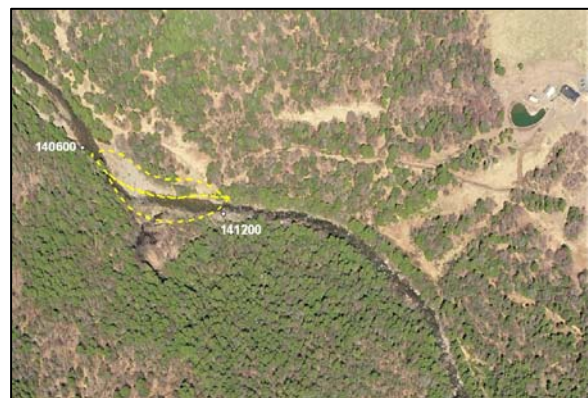
Downstream, at Station 141200 there were two wetlands, which were differentiated by their physical and vegetative characteristics. The wetland along the right streambank was 0.7 acres in size, and was classified as Riverine, Upper Perennial, Unconsolidated Shore, Seasonally Flooded (R3USC). The wetland along the left streambank was also 0.7 acres in size and was

*Wetland located at Station 141200-140600
Approximate wetland boundary delineated by NWI*

classified as Palustrine, Forested, Broad-Leaved Deciduous, Temporarily Flooded (PFO1A).

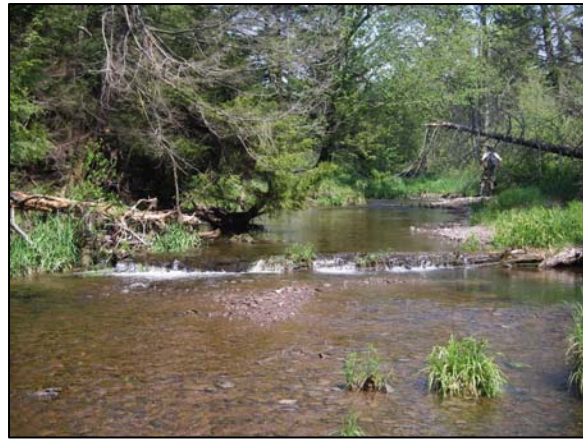
There were four fish habitat structures in this management unit. Habitat structures were historically installed throughout the Schoharie Creek by the New York State Department of Environmental Conservation (NYSDEC), often in an effort to create scour pools. Scour pools offer deeper holding habitat, and the spillways increase the level of dissolved oxygen in the water. The structures, most often in the form of a flat log weir perpendicular to the channel, also provided temporary grade control. In general due to the horizontal, channel spanning design, they cause water to back

Habitat structure

up on the upstream side of the structure which can increase sediment deposition. Because most of these structures do not include an area for concentrated flow that provides for sediment transport, sediment deposition often occurs downstream from an initial scour area under the structure. This can cause widening of the channel, which further decreases sediment transport. In some settings, this can promote lateral channel migration, increase stream channel width-to-depth ratios and result in bank erosion up- or downstream. In wild streams, these functions – both positive and negative – are performed to a large extent by large woody debris. It is recommended that an aquatic habitat study be conducted on the Schoharie Creek with particular attention paid to springs, tributaries and other potential thermal refuge for cold water fish, particularly trout. Once identified, efforts should be made to protect these thermal refugia locations in order to sustain a cold water fishery throughout the summer.
