Schoharie Creek Management Unit 4

Town of Hunter - Station 138610 to Station 124311

2006 Stream Feature Statistics

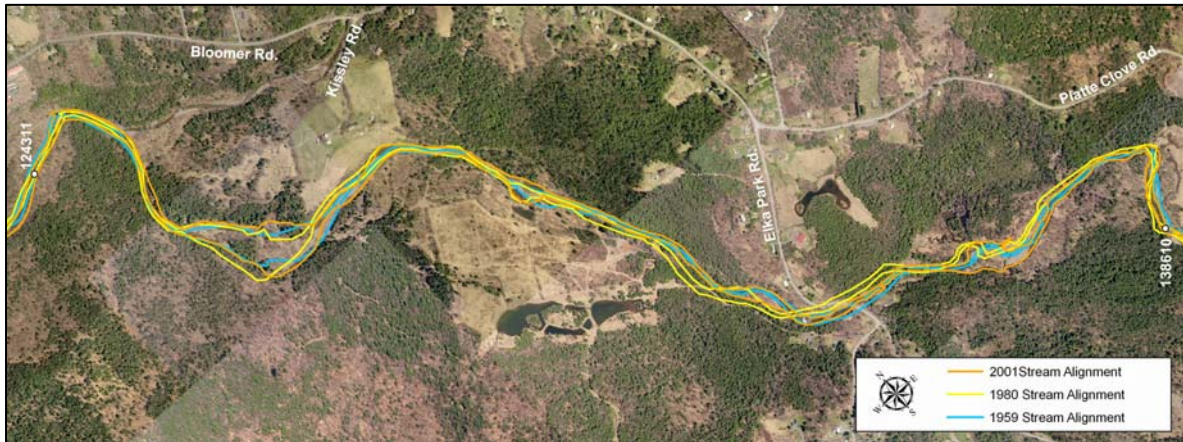
As seen from the historical stream channel alignments (below), the channel alignment has not changed significantly since 1959.

Historic stream channel alignments overlaid with 2006 aerial photograph

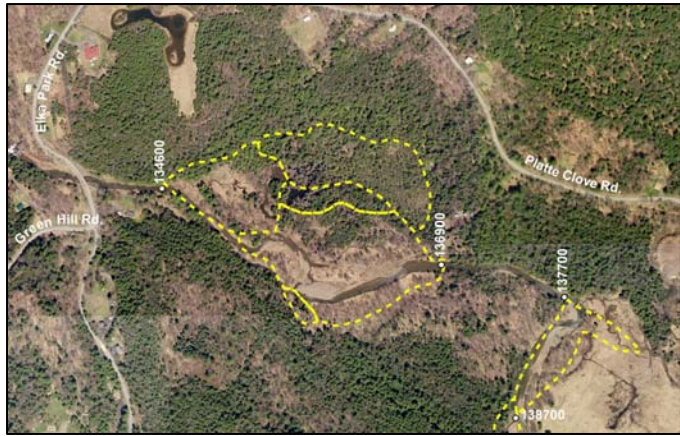
The beginning of this management unit was dominated by two large palustrine wetlands (Station 138700 - 137700 and 136900 - 134600). Wetlands are important features in the landscape that provide numerous beneficial functions including protecting and improving water quality, providing fish and wildlife habitats, storing floodwaters, and maintaining surface water flow during dry periods. The first palustrine wetland was approximately 3.6 acres with forested vegetation (Station 138700 – 137700) (PFO1A); and the larger 28.6 acre wetland downstream had a mixture of forested and shrub-scrub vegetation (Station 136900 – 134600) (PFO1A, PFO4E, PSS1A, PSS1Eb) (see Section 2.6 for detailed wetland type descriptions).

Wetland (Station 138700 - 137700 and 136900 - 134600)
Approximate wetland boundary delineated by NWI

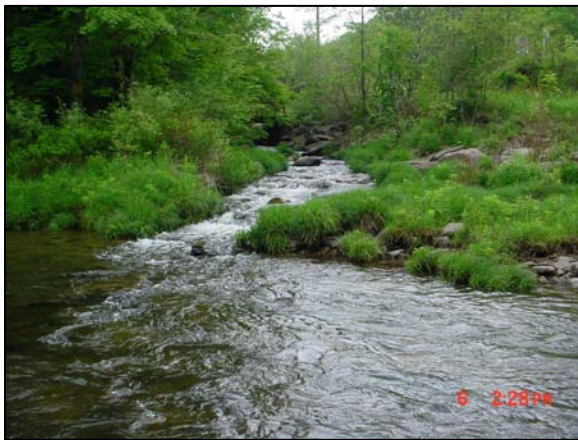
Cook Brook tributary confluence at Station 134200

Downstream, Cook Brook *tributary* entered the Schoharie Creek from the left streambank (Station 134200). This tributary drains the slopes of Plateau and Spruce Top Mountains. The New York State Department of Environmental Conservation classifies streams and rivers based on their “best use” (NYSDEC, 1994). The headwaters of this tributary was classified C(ts) by the NYS DEC, indicating that the

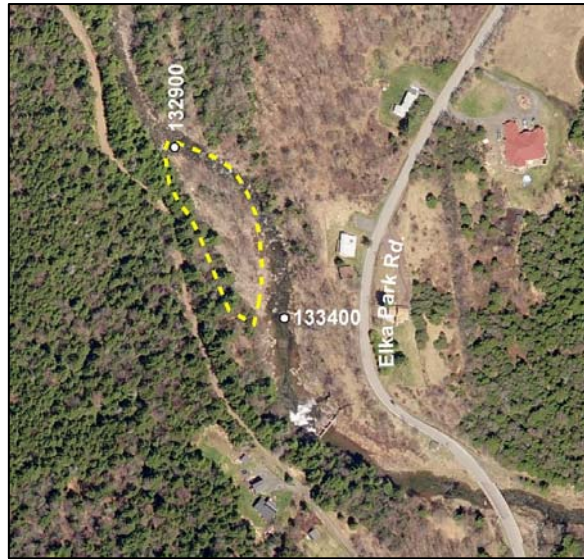
Downstream of the dam, the stream channel was fairly straight, confined by the valley form, and the streambanks appeared stable. There was a 1 acre palustrine wetland with shrub-shrub vegetation along the left streambank (Station 133400-132900) (PSS1A). Woody debris had accumulated in this area but did not seem to have caused any detrimental effects. The right streambank had experienced scour during high flow events, resulting in a 30ft long segment of exposed glacial lake silt/clay (Station 133100).

Wetland (Station 133400-132900)

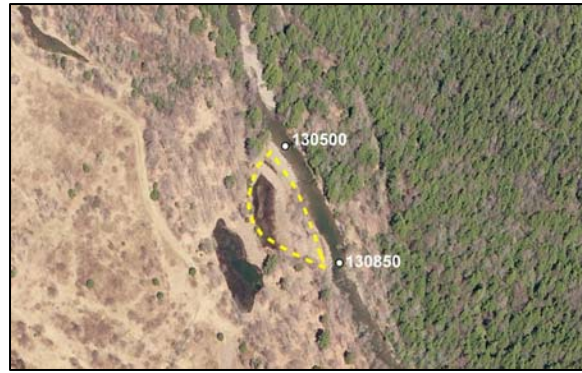
Beyond this rip-rap was another small palustrine wetland located on the left streambank (Station 130850-130500). This wetland encompassed approximately 0.7 acres with shrub-scrub vegetation (PSS1A). On the opposite bank from this rip-rap, the right streambank (Station 130850) was experiencing erosion along 388ft, exposing an area of 2230ft². This failure had begun to undermine several mature trees at the top of the bank.

*Wetland (Station 130850-130500)
Approximate wetland boundary delineated by NWI*

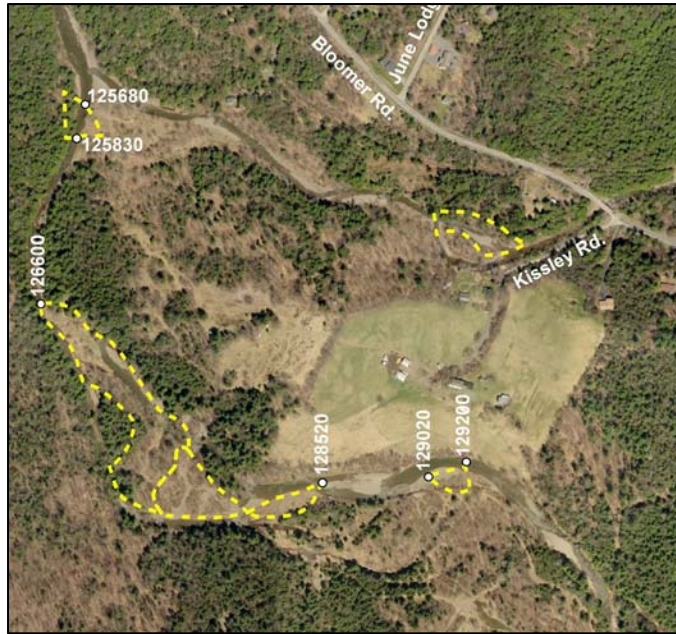
There were several wetlands in this area. The first wetland was a small 0.3 acre wetland classified as riverine upper perennial with an unconsolidated shore, signifying it was contained in the natural channel and characterized by a high gradient and fast water velocity (Station 129200-129020) (R3USA).

The large wetland between Station 128520 and 126600 was comprised of two wetland types. The upstream half, approximately 2 acres, was classified as riverine upper perennial with an unconsolidated shore (R3USA), while the lower 4 acre wetland was palustrine with forested vegetation (PFO1A). Another small riverine upper perennial wetland with an unconsolidated shore, approximately 0.5 acres in size, was located between Stations 125830-125680 (R3USA).

Wetland boundaries approximately delineated by NWI (Stations 129200-129020, 128520-126600, 125830-125680)

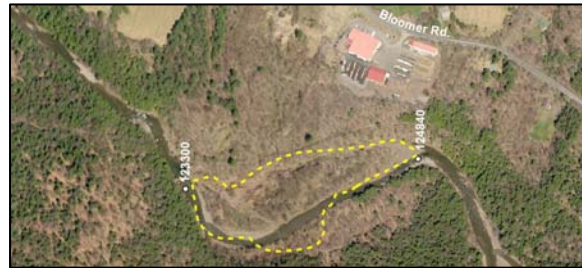
At the end of this management unit, a large palustrine wetland began and extended into the next unit (Station 124840-123300). This wetland was classified as palustrine with forested vegetation (PFO1A).

Wetland boundary approximately delineated by NWI (Stations 124840-123300)
