Manor Kill Management Unit 5

Town of Conesville – Station 24315 to Station 19795

This management unit began at Station 24315, and continued approximately 4,520 ft to Station 19795 in the Town of Conesville.

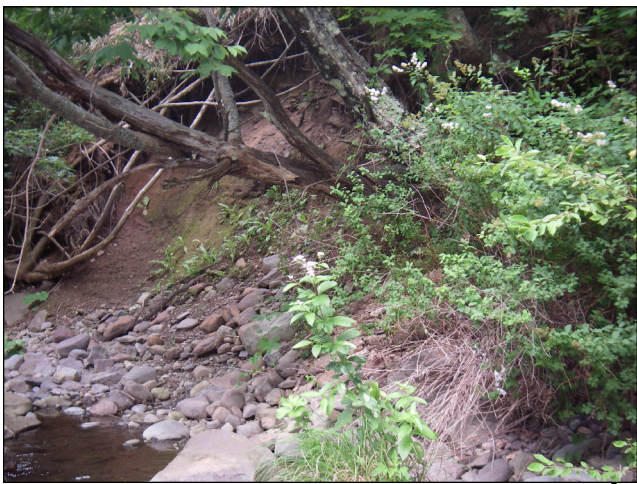
A

Along the middle portion of this planting site, there were two areas of erosion. The first erosion site (Figure 4.5.1, Inset A, Stations 20484 – 20374) stretched along approximately 110 feet of the right bank and resulted in an erosion area of 1,318 ft² with exposed roots, fallen trees and overhanging bank material. Some of the fallen trees and associated woody debris contributed to localized scour of the channel bed and toe of the streambank. The second erosion site (Stations 20335 – 20124), was less significant, although

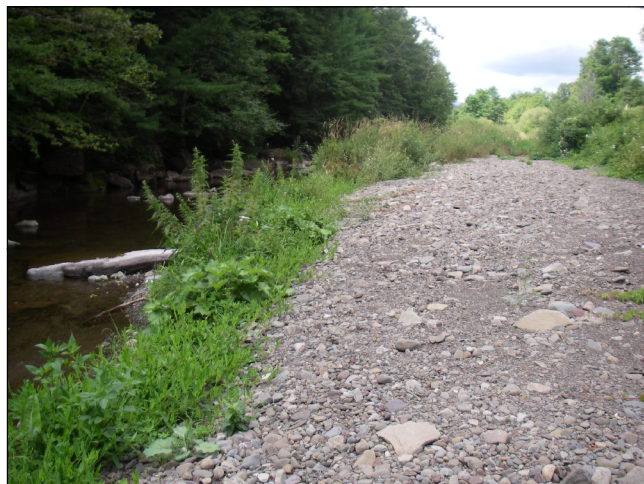
**B**

21024) at its confluence. There was also a significant side bar (Figure 4.5.1, Inset B, Stations 21022 – 20748) along approximately 274 feet of the right channel bed, just downstream of the tributary. Sediment deposition is a common feature of confluence areas, which often contain extensive sediment bars, function as important sediment storage areas, and are typically among the most dynamic and changeable areas in the stream system. This tributary was classified C(ts) by the NYS DEC, indicating that the best uses for this stream are supporting fisheries, including trout spawning, and other recreational activities.

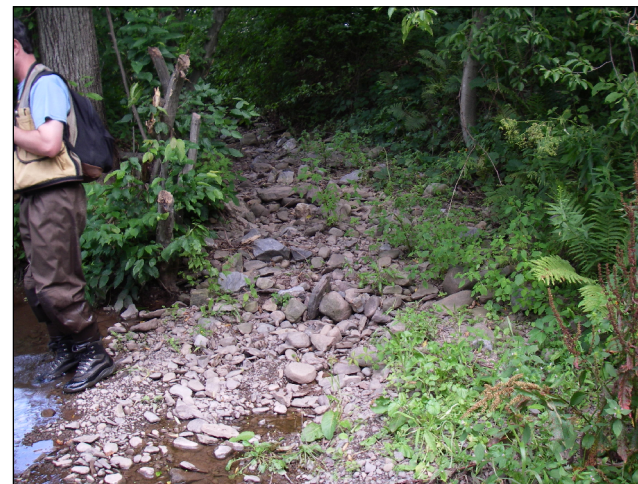
**C**

Downstream a sizable unnamed, intermittent tributary entered from the left streambank (Figure 4.5.1, Insert C, Station 21844, photograph orientation looking at). At the time of the assessment, flow was subsurface. The New York State Department of Environmental Conservation classifies streams and rivers based on their “best use” (NYSDEC, 1994). This tributary was

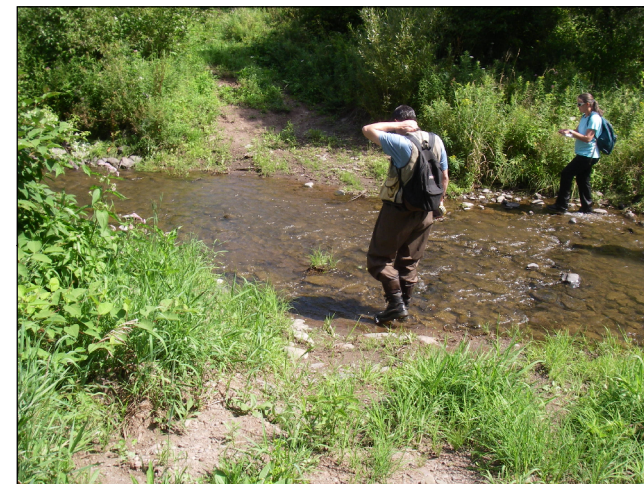
**D**

include planting native trees and shrubs along the streambank and the upland area. Buffer width should be increased by the greatest amount agreeable to the landowners. At this site, there was a narrow forested buffer beyond the successional old field, followed by maintained herbaceous agricultural fields. By planting this site from the stream's edge to the forested area, a 100 foot buffer would be created. Increasing the buffer width to at least 100 feet will increase the buffer functionality and protect the stream from nearby land uses. Along this planting site, there was a stream channel crossing (Figure 4.5.1, Inset D, photograph orientation looking at, Station 24253) that appeared to be used for recreational purposes.

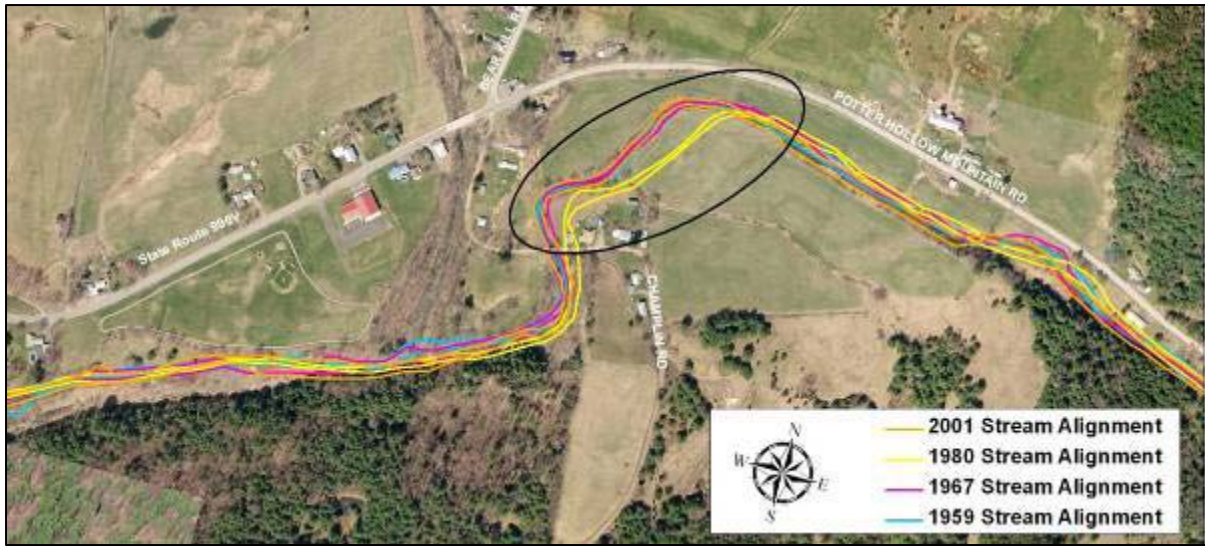
Historic stream channel alignments overlaid with 2006 aerial photograph

As seen from the historical stream channel alignments (above), the *planform* of the channel has not changed significantly over the years along this management unit; the channel has remained fairly stable. When *georeferencing* the 1980 aerial imagery, or establishing a relation between the images to map projections or coordinate systems within a *Geographic Information System (GIS)*, we encountered some problems with accuracy. The area indicated on the map above shows that the alignment and shape of the channel remained similar to previous years, although it is slightly off in location; this is primarily due to problems associated with the georeferencing process.
