Manor Kill Management Unit 6

Town of Conesville – Station 19795 to Station 15492

This management unit begins at Station 19795 continuing approximately 4,303 ft to Station 15492 in the Town of Conesville.

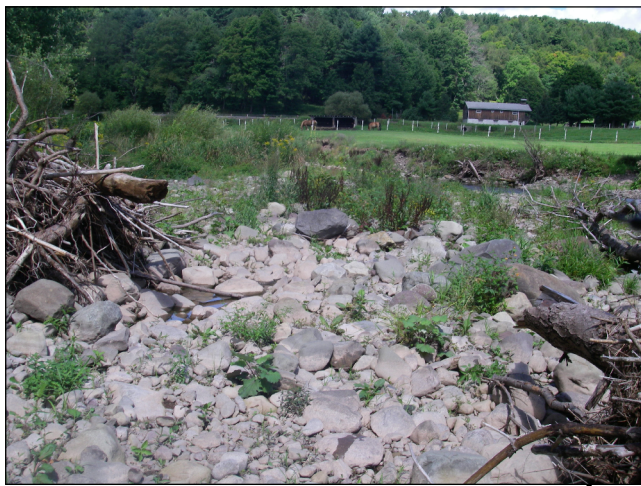
A

the start of this wetland, as the stream meandered to the left, there was a substantial point bar (Figure 4.6.1, Inset A, Stations 16060 - 15714) stretching along the left channel bed for approximately 346 feet. Point bars commonly form on the inside of meander bends, where stream velocity is slower during high flows, allowing sediment to drop out of

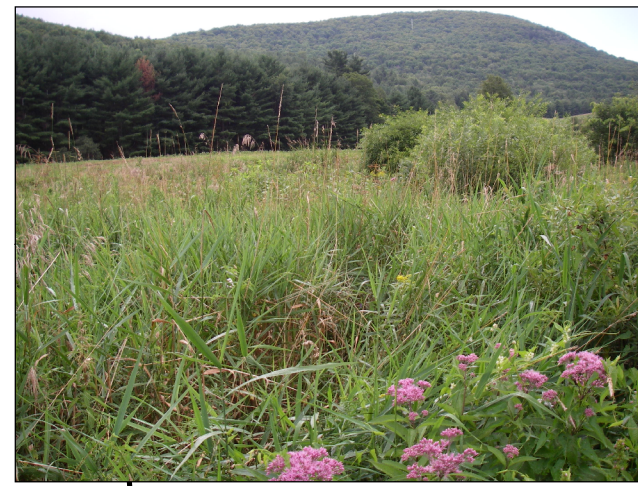
**C**

Along this stretch of stream, there were two additional proposed riparian planting sites; one on the left streambank (Figure 4.6.1, Inset C, Stations 18252 – 18132) for

approximately 120 feet and the other on the right streambank (Stations 18215 – 17786) for approximately 429 feet. Recommendations for these sites remain consistent with the previously discussed planting sites including, planting native tree and shrub species along the streambank and upland areas and increasing the buffer width to at least 100 feet or the greatest amount agreeable to the landowners. Aggradational conditions

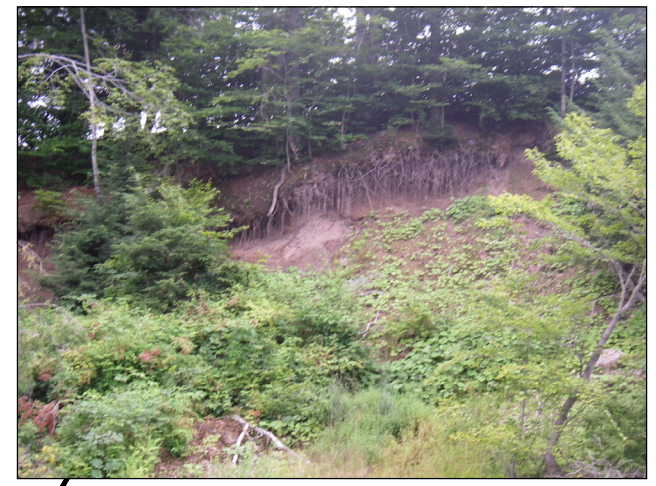
**D**

Continuing along this meander bend, the *thalweg*, or deepest part of the stream channel, flowed up against the left streambank causing the first mass failure (Figure 4.6.1, Inset D, Stations 19015 – 18872). This mass failure resulted in an erosion area of approximately 7,174 ft², exposing roots and compromising mature trees along the bank. During the field assessment, this bank was identified as a proposed Bank Erosion Monitoring Site (BEMS) to study erosion along this reach. To monitor BEMS, a cross-section and long profile may be conducted to collect baseline data. Once the baseline data has been collected, this cross-section can be resurveyed in the future to calculate the bank's erosion rate. Along this erosion site, multiple large trees (Stations 19000 and 18918) had fallen across the stream channel contributing to upstream aggradation and localized scour of the channel bed and toe of the streambank. The first woody debris obstruction contributed to scour that created large, deep pools. Woody debris such as this, is beneficial to a stream system, it provides critical habitat for fish and insects, and adds essential organic matter that will benefit organisms downstream.

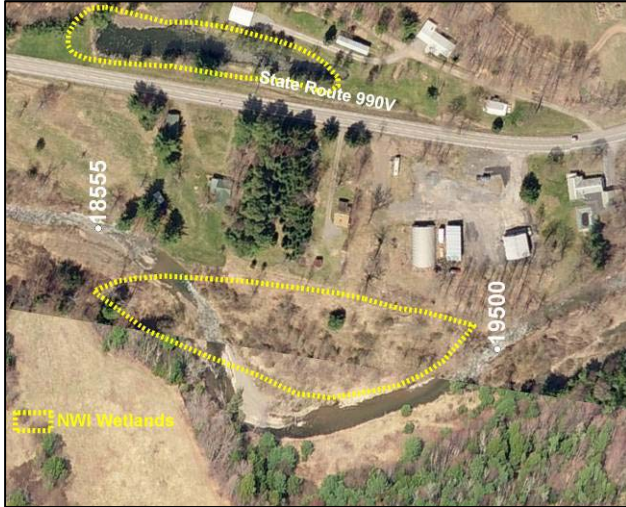
Wetland Boundary approximately delineated by NWI Stations 19500 - 18555

As the stream meandered to the right, there was a 2 acre palustrine wetland (Stations 19500 – 18555). Wetlands are important features in the landscape that provide numerous beneficial functions including protecting and improving water quality, providing fish and wildlife habitats, storing floodwaters, and under certain conditions

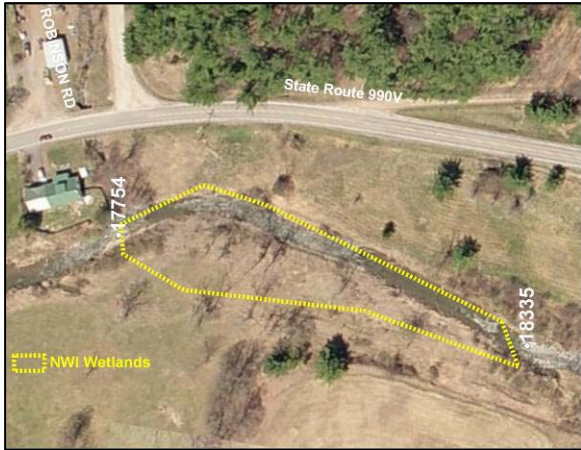
Wetland boundary approximately delineated by NWI Stations 18335 - 17754

appropriate species and locations for plantings. Aggradational conditions persisted along this stretch of stream. Downstream of the proposed planting site there was a one acre palustrine wetland (Stations 18335 – 17754) classified as PEM1A, *palustrine, emergent, persistent, temporarily flooded*.

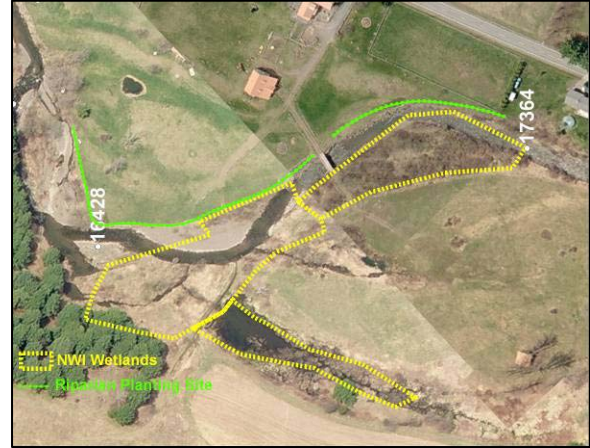
Riparian Planting Sites Stations 17300 – 16963 and 16937 - 16264

There were two proposed riparian planting sites (Stations 17300 – 16963 and Stations 16937 - 16264) along this wetland complex stretching for a total of approximately 1,010 feet along the right streambank. Along these sites, there was mown lawn to the stream's edge. Recommendations for this site include, discontinued mowing to the stream's edge and

Wetland boundary approximately delineated by NWI Stations 17384 – 16428

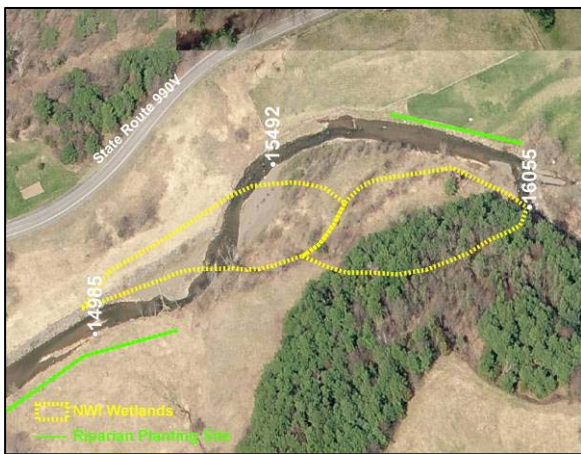
Riparian Planting Site at Stations 15969 - 15716

Wetland boundary approximately delineated by NWI Stations 16055 – 14985
