Manor Kill Management Unit 7

Town of Conesville – Station 15492 to Station 9805

This management unit begins at Station 15492, continuing approximately 5,687 ft to Station 9805 in the Town of Conesville.

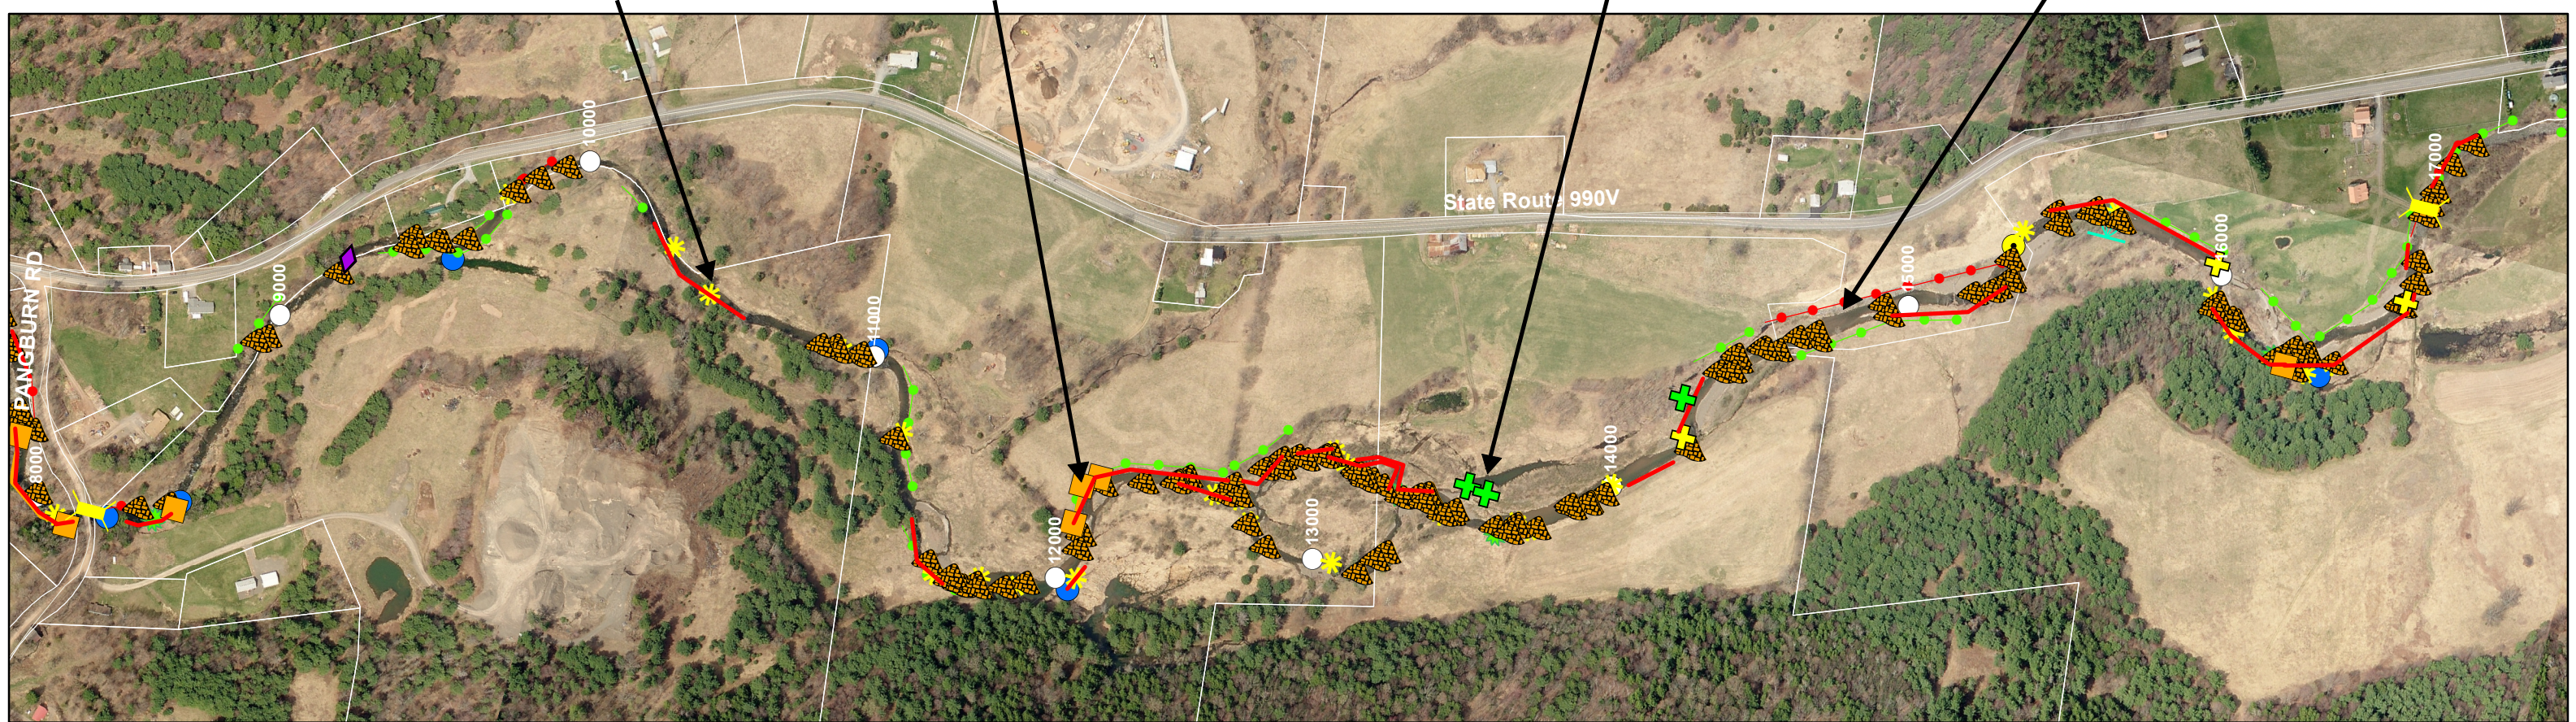
Figure 4.7.1 Management Unit 7 - 2006 aerial photography with 2008 stream feature inventory.

The 2008 stream feature inventory revealed that 24% (2,714ft) of the streambanks exhibited signs of active erosion along the 11,374 ft. of total streambank length in the unit (Figure 4.7.1). *Revetment* has been installed on 6.7% (767 ft.) of the streambanks. Approximately 0% (0 ft.) of the streambanks have been bermed.

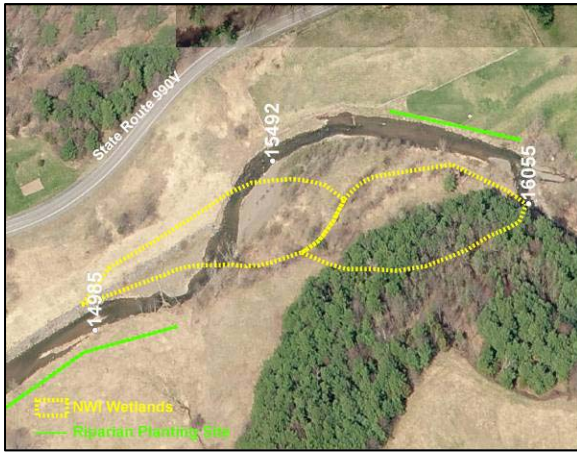
Riparian Planting Site at Stations 15127 - 14683

Wetland boundary approximately delineated by NWI Stations 16055 – 14985

Increasing the buffer width to at least 100 feet will increase the buffer’s functionality. The eroding conditions along the upstream portion of the proposed planting site should be given careful consideration when identifying the appropriate species and locations for plantings. Prior to proceeding with any vegetative plantings, a more detailed site assessment may be necessary to determine whether stream bank grading will be required.

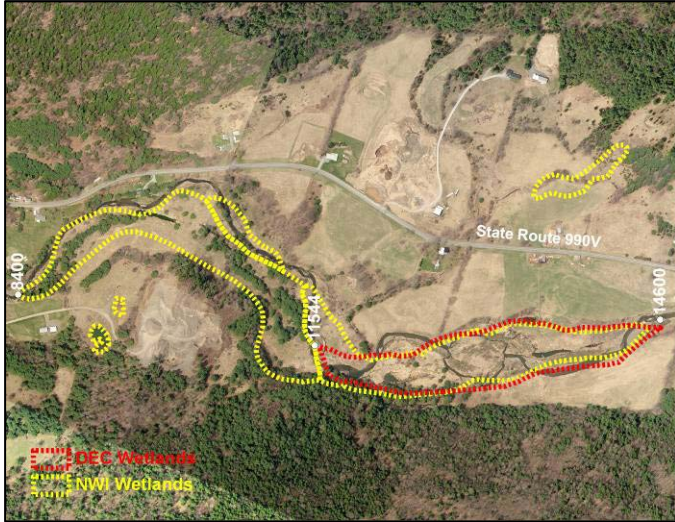
Wetland boundaries approximately delineated by NWI
 NYS DEC designated wetland
 Stations 14600 - 8400

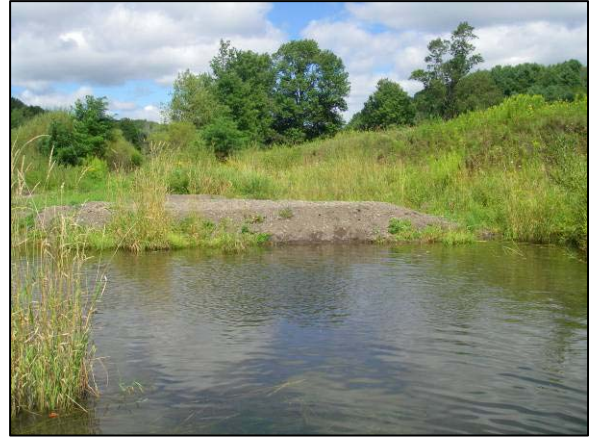
Point Bar at Stations 14491 - 14251

Opposite the erosion site, there was a point bar that stretched for approximately 240 feet along the left stream bed. There was an overflow channel along the backside of the point bar. The overflow channel contributed to the excess sediment deposition, particularly along the downstream end of the point bar, which had a steep drop off into a deep pool in the main channel. Just downstream, there was a stream channel crossing or access point (Station 14250) that appeared to be used for recreational purposes, and was only maintained along the right streambank.

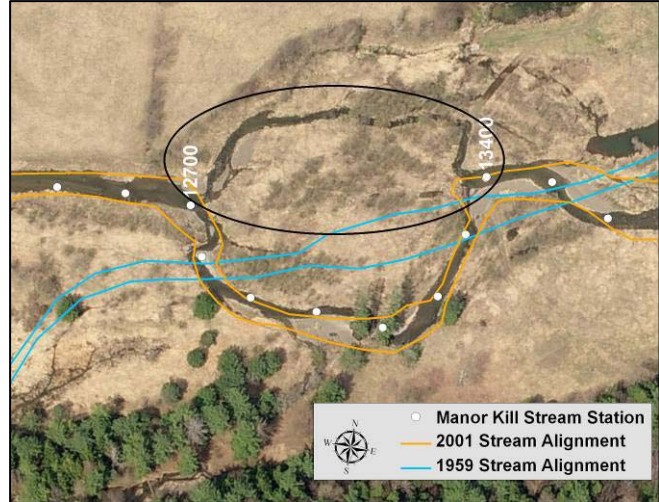
Lateral Migration between Stations 13400 - 12700

main channel. Flood chutes convey flow through a secondary channel during periods of high flows; this flood chute converged (Station 12665) with the main channel approximately 728 feet downstream. Based on a review of the historic and recent aerial photographs, this area has experienced significant lateral migration. Sometime between 1980 and 2001, the relatively straight channel observed in the 1959, 1967 and

1980 aerial imagery, meandered to the left, creating a new more sinuous channel. This new channel appeared to function as the main channel through 2006 (stream stationing based on 2006 aerials), and a less significant channel meandered to the right (see area indicated with black oval). Between 2006 and the 2008 assessment, the existing secondary channel (right (black oval)) became the main channel, while the left channel (previously mentioned, Stations 13393 – 12665) appeared to be cut off from the main channel due to abundant woody debris and aggradation. This channel may function as an overflow channel during very high flood flows.

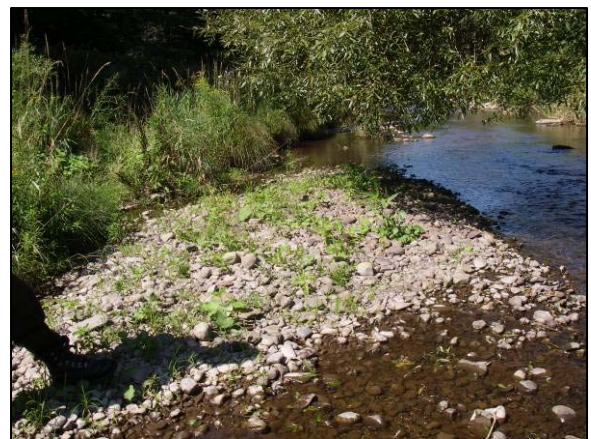
Transverse Bar at Stations 10914-10854

As the stream meandered to the left, a tributary (Station 11029) entered from the right streambank. This tributary drains the slopes of Bull Hill Mountain before it reaches the flatter topography of the valley floor where it enters the Manor Kill. The New York State Department of Environmental Conservation classifies streams and rivers based on their "best use" (NYSDEC, 1994). This tributary was classified C by the NYS DEC, indicating that the best uses for this stream are supporting fisheries and other recreational activities. Downstream of the tributary were multiple depositional features including transverse and point bars. Excess deposition is a common feature of confluence areas, which often contain

extensive sediment bars, function as important sediment storage areas, and are typically among the most dynamic and changeable areas in the stream system.

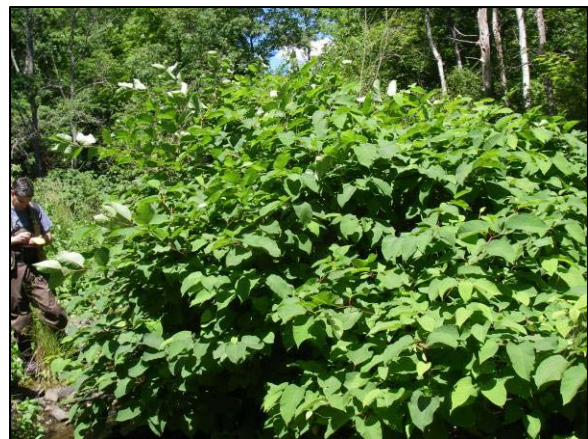
Japanese knotweed at Station 42469

Plant species that are not native can create difficulties for stream management, particularly if they are invasive. Japanese knotweed (*Fallopia japonica*), for example, has become a widespread problem in recent years. Knotweed shades out other species with its dense canopy structure (many large, overlapping leaves), but stands are sparse at ground level, with much bare space between narrow stems, and without adequate root structure to hold the soil of streambanks. The result can include rapid streambank erosion and increased surface runoff leading to a loss of valuable topsoil. Japanese knotweed locations were documented as part of the stream feature inventory conducted during the summer of

2008 (Riparian Vegetation Mapping, Section 2.7). In total, one 10-foot long patch of Japanese knotweed was documented during the stream feature inventory. The best means for controlling knotweed is prevention of its spread, therefore, effort should be made to ensure that all fill brought into the area is clean and does not have fragments of knotweed or other invasive plants. If Japanese knotweed sprouts, or small stands are observed, they should be eradicated immediately to avoid further spread within this unit and to downstream management units.
