# Manor Kill Management Unit 8

Town of Conesville – Station 9805 to Station 4523

This management unit began at Station 9805 and continued approximately 5,282 ft to Station 4523 in the Town of Conesville.

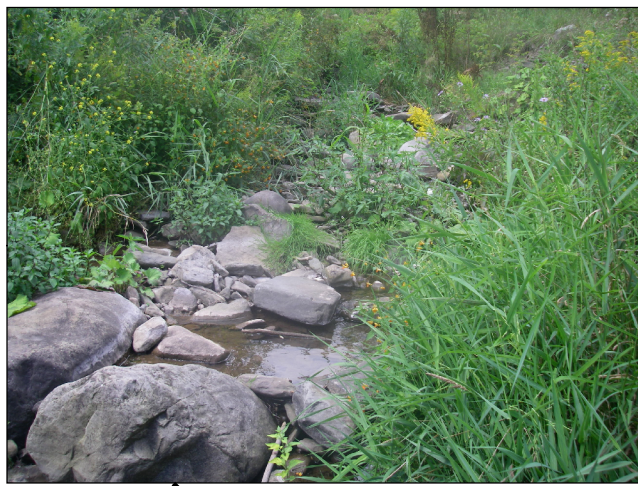
**A**

Continuing downstream, an unnamed tributary (Figure 4.8.1, Inset A, Station 4552) entered from the right streambank. This tributary was classified A by the NYS DEC, indicating that the best uses for this stream are drinking, supporting fisheries and other recreational activities. At the mouth of the tributary, and along the upper portion of the stream bank, a large stand of knotweed was observed. Management Unit 8 ended just downstream of the tributary at Station 4523.

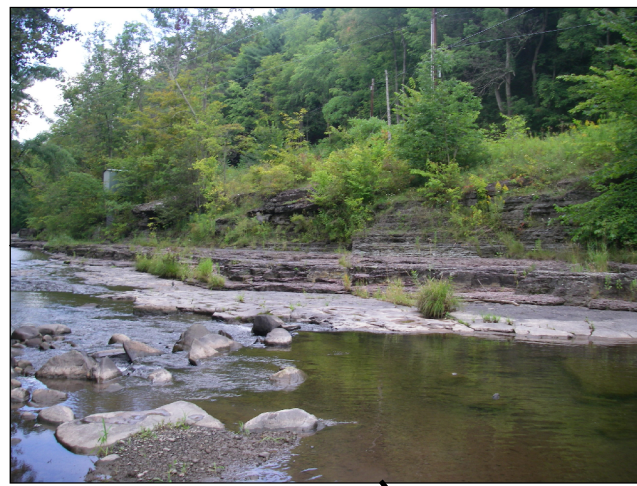
**B**

interplanted into the rip rap. As the stream turned sharply to the left, bedrock (Figure 4.8.1, Inset B, Stations 7368-6336) extended from the top of the bank along State Route 990V into the channel of the right streambank and bed for approximately 1,032 feet. This bedrock at times covered the full bed of the stream channel. The bedrock provides lateral control along the right bank by limiting stream bank erosion; it provides grade control for the channel by preventing degradation or downcutting of the stream, the process by which streambeds and floodplains are lowered in elevation by eroding downward into the stream bed over time.

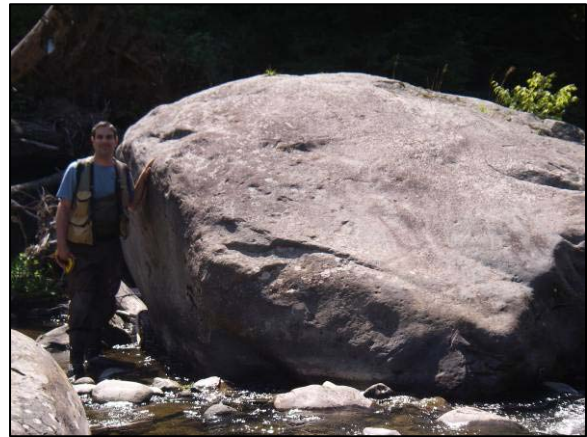
*Boulder at Station 8322*

Along this erosion clay was exposed in the bed and bank for approximately 10 feet. Clay inputs into a stream are a serious water quality concern because they increase turbidity, degrade fish habitat, and can act as a transport mechanism for other pollutants and pathogens. Large boulders in the stream contributed to aggradation as well as the scouring of pools along the erosion. Multiple large trees (Stations 8346) had fallen into the stream channel contributing to minor scouring and deposition. Woody debris such as this is beneficial to a stream system; it provides critical habitat for fish and insects, and adds essential organic matter that will benefit organisms downstream.
