Manor Kill Management Unit 9

Town of Conesville – Station 4523 to Station 1775

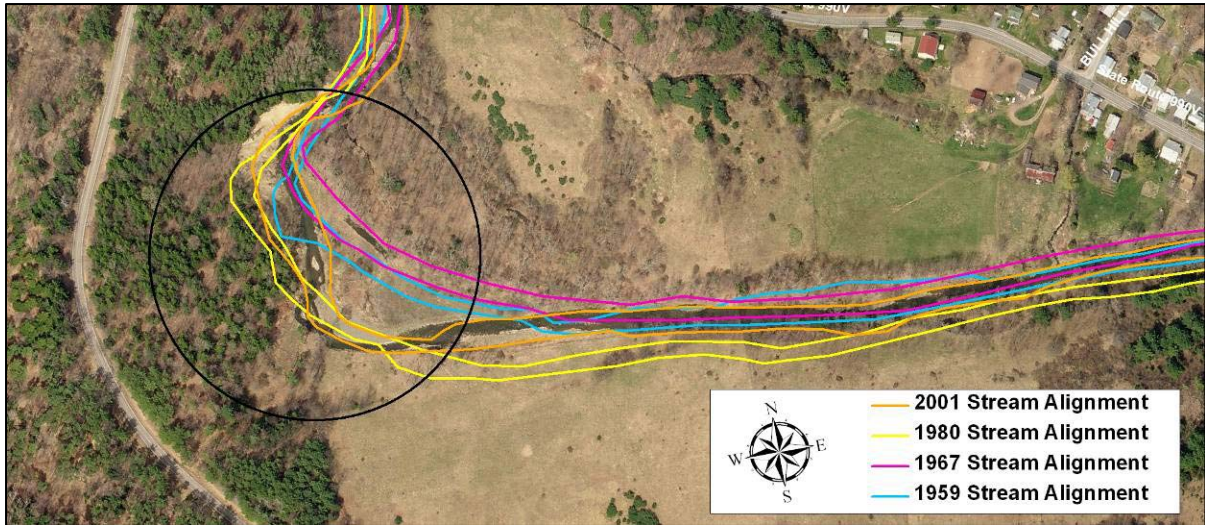
Historic stream channel alignments overlaid with 2006 aerial photograph

As seen from the historical stream channel alignments (above), the *planform* of the channel has remained fairly stable through the upstream portion of the management unit; the downstream portion appears to be experiencing *lateral migration*. Lateral migration is the movement of a channel across its floodplain, which usually results in extensive bank erosion. The outside banks of meander bends tend to move laterally across the valley floor and down the valley.

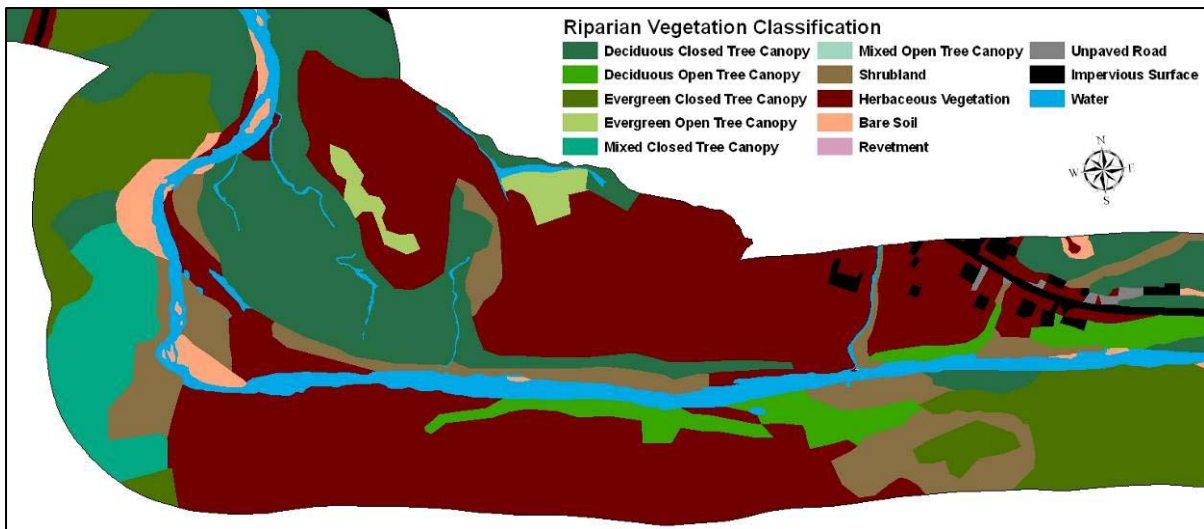
Riparian vegetation classification map based on aerial photography from 2006

An analysis of vegetation was conducted using aerial photography from 2006 and field inventories (see above map and Riparian Vegetation Mapping, Section 2.7). In this management unit, the predominant vegetation type within the 300 ft. riparian buffer was herbaceous (52.52%) followed by forested (32.22%). *Impervious* area (0.08 %) within this unit's buffer was primarily the local and private roadways. Areas of herbaceous (non-woody) cover may present opportunities to improve the riparian buffer with tree plantings in order to promote a more mature vegetative community along the streambank and in the floodplain.

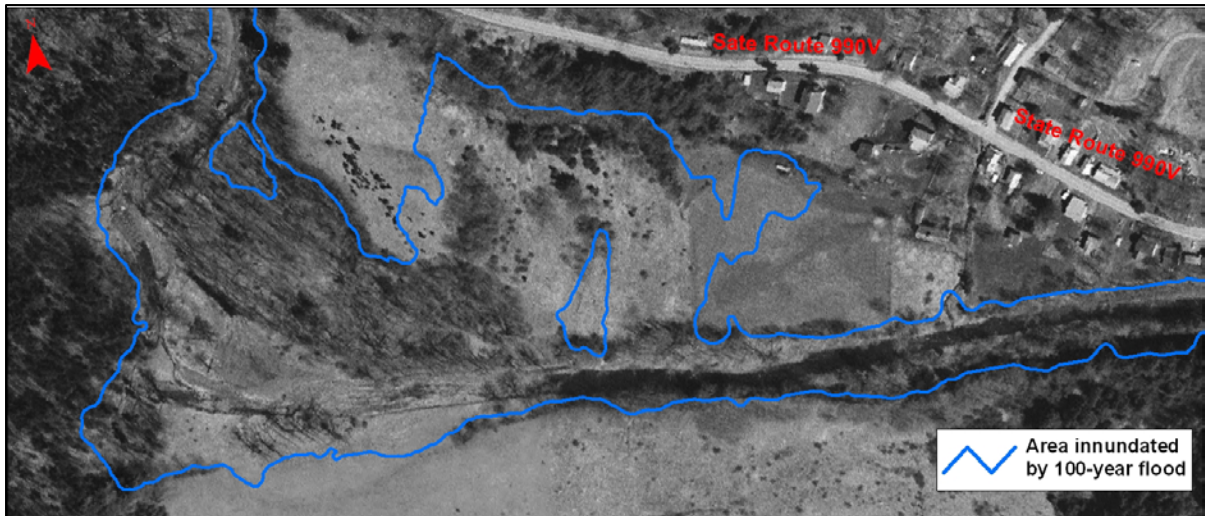
100-year floodplain boundary map

According to the current floodplain maps (above), no existing structures in this unit appeared to be situated within the estimated 100-year floodplain. The 100-year floodplain is that area predicted to be inundated by floods of a magnitude that is expected to occur once in any 100-year period, on the basis of a statistical analysis of local flood record. Most
