Manor Kill Management Unit 10

Town of Conesville –Station 1775 to Station 0

This management unit begins at Station 1775, continuing approximately 1,775 ft to Station 0, at Manor Kill’s confluence with the Schoharie Reservoir, in the Town of Conesville.

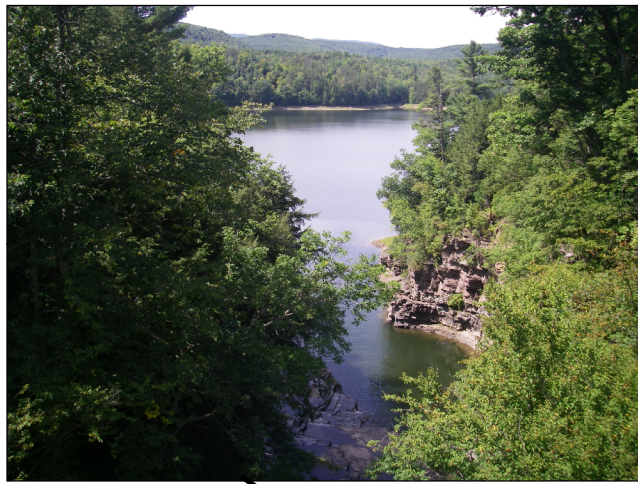
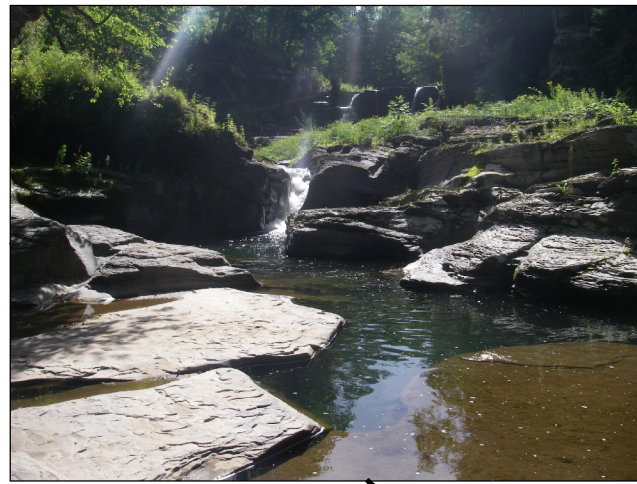
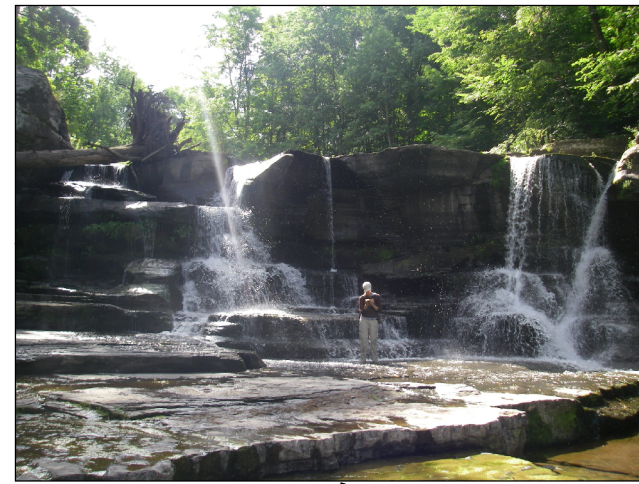
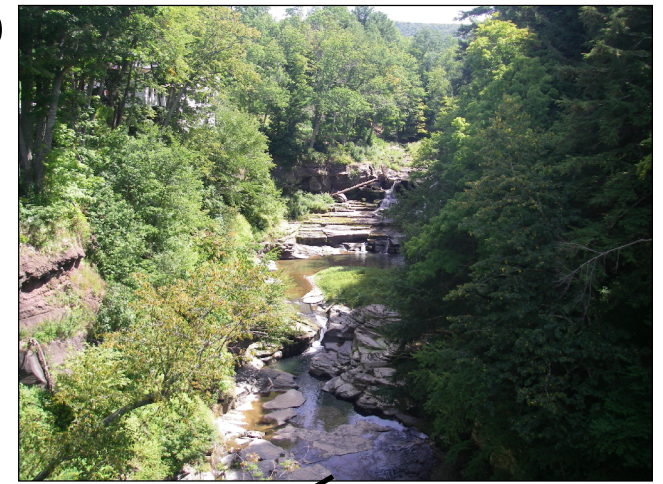
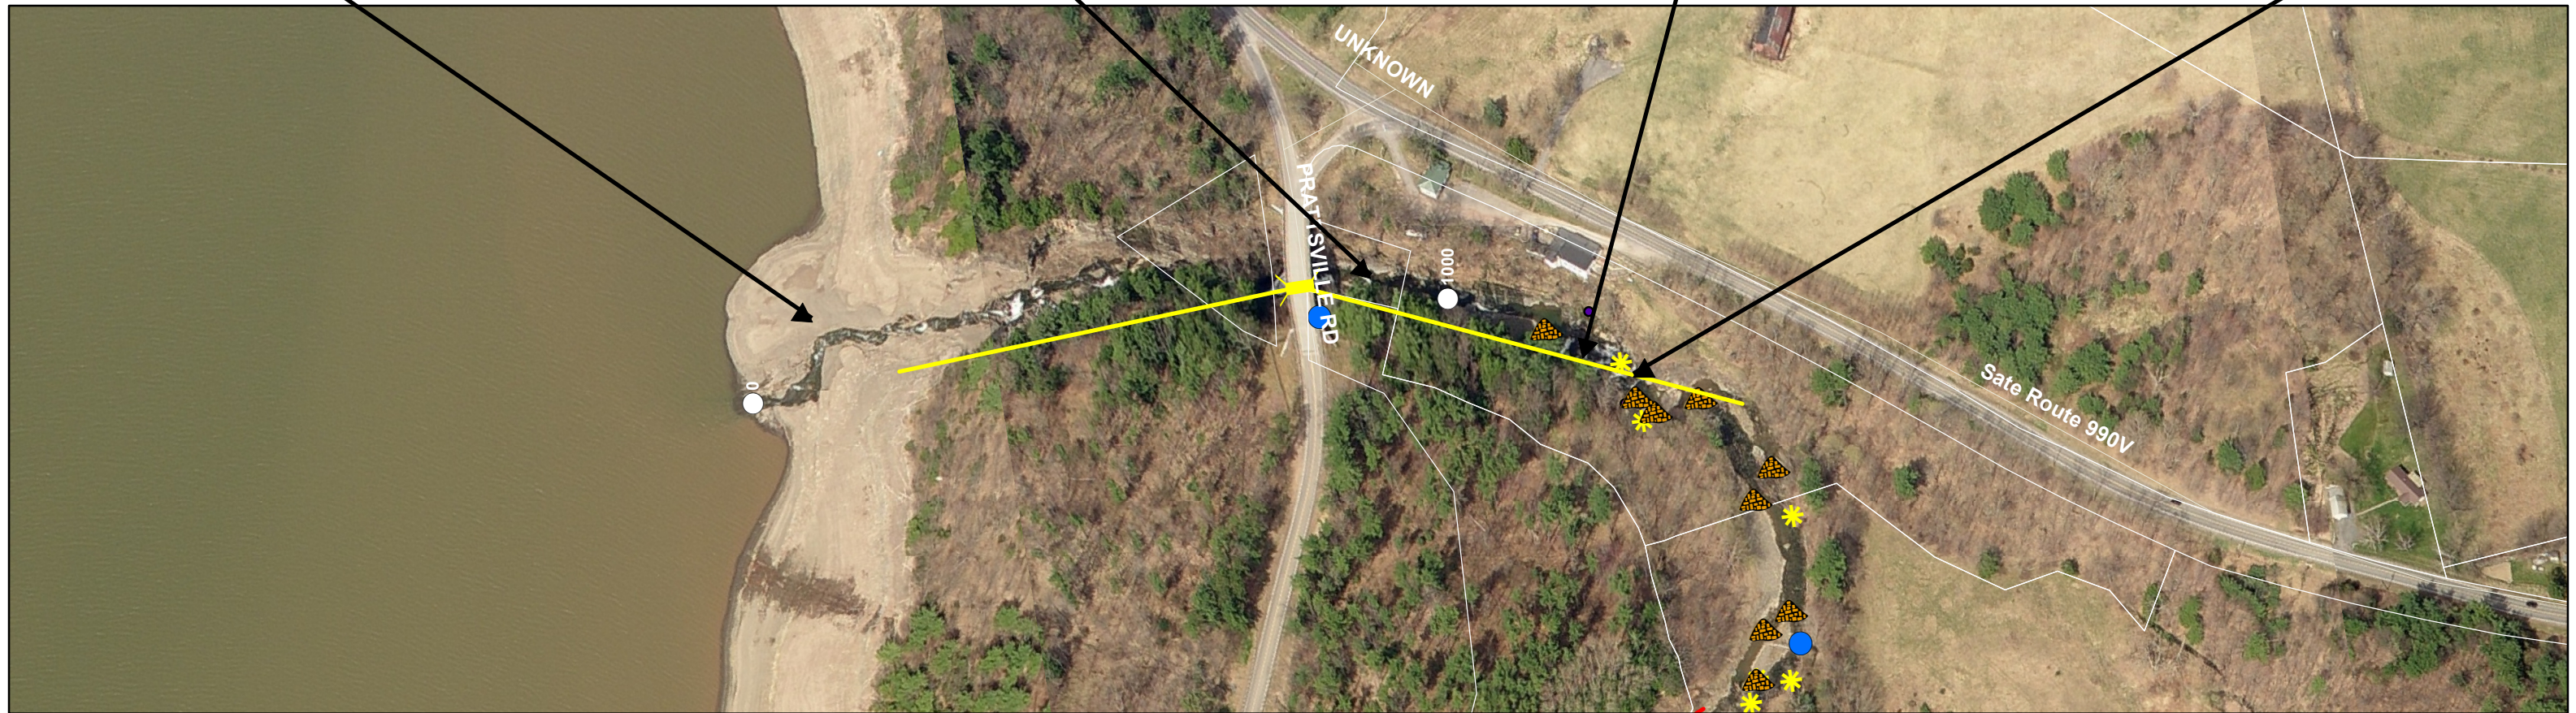
Figure 4.10.1 Management Unit 10 - 2006 aerial photography with 2008 stream feature inventory.

The 2008 stream feature inventory revealed that there were no streambanks with signs of active erosion along the 3,550 ft. of total streambank length in the unit (Fig. 4.10.1). There were also no *Revetments* or berms in Management Unit 10.

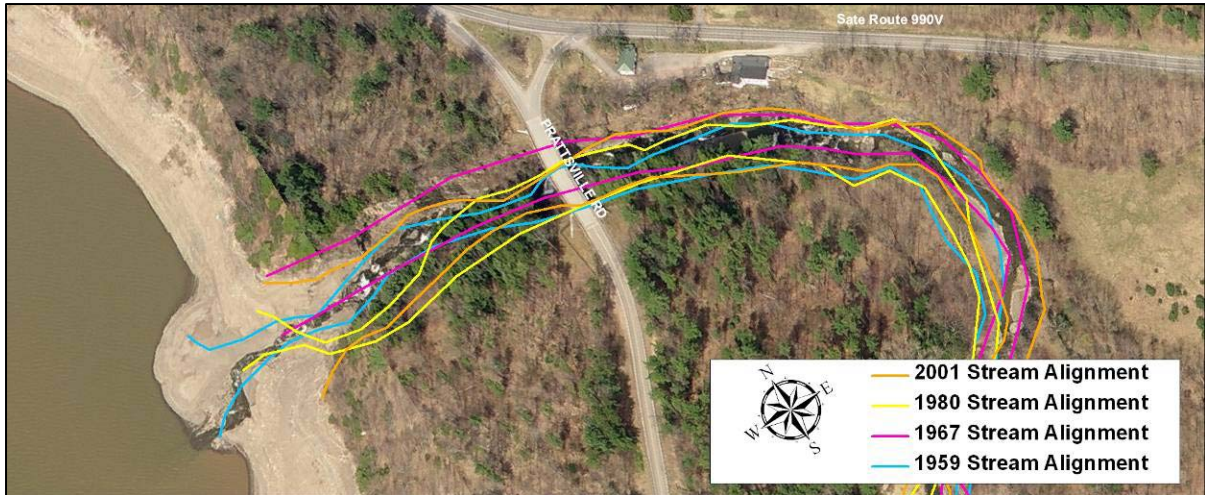
Historic stream channel alignments overlaid with 2006 aerial photograph

As seen from the historical stream channel alignments (above), the *planform* of the channel has not changed significantly over the years; the channel has remained fairly stable throughout this management unit.

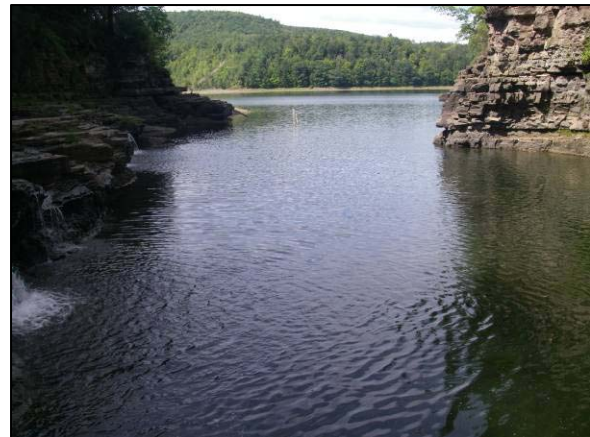
showed no signs of scour and the bridge appeared to pass stream flows effectively. Under the bridge, a seep entered the stream over vegetated bedrock along the left bank. Management Unit 10 ended as the stream exited the pool downstream of the fourth tier and flowed into the Schoharie Reservoir. (Figure 4.10.1, Inset A, Station 0). The Schoharie Reservoir contributes approximately 15% of NYC water annually (Joint Venture, 2004).

Manor Kill Confluence with the Schoharie Reservoir

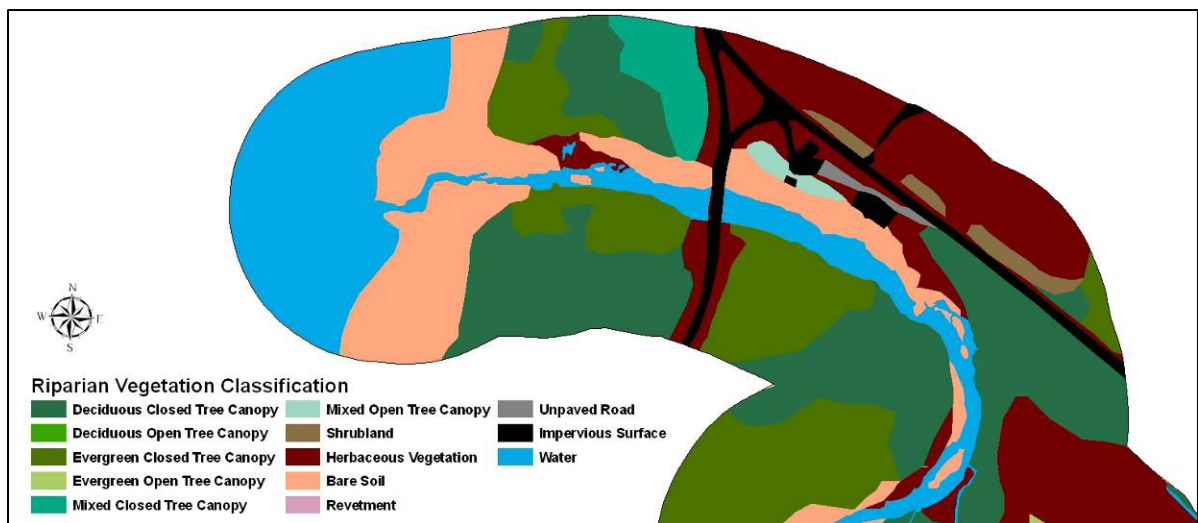
Riparian vegetation classification map based on aerial photography from 2006

An analysis of vegetation was conducted using aerial photography from 2006 and field inventories (see above map and Riparian Vegetation Mapping, Section 2.7). In this management unit, the predominant vegetation type within the 300 ft. riparian buffer was forested (45.66%) followed by herbaceous (17.12%). *Impervious* area (4.48 %) within this unit’s buffer was primarily the local and private roadways. Areas of herbaceous (non-woody) cover may present opportunities to improve the riparian buffer with tree plantings in order to promote a more mature vegetative community along the streambank and in the floodplain.

Summary of Recommendations Management Unit 10	
Intervention Level	Assisted Self-Recovery
Stream Morphology	No recommendations at this time.
Riparian Vegetation	Treat, remove and prevent the spread of Japanese knotweed where feasible. Plant a buffer of trees and shrubs along proposed planting sites and increase width of riparian buffer in appropriate locations.
Infrastructure	When bridges are replaced, construct with the appropriate height and width to allow conveyance of flood flows. Inspect the stormwater infrastructure to ensure some level of treatment prior to emptying into the stream.
Aquatic Habitat	Watershed Aquatic Habitat Study
Flood Related Threats	No recommendations at this time.
Water Quality	Encourage homeowners to participate in the CWC septic program, if eligible.
Further Assessment	Consider hydraulic analysis of bridge openings.
