Manor Kill Management Unit 1

Town of Conesville – Station 53,637 to Manor Creek Road (Station 45,598)

Manor Kill Management Unit 1 Stream Feature Inventory

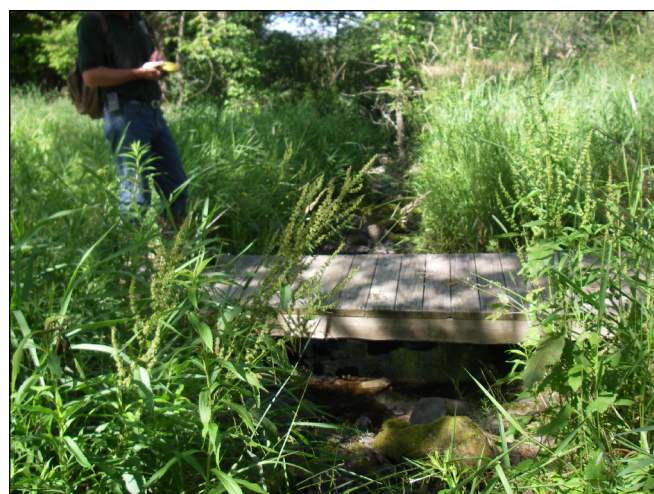
**B**

Downstream of the berm, there was a private wooden foot bridge (Figure 4.1.1, Inset B, Station 46755). This bridge was adequate width and height for low flows, but may pose an obstruction during higher flows. At the time of the assessment flow became subsurface downstream of the bridge.

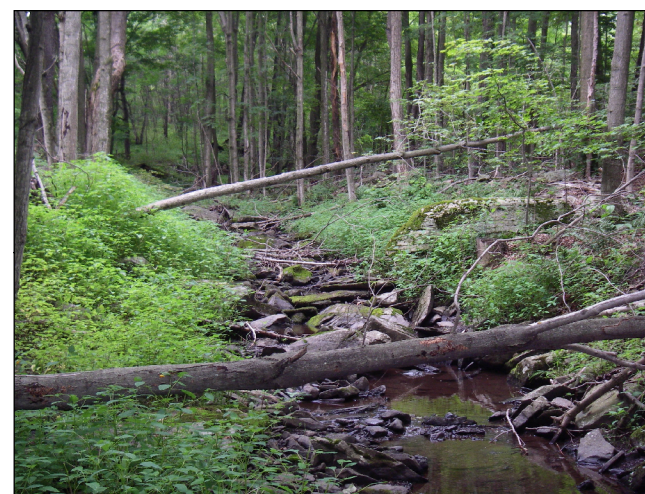
**C**

Further downstream there were multiple observations of woody debris, including some fallen trees across the stream (Station 50032, Figure 4.1.1, Inset C). Woody debris is beneficial to a stream system. It provides critical habitat for fish and insects and adds essential organic matter that will benefit organisms downstream. Although the trees did not pose an obstruction at low flow, they may pose a more significant obstruction during higher flows. Unless the woody debris is causing an imminent threat to infrastructure or long-term bank stability (meaning it may cause a mass bank failure) it should be left in the stream.

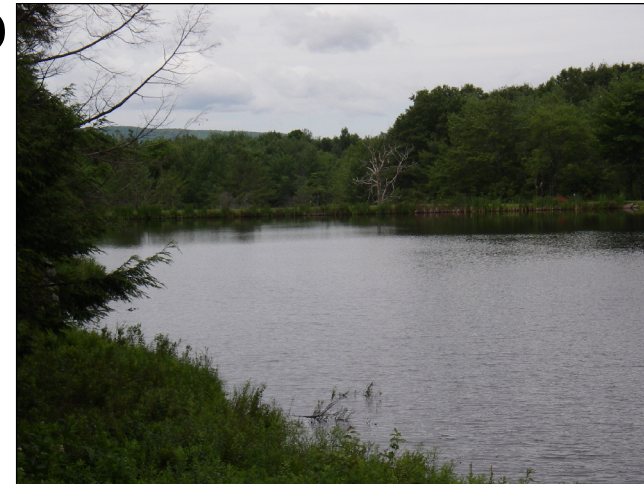
**D**

Continuing downstream, there was a private earth dam (NY00832, Station 52058) that was completed in 1977 to form a recreational pond (Figure 4.1.1, Inset D, looking downstream, Station 52800-52071). It measures 15 feet high and approximately 230 feet in

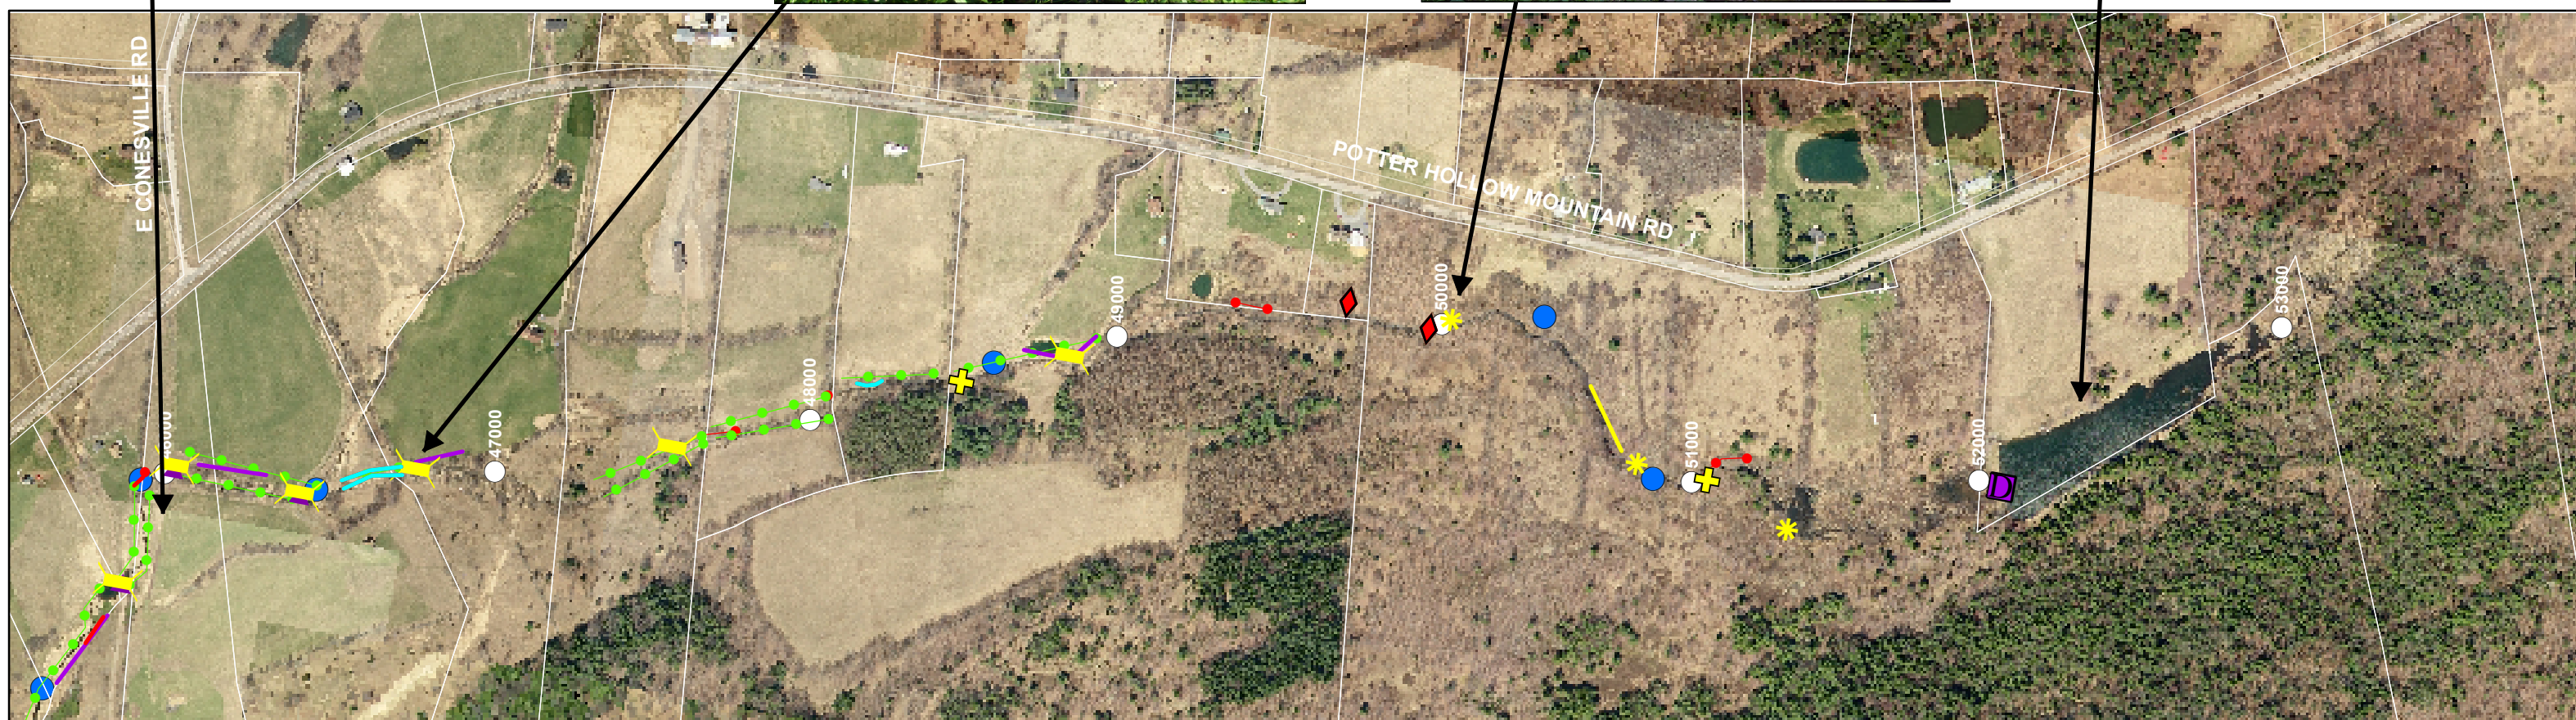
Figure 4.1.1 Management Unit 1 - 2006 aerial photography with 2008 stream feature inventory.

The 2008 stream feature inventory revealed that 3.0% (472 ft.) of the streambanks exhibited signs of active erosion along the 16,075 ft. of total streambank length in the unit (Fig. 4.1.1). *Revetment* has been installed on 2.3% (376 ft.) of the streambanks. Approximately 3.6% (579.5 ft.) of the streambanks have been bermed.

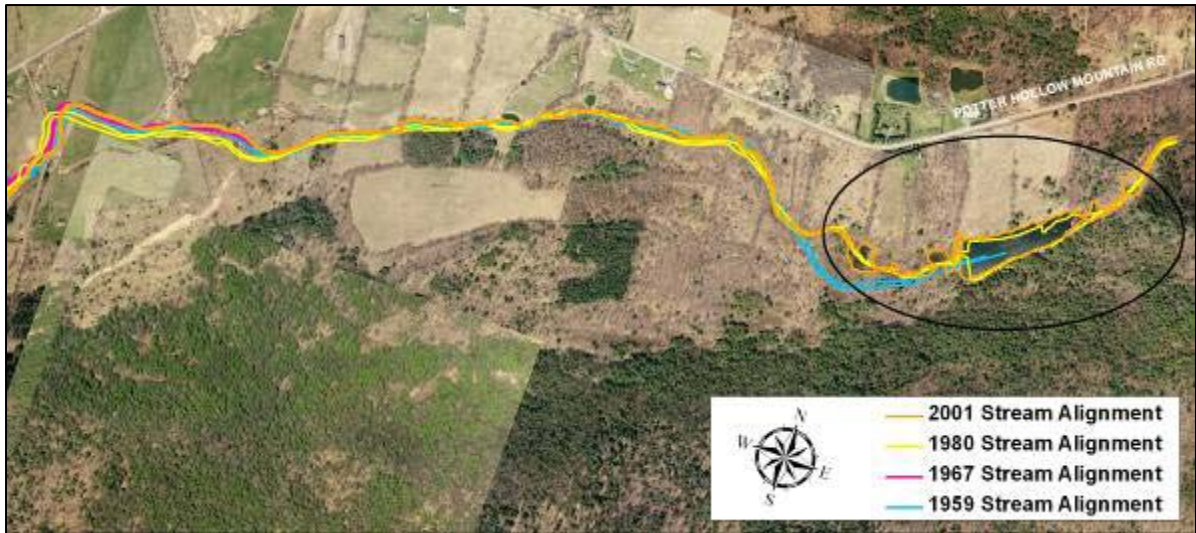
Historic stream channel alignments overlaid with 2006 aerial photograph

As seen from the historical stream alignments (above), the *planform* of the channel has experienced significant changes between 1959 and 1980 (aerial photographs of 1967 did not extend beyond the lower portion of this management unit). This is primarily due to the creation of a private pond. According to the National Inventory of Dams (NID) maintained by the U.S. Army Corps of Engineers (ACOE), a fifteen-foot private dam was built in 1977 for recreational purposes. Just downstream of the private pond, additional areas of open water wetlands also formed between 1980 and 2001. Except for the historical changes due to the formation of the private pond and the downstream open water wetlands, the Manor Kill channel in management unit 1 has remained fairly stable.

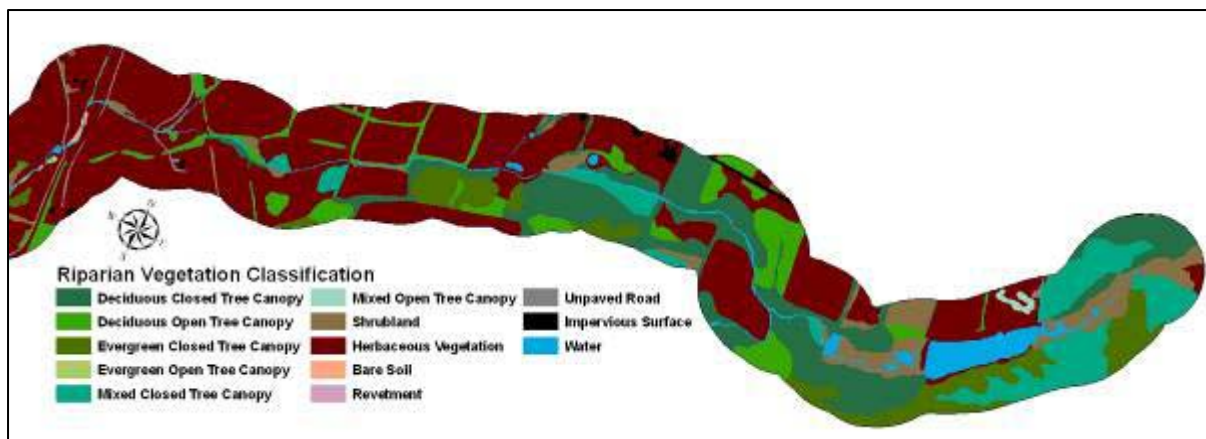
Riparian vegetation classification map based on aerial photography from 2006

An analysis of vegetation was conducted using aerial photography from 2006 and field inventories (see above map and Riparian Vegetation Mapping, Section 2.7). In this management unit, the predominant vegetation type within the 300 ft. riparian buffer was forested (46.3 %) followed closely by herbaceous (45.8 %). *Impervious* area (0.65 %) within this unit's buffer was primarily the local and private roadways. Areas of herbaceous (non-woody) cover may present opportunities to improve the riparian buffer with tree plantings in order to promote a more mature vegetative community along the streambank and in the floodplain.
