Manor Kill Management Unit 2

Town of Conesville – Manor Creek Rd. (Station 45598) to Beaver Hill Rd. (Station 38909)

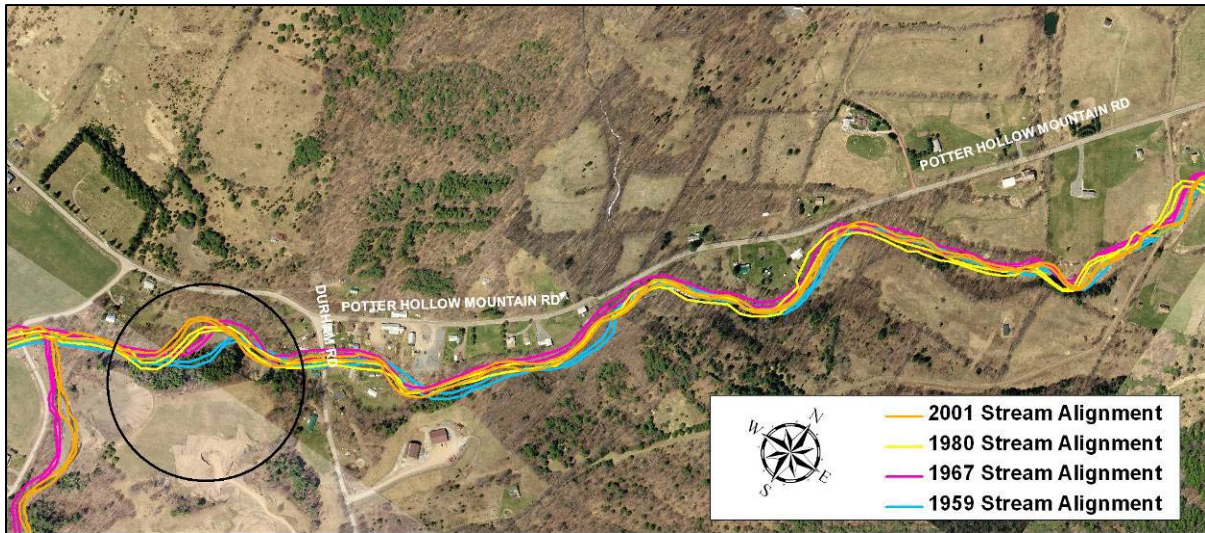
Historic stream channel alignments overlaid with 2006 aerial photograph

As seen from the historical stream channel alignments (above), the *planform* of the channel has not changed significantly from 1959 to 2001 along this management unit; the channel has remained fairly stable. However, there has been lateral migration (between Stations 40400 and 39500) and the formation of a secondary channel (between 2001 and 2006) along the downstream portion of this management unit as indicated on the alignment map above. Along this stretch of stream there is an active gravel mine that didn't appear to become active until sometime between 1967 and 1980. The activity associated with this gravel mine has contributed to streambank instability along this stretch of stream.

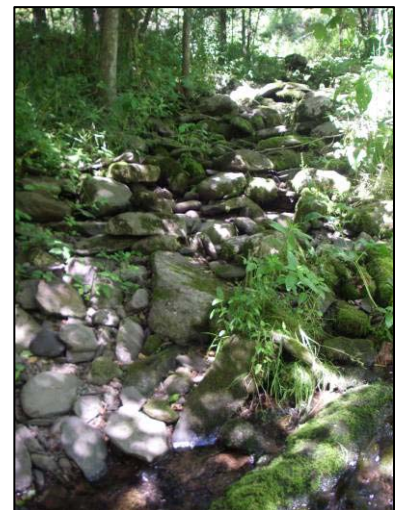
Tributary at Station 44143

an unnamed intermittent tributary (Station 44143) entered from the left streambank. The New York State Department of Environmental Conservation classifies streams and rivers based on their “best use” (NYSDEC, 1994). This tributary was classified C by the NYS DEC, indicating that the best uses for this stream are supporting fisheries and for other recreational activities.

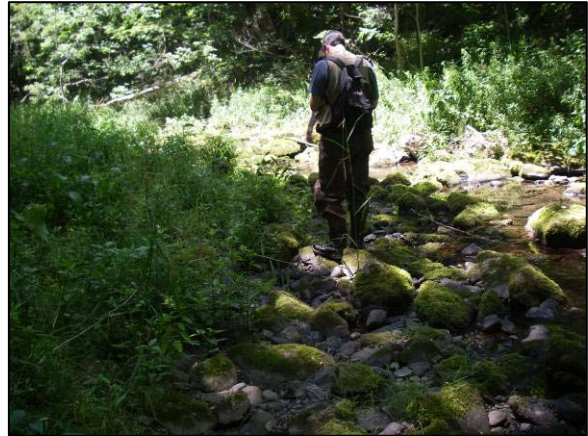
Point bar at Station 43862

As the stream meandered to the left, there was a point bar (Station 43862) with established herbaceous vegetation along the left stream bed. Point bars commonly form on the inside of meander bends, where stream velocity is slower during high flows, allowing sediment to drop out of the water column and settle along the stream bed. Also along the left streambank, there was a channel

divergence (Station 43868) where a *flood chute* split off from the main channel. Flood chutes convey flow through a secondary channel during periods of high flows; this flood chute converges (Station 43686) with the main channel approximately 182 feet downstream.

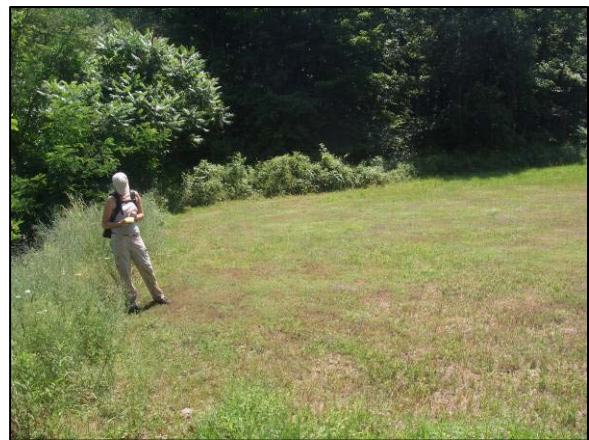
Riparian Planting Site at Stations 39867 - 39790

As the main channel meandered to the left, there was erosion (Stations 39970 - 39812) along approximately 158 feet of the right streambank, causing exposed roots, an undercut bank, and compromising small trees. Along the upstream portion of the erosion site, there was a young forest; continuing downstream, there was herbaceous vegetation mowed to the edge of the bank. This area was identified as a potential riparian planting site (Station 39867 – 39790). Recommendations for this site include planting native trees and shrubs along the streambank and the upland area, and reinforcing the toe of the bank by planting sedge species. Buffer width should be increased by the greatest amount agreeable to the landowners. Increasing the buffer width to at least 100 feet will increase the buffer functionality and protect the stream from nearby land uses. Due to the erosion along this site and the potential need for bank grading, a more detailed site assessment may

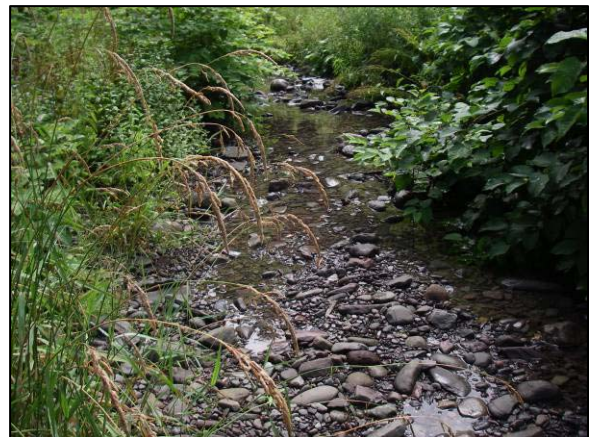
Convergence at Station 39395

Continuing downstream, there was a channel divergence (Station 39568) along the left, where a flood chute split off from the main channel. Flow was subsurface for much of the channel length; along the downstream portion of the flood chute flow returned to the surface. This secondary channel converged (Station 39395) with the main channel approximately 173 feet downstream from the channel divergence. At this location, the flood chute continued with a second divergence from the main channel that converged (Station 39174) approximately 221 feet downstream. Along the left bank of the secondary channel there was a mass failure (Figure 4.2.1, Inset A, Stations 39532 - 39316). This resulted in an erosion area of approximately 6,490 ft² that had compromised mature trees along the bank.

Although this bank was a significant erosion site, it appeared to be slowly recovering, with herbaceous vegetation, shrubs and young trees becoming established on the face of the bank. However, if this secondary channel became the main channel or carried significant flow during high flood events, it would further compromise the mass failure. The instability along this stretch of stream was also

influenced by the adjacent gravel mine. It is recommended that mining of gravel close to the stream's edge be discontinued, allowing a vegetated buffer to regenerate naturally. Opposite the mass failure and continuing downstream, the right streambank was experiencing hydraulic erosion in three locations totaling approximately 388 feet.

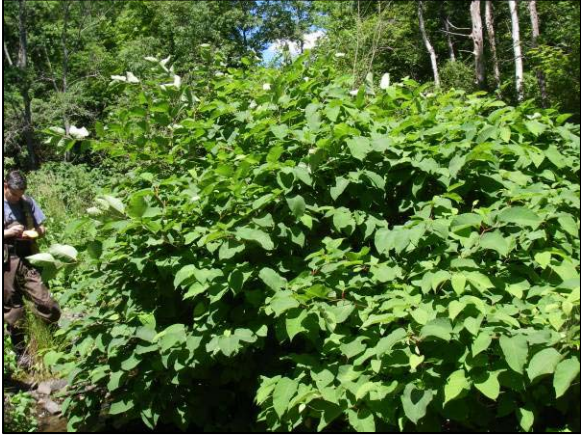
Japanese knotweed at Station 42469

Some plant species that are not native can create difficulties for stream management, particularly if they are invasive. Japanese knotweed (*Fallopia japonica*), for example, has become a widespread problem in recent years. Knotweed shades out other species with its dense canopy structure (many large, overlapping leaves), but stands are sparse at ground level, with much bare space between

narrow stems, and without adequate root structure to hold the soil of streambanks. The results can include rapid streambank erosion and increased surface runoff leading to a loss of valuable topsoil. Japanese knotweed locations were documented as part of the stream feature inventory conducted during the summer of 2008 (Riparian Vegetation Mapping, Section 2.7). In total, 54 Japanese knotweed occurrences, along an estimated length of 2,816.50 feet, were documented during the stream feature inventory. The best means for controlling knotweed is prevention of its spread, therefore, effort should be made to ensure that all fill brought into the area is clean and does not have fragments of knotweed or other invasive plants. If Japanese knotweed sprouts or small stands are observed, they should be eradicated immediately to avoid further spread within this unit and downstream management units.

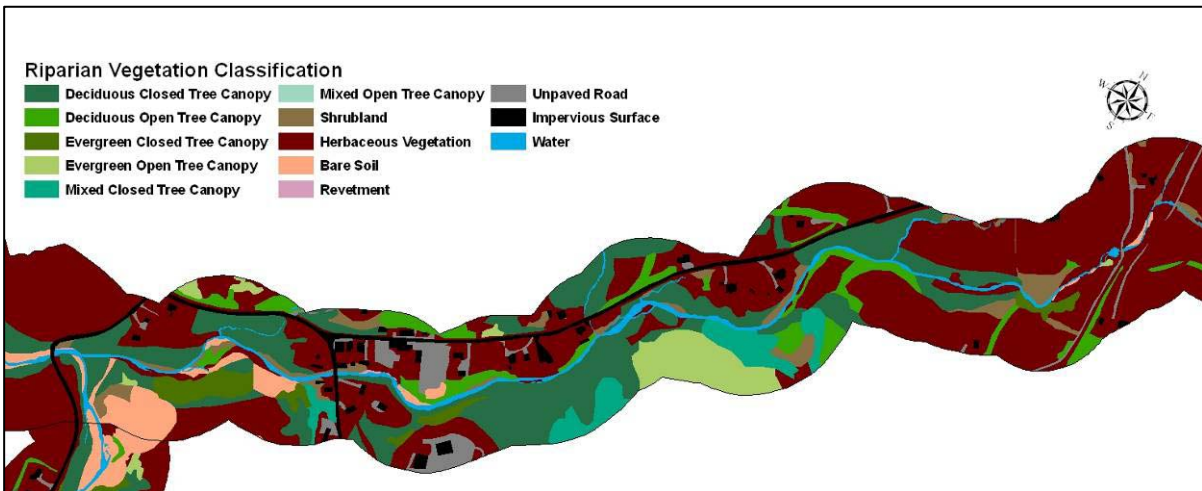
Riparian vegetation classification map based on aerial photography from 2006

field inventories (see above map and Riparian Vegetation Mapping, Section 2.7). In this management unit, the predominant vegetation type within the 300 ft. riparian buffer was herbaceous (44.57%) followed by forested (40.06). *Impervious* area (4.64 %) within this unit's buffer was primarily the local and private roadways. Areas of herbaceous (non-woody) cover may present opportunities to improve the riparian buffer with tree plantings in order to promote a more mature vegetative community along the streambank and in the floodplain.

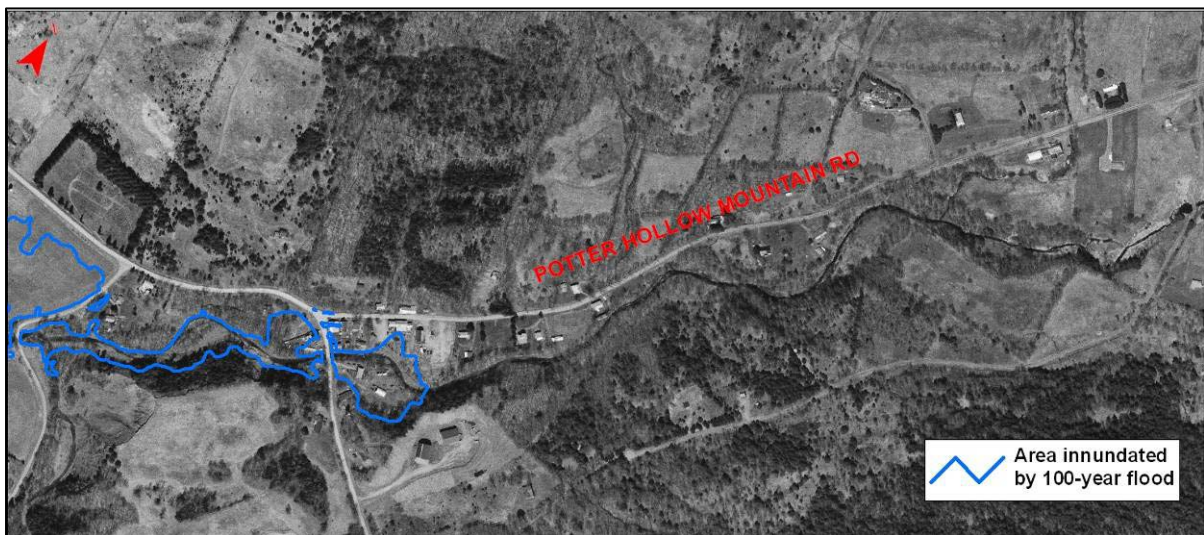
100-year floodplain boundary map

According to the current floodplain maps (above), eight existing structures in this unit appeared to be situated within the estimated 100-year floodplain. For this management unit, floodplain map coverage did not include the upstream portion of the Manor Kill. It is recommended that hydraulic analysis be completed to create floodway and floodplain maps from the end point of existing maps upstream to the headwaters wetland complex where the
