Manor Kill Management Unit 3

Town of Conesville – Beaver Hill Rd. (Station 38909) to Station 26995

This management unit begins at Beaver Hill Road, continuing approximately 11,914 ft to Station 26995 in the Town of Conesville.

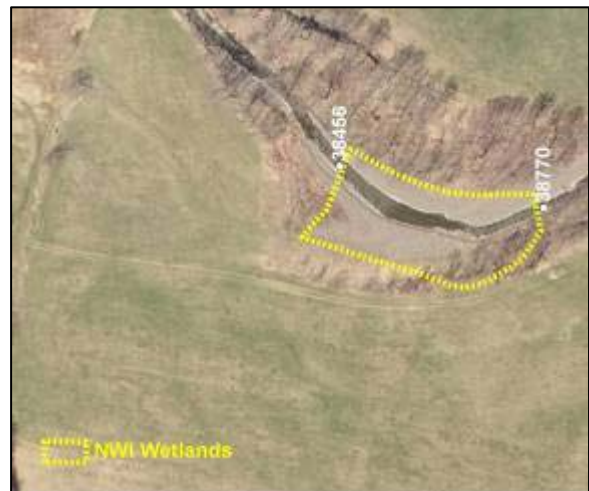
Wetland boundary approximately delineated by NWI
(Stations 38770 - 38456)

As the stream meandered to the right, there was a 0.8 acre riverine wetland (Stations 38770 – 38456). Wetlands are important features in the landscape that provide numerous beneficial functions including protecting and improving water quality, providing fish and wildlife habitats, storing floodwaters, and maintaining surface water flow during dry periods. This wetland is classified as R2USA, *riverine, lower perennial, unconsolidated shore, temporarily flooded* (see Section 2.6 for detailed wetland type descriptions).

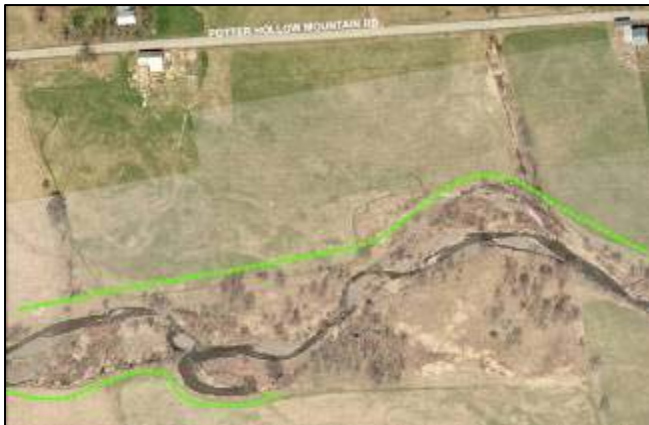
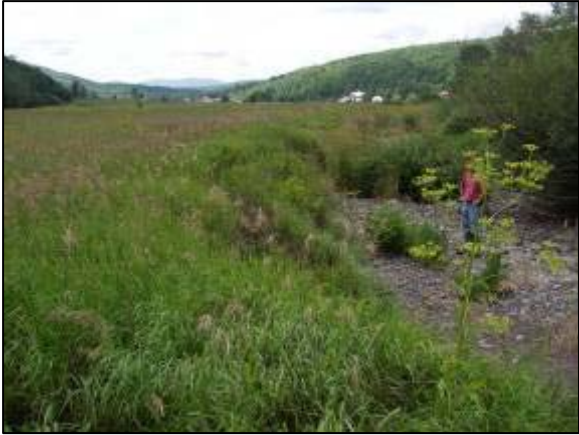
Riparian Planting Site at Stations 38170 - 36468

As the stream meandered to the left, and continuing downstream for approximately 1,702 feet, there was a proposed riparian planting site (Stations 38170 – 36468) along the right streambank. This is the first of many proposed planting sites within management unit three. A vigorous buffer with mature trees is important at this site because it may also filter

nutrients and pollutants, if any, from the adjacent agricultural fields. Along portions of this site, herbaceous vegetation is maintained to the edge of the stream, while there are also short sections with a thin wooded buffer. Opposite the downstream portion of this planting site, there is a second proposed planting site (Stations 37087 – 35810) along the left streambank

for approximately 1,277 feet. Vegetative and stream stability conditions are similar along this site. Recommendations for both sites include establishing a buffer where none exists, and augmentation of the existing buffered areas by planting native trees and shrubs along the streambank and the upland area. Buffer width should be increased by the greatest amount agreeable to the landowners. Increasing the buffer width to at least 100 feet

will increase the buffer's functionality and protect water quality by slowing stormwater runoff, filtering nutrients and pollutants and increasing streambank stability. Portions of both proposed planting sites are experiencing erosion. Therefore, prior to proceeding with any vegetative plantings, these conditions should

be given careful consideration when identifying the appropriate species and locations for plantings. A more detailed site assessment may be necessary to determine whether stream bank grading will be required. Along both planting sites, there was a 1.2 acre palustrine wetland (Stations 37940 – 37460) followed by a 3.3 acre riverine wetland (37460 – 35800). These wetlands were classified as PEM1A, *palustrine, emergent, persistent, temporarily flooded*, and R2USA, *riverine, lower perennial, unconsolidated shore, temporarily flooded*, respectively. Along these wetlands excess sediment deposition caused multiple point bars and full channel aggradation. Point bars commonly form on the inside of meander bends, where stream velocity is slower during high flows, allowing sediment to drop out of the water column and settle along the stream bed.

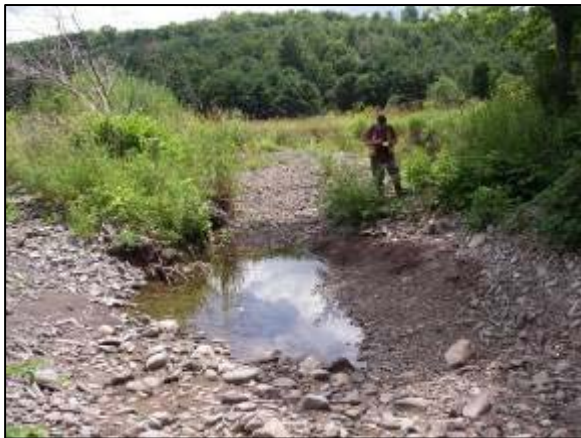
Convergence at Station 36855

divergence (Station 37112) along the left that converged (Station 36855) with the main channel approximately 257 feet downstream. Along this channel, there were approximately 359 feet of hydraulic erosion (Figure 4.3.1a Inset D, Stations 37120 – 36869), exposing 1,976 square feet of the left streambank. This eroding bank was along the second proposed riparian planting site that was previously discussed. Japanese knotweed persisted

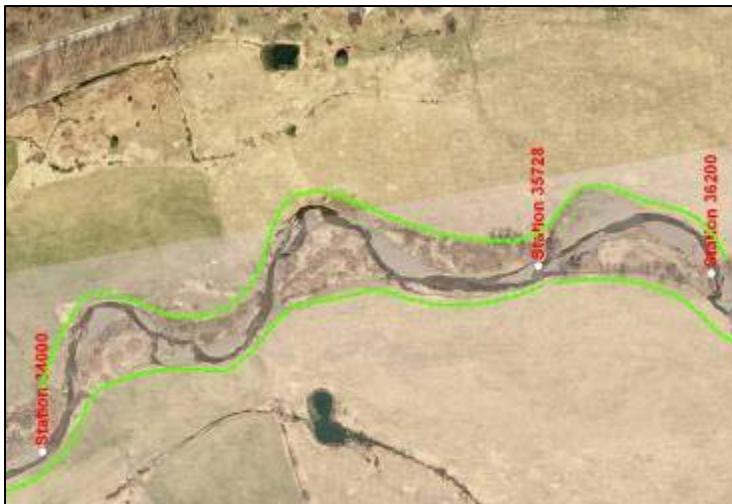
Riparian Planting Sites between Stations 36200 & 34000

As the stream meandered to the left, there was a third proposed riparian planting site (Stations 36190 – 34170) along

mentioned planting sites, recommendations for these sites include establishing a buffer where none exists and augmentation of the existing buffered areas by planting native trees and shrubs along the streambank and the upland area. Buffer width should be increased to 100 feet or by the greatest amount agreeable to the landowners. Portions of both proposed planting sites are experiencing erosion in multiple locations along the streambank. Therefore, prior to proceeding with any vegetative plantings, these conditions should be given careful consideration, and additional assessment may be necessary.

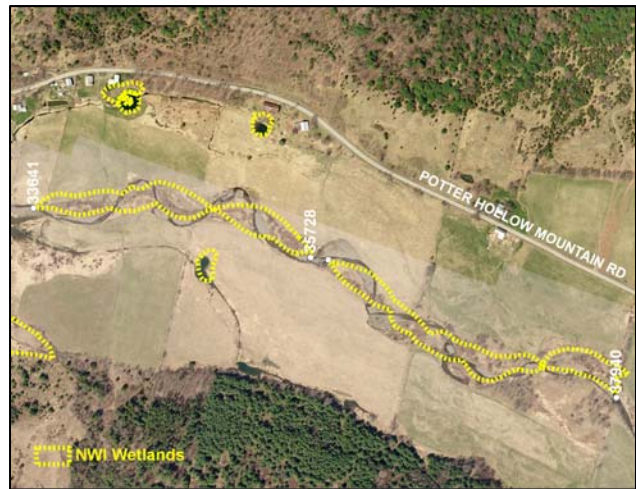
Wetland boundary approximately delineated by NWI (Stations 35728 – 33641)

Beginning along this stretch of stream and continuing downstream, there was a 3.9 acre riverine wetland (35728 –

33641). This wetland was classified as R2USA, *riverine, lower perennial, unconsolidated shore, temporarily flooded*. Set back from the stream's edge, there was a small, 0.3 acre, palustrine wetland classified as PUBHh, *palustrine, unconsolidated bottom, permanently flooded, diked/impounded*.

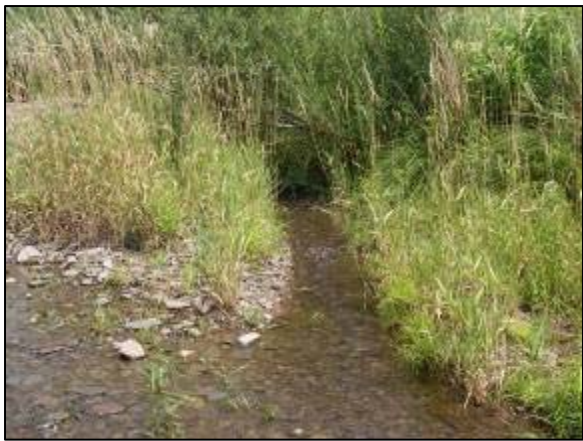
Tributary at Station 33464

Continuing downstream an unnamed *tributary* entered from the left streambank (Station 33464, photo orientation looking upstream). The New York State Department of Environmental Conservation (NYSDEC) classifies streams and rivers based on their “best use” (NYSDEC, 1994). This tributary was classified C by the NYS DEC, indicating that the best uses for this stream are supporting fisheries and other recreational activities. There was a relatively deep pond-

like area along this tributary, upstream of its confluence with the Manor Kill (see aerial imagery in Figure 4.3.1a); it appeared to be caused in part by beaver activity.

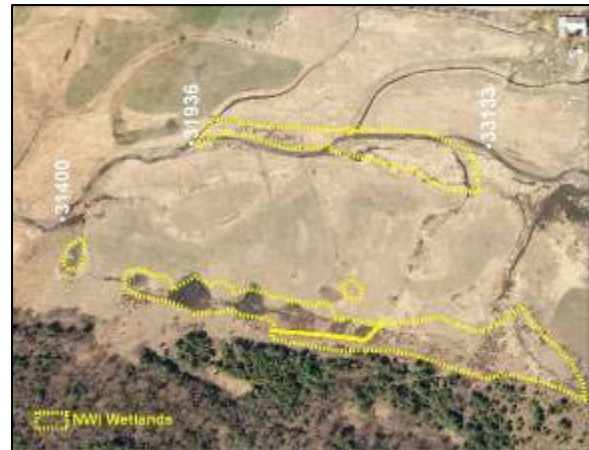
Wetland boundary approximately delineated by NWI (Stations 33133 – 31400)

Beginning along this stretch of stream and continuing downstream, there was a 2.6 acre palustrine wetland (Stations 33133 - 31936) along the stream corridor. This wetland was classified as PEM1A, palustrine, *emergent, persistent, temporarily flooded*. Set back from the stream's edge, there was a wetland complex that drained to the Manor Kill through a downstream tributary (Station 31364).

This complex included 4 palustrine wetlands; these wetlands were classified as PEM1A (3.5 acres), PEM1/SS1A (2.2 acres), *palustrine, emergent, persistent, scrub-shrub, broad-leaved deciduous, temporarily flooded*, PEM1E (0.1 acres), *palustrine, emergent, persistent, seasonally flooded/saturated*, and PUBHh (0.15 acres), *palustrine, unconsolidated bottom, permanently flooded, diked/impounded*.

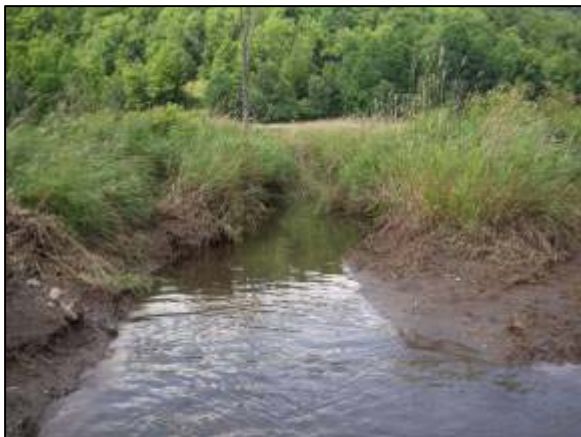
Tributary at Station 32604

Continuing downstream an unnamed tributary entered from the right streambank, draining the adjacent agricultural fields

This type of channel modification requires a NYSDEC issued permit, and is not recommended, especially due to the trout spawning activity that may take place in this tributary and along the Manor Kill. Further downstream, another unnamed tributary that drains the adjacent fields (Figure 4.3.1b, Inset D, Station 32487) entered along the left streambank. This tributary was not classified by NY DEC.

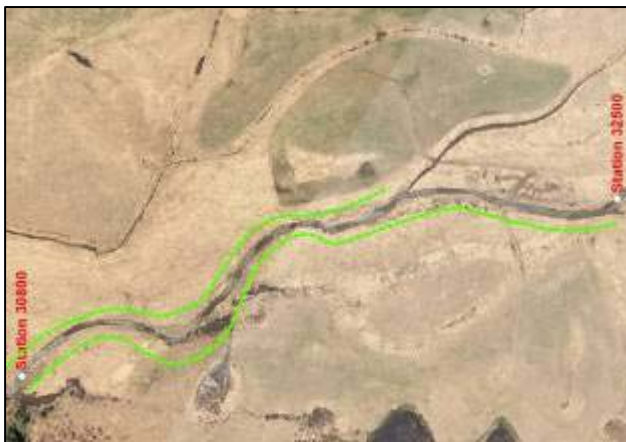
Riparian Planting Sites, Stations 32500 - 30800

Continuing downstream, there were additional proposed riparian planting sites along both streambanks. Along the left streambank, the planting site (Stations 32465 – 30800) stretched for approximately 1,561 feet. Along the right streambank, the planting site (Stations 31909 – 28916) stretched for approximately 2,654 feet. Along both of these sites, herbaceous vegetation was maintained to the edge of the stream. Aggradational conditions persisted along these planting sites, including multiple point, side, center and transverse bars.

As with the previously mentioned planting sites, recommendations for this site include planting native trees and shrubs along the streambank and the upland area. Buffer width should be increased to 100 feet or by the greatest amount agreeable to the landowners. Sections of both proposed planting sites are experiencing some erosion. Also, along this stretch of stream multiple beaver dams were

destroyed and deposited along the streambanks. Therefore, prior to proceeding with any vegetative plantings, these conditions should be given careful consideration, and additional assessment may be necessary. Any vegetation that is planted may require protection, such as tree tubes, to minimize the impact that beaver activity may have on survival of planted species.

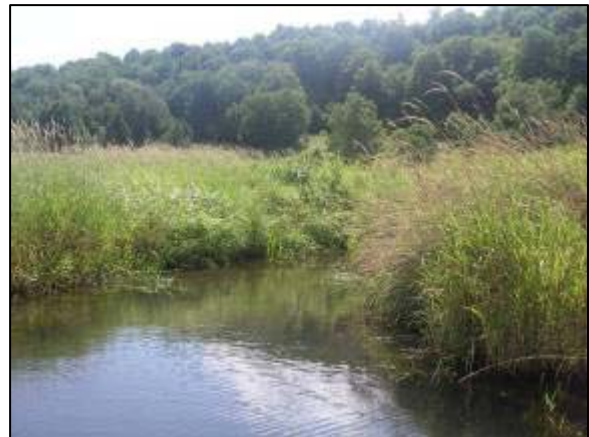
Tributary at Station 31364

As the stream gently meandered to the right, an unnamed tributary (Station 31364) entered along the left streambank. The tributary flows into a relatively deep pool along the Manor Kill; this pool is along the

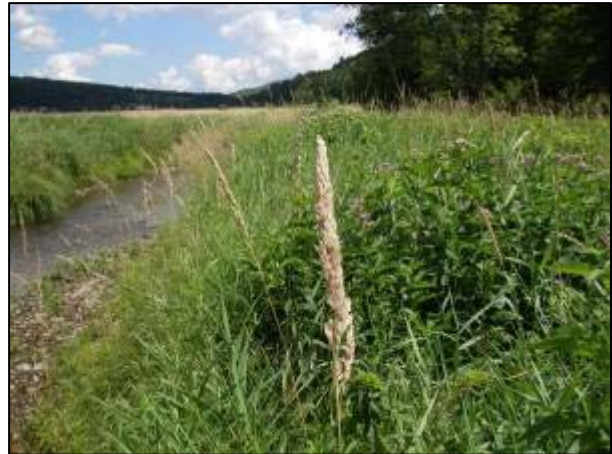
Continuing downstream, there was a proposed riparian planting site (Stations 30280 – 30046) for approximately 234 feet of the left streambank. This site had a relatively narrow successional old field between the stream's edge and the adjacent forest. Recommendations for this site include willow staking along the toe and streambank. It is also recommended that this field remain in succession with no mowing activity, in order to allow natural regeneration of shrubs and trees.

Riparian Planting Site at Stations 30280 - 30046

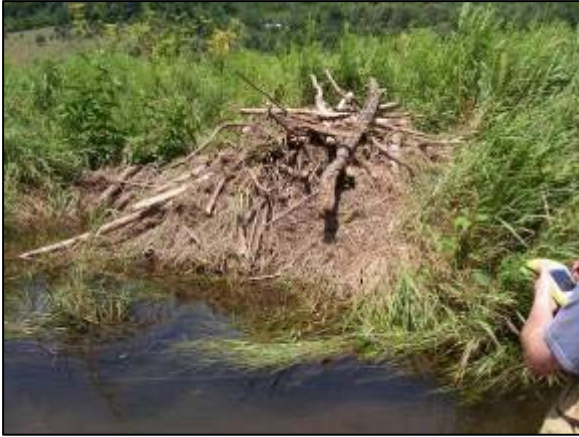
Beaver Lodge at Station 29715

Downstream of the obstructions, there were three beaver lodges along the main channel, including one on the right streambank (Station 29715) and two on the left streambank (Stations 29684 and 29572), and multiple locations of woody debris accumulation along both streambanks.

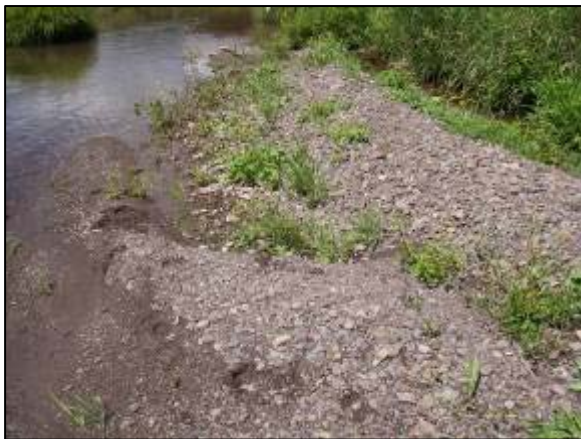
Point Bar at Stations 29549 - 29421

including a point bar (Stations 29549 - 29421) on the right that directs flow towards the left streambank. Along the right side of the dam, there was a beaver slide, creating a small secondary channel where water gets around the dam and flows behind the point bar and a small area vegetated with willows; this channel converged (Station 29400) with the main stem approximately 63 feet downstream.

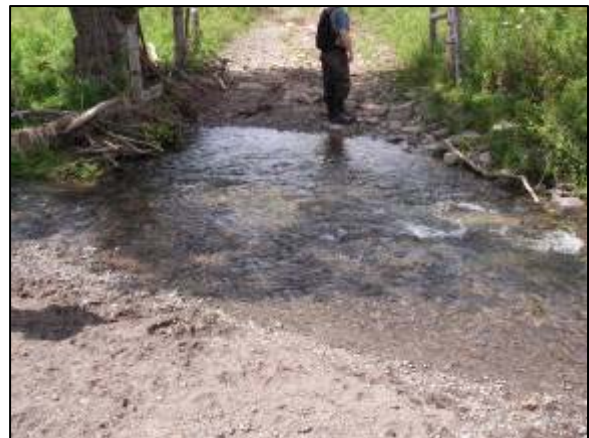
Continuing downstream, a small unnamed tributary (Station 28787) that drains the adjacent agricultural fields, entered along the right streambank. As the stream meandered to the left, there was a channel crossing to provide cows access to pasture fields along both sides of the stream. Along this crossing there was also full channel aggradation; maintenance of the crossing appeared to contribute to the localized aggradational conditions. Just downstream of the channel crossing, there was a short section of rip rap, comprised of small to medium cobbles, along

Channel Crossing at Station 28745

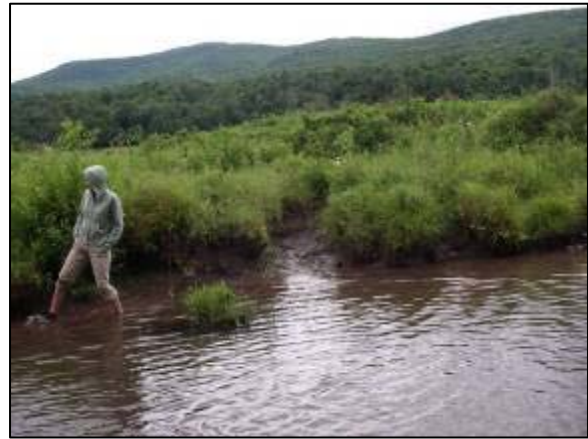
Tributary at Station 27951

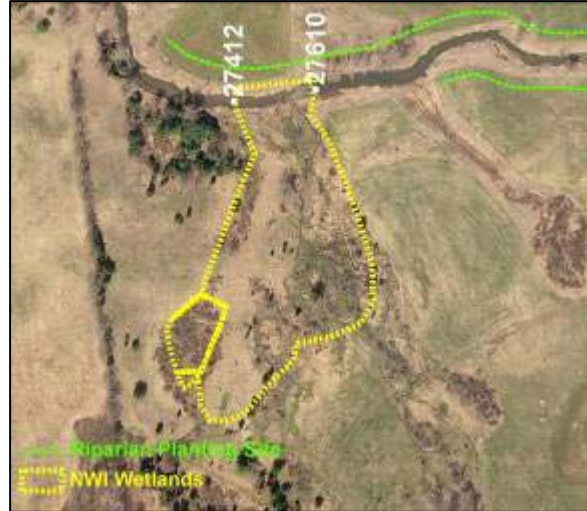
Wetland Boundary approximately delineated by NWI (Stations 27610 – 27412)

Continuing downstream, there was a wetland complex comprised of two palustrine wetlands. The complex began adjacent to the stream channel and stretched back into the fields along the left side of the stream. The first one was approximately 4.7 acres and is classified as PEM1B, *palustrine, emergent, persistent, saturated*. Two small tributaries (Stations 27552 and 27518) flowed through this wetland. The second wetland was approximately 0.4 acres and is classified PEM1/SS1A, *palustrine, emergent, persistent, scrub-shrub, broad-leaved deciduous, temporarily flooded*. A proposed riparian planting site continued along the opposite streambank.
