Manor Kill Management Unit 4

Town of Conesville – Station 26995 to Station 24315

This management unit begins at Station 26995, continuing approximately 2,680 ft to Station 24315 in the Town of Conesville.

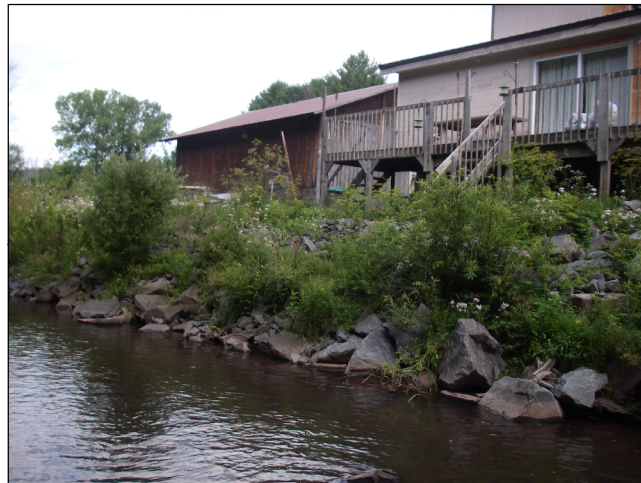
**B**

sediment deposition, including full channel aggradation (Station 25503) and a transverse bar (Stations 25337 – 25285). A small unnamed tributary (Station 25438) entered from the left streambank; there was a relatively large patch of Japanese knotweed just downstream of the tributary. Along this stretch of stream, the right streambank was reinforced with rip rap (Figure 4.4.1, Inset B, Stations 25485 – 25301) for approximately

184 feet. The rip rap was in good structural and functional condition and provided scour protection along the toe of the streambank. Along the upstream portion of the rip rap there was mowed lawn to the edge of the bank. Interplanting the rip-rap and reinforcing the toe of this streambank with native shrub and sedge species is recommended. Although this site was not identified as a proposed riparian planting site, planting native shrub and tree species along the upland area is recommended. As mentioned previously, a permit was issued for 100 feet of streambank rip rap repair, installation of new rip rap, and minor fill and grading in pre-disturbed lawn areas, in order to prevent the stream from undermining the adjacent home. This permit expires on September 30, 2009.

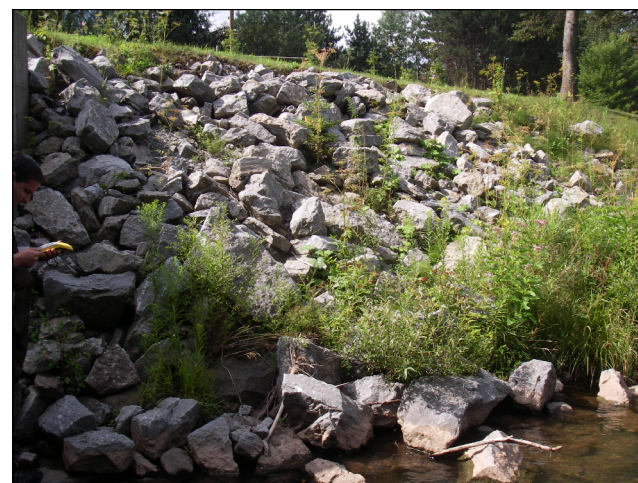
**C**

Along the left streambank, rip rap (Figure 4.4.1, Inset C, Stations 25833 – 25797) began at the bridge abutment and continued downstream for approximately 36 feet. The revetment was in good structural and functional condition and provided scour protection at the toe of the bank. Interplanting the rip-rap and reinforcing the toe of this streambank with native shrub and sedge species is

recommended. This planting will help to strengthen the revetment, while enhancing aquatic habitat. The riparian buffer beyond the rip-rap installation was sparse, with some mature trees and mown grass to the edge of the bank. The risk to bank stability can be minimized by maintaining mature trees along the critical 100 foot buffer zone. The buffer width should be increased by the greatest

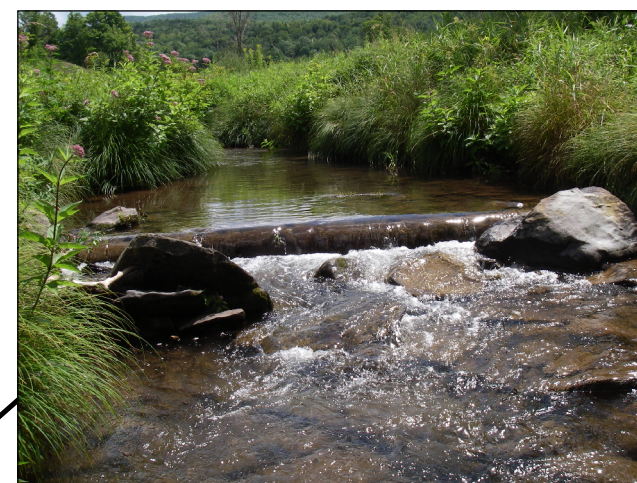
**D**

Continuing along this meander bend, there was log across the stream channel providing grade control (Figure 4.4.1, Inset D, photograph orientation looking upstream, Station 26687). The log appeared to have been placed to provide fish habitat, and may contribute to upstream aggradational conditions, including transverse and center bars. Water flows around the structure along the right side.

amount agreeable to the landowner. There were two significant stands of Japanese knotweed (Station 24586, Figure 4.4.1, Inset D, and Station 24500) along this planting site. Prior to beginning planting efforts, these stands should be removed if feasible, or effort should be made to avoid spreading this invasive plant.

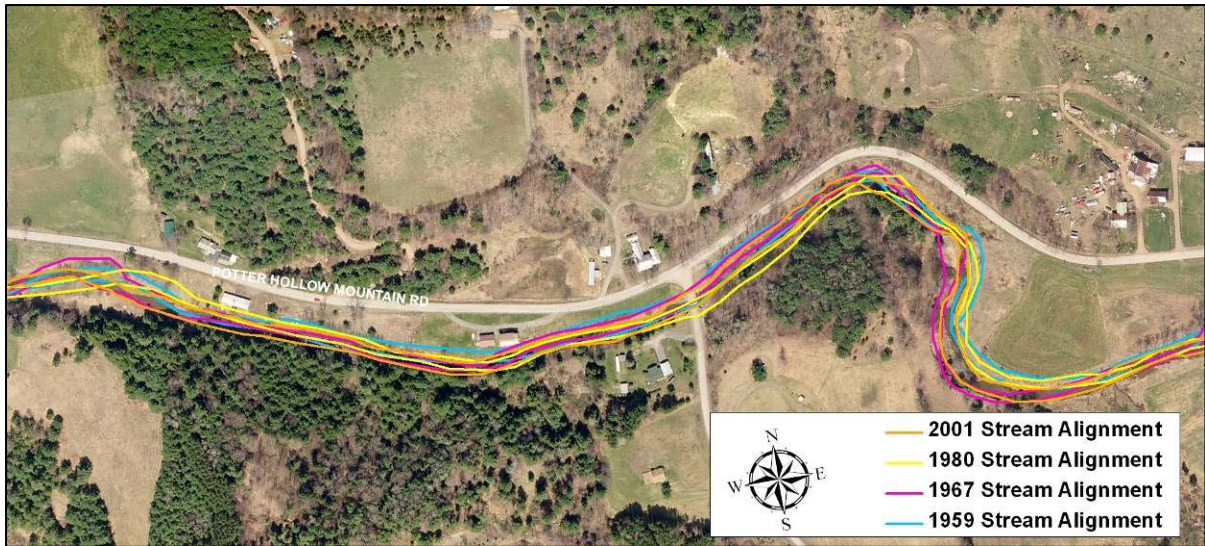
Historic stream channel alignments overlaid with 2006 aerial photograph

As seen from the historical stream channel alignments (above), the *planform* of the channel has not changed significantly over the years along this management unit; the channel has remained fairly stable.

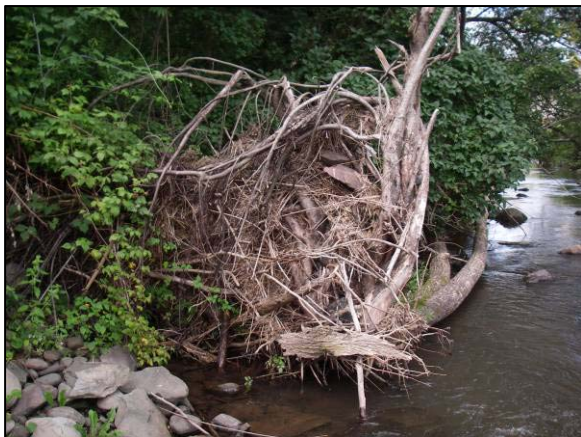
Woody Debris at Station 25632

amount agreeable to the landowners. In addition to interplanting the rip rap, recommendations for this proposed riparian planting site (Stations 25833 – 25673, photograph orientation looking upstream) include planting native trees and shrubs along the streambank and the upland area. Downstream of the revetment, and continuing along the proposed riparian planting site, the left streambank was eroding (Stations 25785 – 25632) for approximately 153 feet. At the downstream end of the erosion, there was a fallen tree (Stations 25632) with accumulated woody debris; it appeared to contribute to localized scour of the channel bed and the toe of the streambank. Prior to proceeding with any vegetative

plantings, a more detailed site assessment may be necessary. The conditions at this site should be given careful consideration when identifying the appropriate species and locations for plantings.
