## Management Segment 1

### Source to C.D. Lane Park

Map VI-2  
Greene County Soil & Water Conservation District  
Batavia Kill Stream Corridor Management Plan

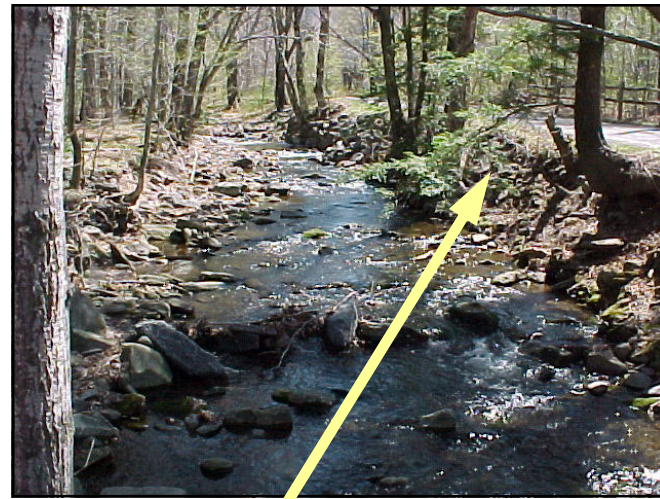
B

While the upper portion of the reach is characterized as being relatively stable, the lower portion of reach 1b was noted as having significant areas of channel erosion (**Figure VI-5b, photos A,B,D,E,F**). The erosion inventoried in 1997 was almost exclusively located to this sub-reach. Instabilities were noted in several areas, with channel aggradation and degradation observed, as well as lateral channel erosion. In August of 1999, three monitoring sections were installed in this section to determine stream type, and to determine the current state of instability.

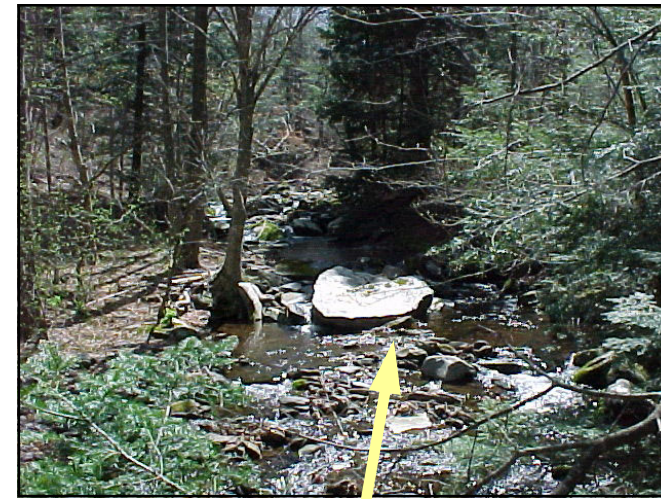
D

The first monitored cross section in the reach (Headwaters #3) is located just upstream of the county bridge (**Figure VI-5b**). This bridge was substantially damaged in the April 1987 flood event, and replaced in 1989. In 1990, the GCSWCD sponsored a stabilization project which included stacked rock rip-rap on the right bank above the bridge, and sloped rip-rap on the left bank below the bridge. The project also included extensive channelization, extending approximately 100 to 150 feet upstream and downstream of the bridge. Flood events in 1996 and 1999 resulted in repetitive damage to the stacked rock rip-rap above the bridge (**Figure VI-5b, photo D**). Subsequently, the GCSWCD has

observed active erosion just above the bridge. The lateral can likely be attributed to the rip-rap bank protection, floodplain fill and channelization of the stream.

While the bridge opening appears to be adequately sized for its location in the watershed, further evaluation of the stream/road alignment, as well as channel entrenchment, could identify an effective strategy to addressing the instability. *Mitigation* of the instability problem at the bridge would have a direct benefit by reducing the frequency and cost of repairs, as well as protecting the structure from future floods. Immediately below the bridge (150'), the stream channel has responded favorably to past disturbances (**Figure VI-5b, photo H**). A well vegetated *bankfull* channel has formed within the over widened channel, and a young, but healthy, riparian buffer is becoming established. The response of this short section to past channelization is an excellent example of a streams ability to re-establish a stable form.

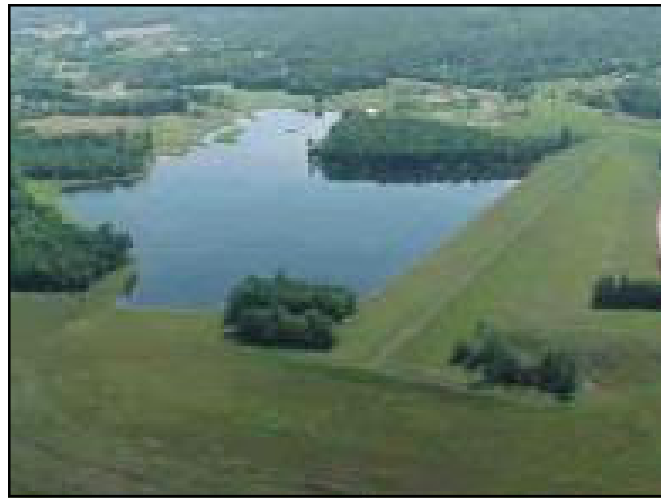
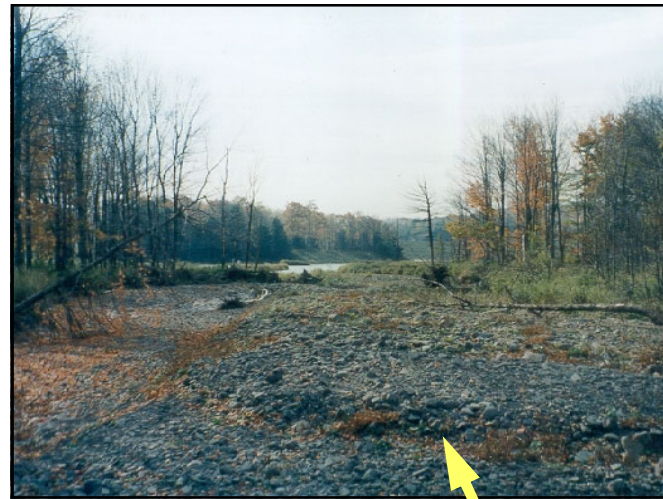
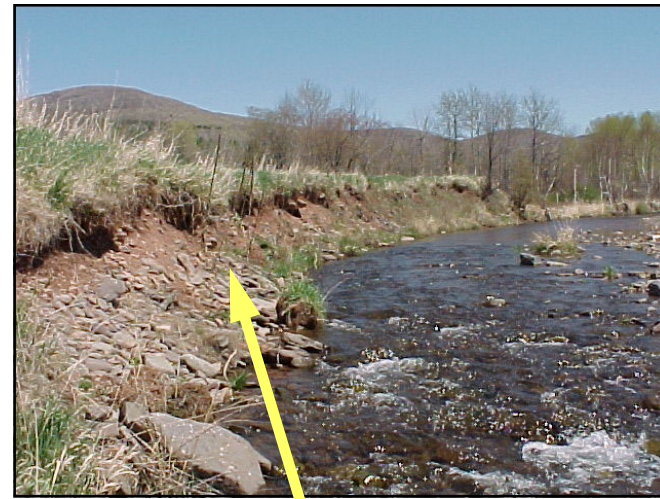
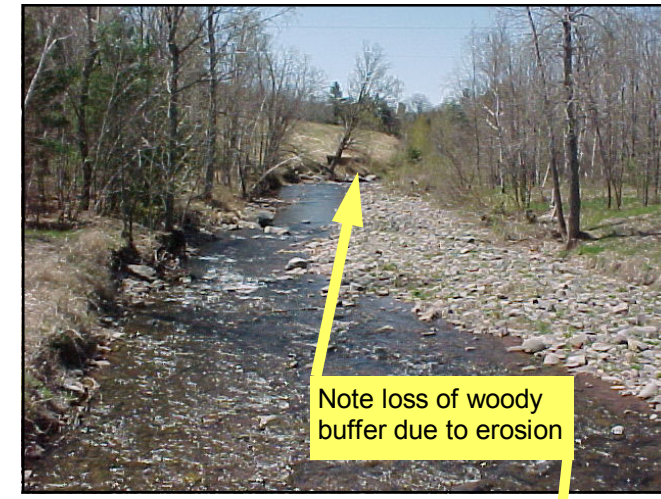
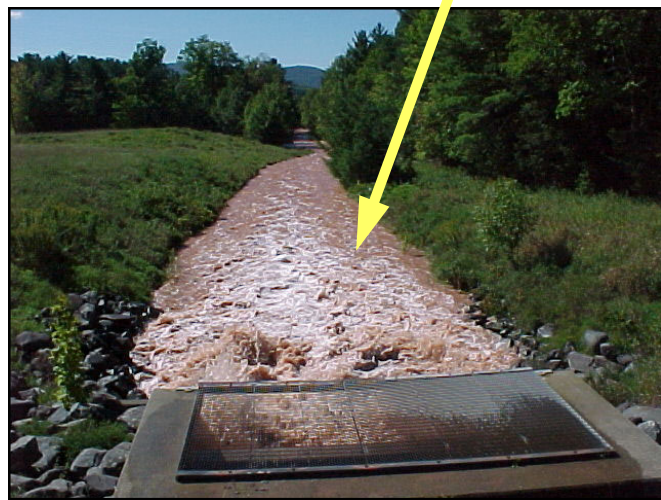
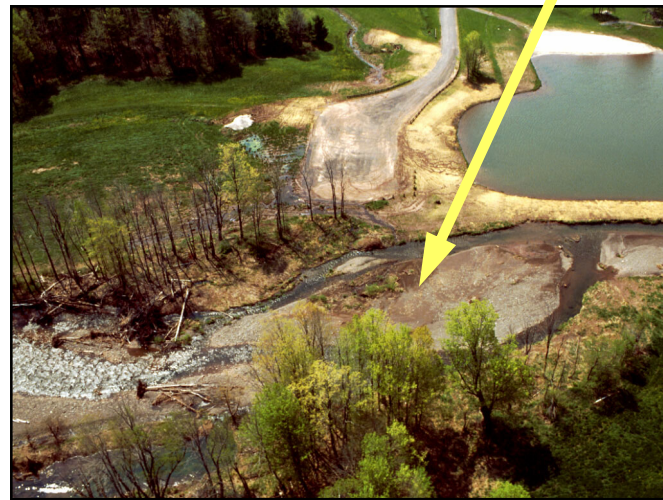
The GCSWCD strongly suggests that this reach be considered for further analysis and treatment. Since the 1996 flood event, the GCSWCD has noted that the center of the reach is showing increasing signs of incisement, and the stream is migrating laterally against the south high terrace behind the Starr residence. Slope failures of the high banks is ongoing, and noted along the majority of the left bank, as well as the right bank. . There is evidence of a small head-cut in this area which appears to be working slowly upstream.

<b>TABLE VI-4</b> <b>Reach No. 1d Peck Road Bridge to C.D.Lane Park</b>	
<b>Intervention Level</b>	Assisted Self Recovery/Preservation
<b>Stream Morphology</b>	Stream morphology is strongly influenced by the flood control structure. Channel aggradation in the lower reach will always be an issues, and will continue to impact local stability. Improper management of the gravel deposition will continue to degrade upstream conditions.
<b>Riparian Conditions</b>	The GCSWCD will continue to improve the riparian buffer on the right bank, in the area being used for the Plant Materials Center. Riparian buffer conditions on the left bank should be improved in the enter of the reach, but only after the active degradation is addressed.
<b>Water Quality</b>	See General Recommendations
<b>Infrastructure</b>	1. Observe function of Peck Road bridge at the top of the reach. Monitor bridges impact on sediment transport, as well as local slope.  2. Develop comprehensive long range management plan for flood control structure (see details in General Recommendations)
