Management Segment 2

C.D. Lane Park to Hensonville CR 65

**Batavia Kill Watershed
 Segment 2 Management Reaches**
 Map VI-3
 Greene County Soil & Water Conservation District
 Batavia Kill Stream Corridor Management Plan

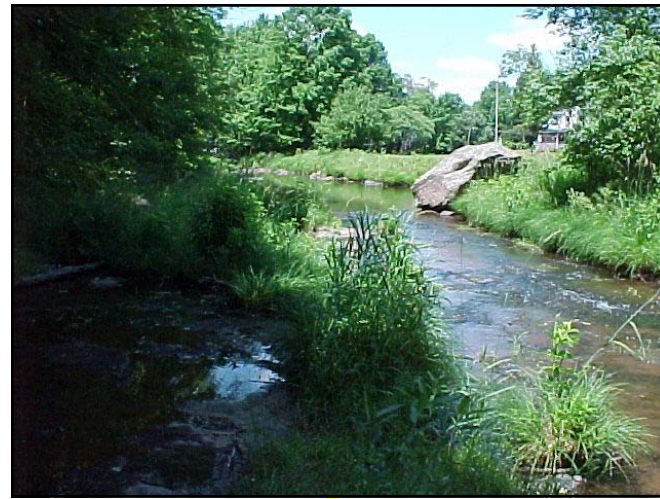
B

The Phase I Inventory and Assessment process characterized the reach as having very low streambank erosion with only 300 feet of stream bank erosion noted on the entire 1.9 mile long reach (**Figure VI-26a, Photo A,B,C,D,E,F**). Stream profile (the slope of the stream bed) is controlled by bedrock exposures at the top of the reach as well as near the bottom, and the remnants of an old K-Dam fisheries structure located near the top of the reach (**Figure VI-26a, photo G**) also appears to exert some control on the profile.
