V-B. Watershed Inventory and Assessment

The watershed level inventory and assessments performed for the Batavia Kill Pilot Project were initiated to assist the GCSWCD in evaluating and monitoring basin wide physical characteristics, hydrology, and water quality. Initial assessments were conducted to characterize the physical attributes of the watershed, to document existing hydrologic characteristics and to refine their relationship to turbidity and total suspended sediment.

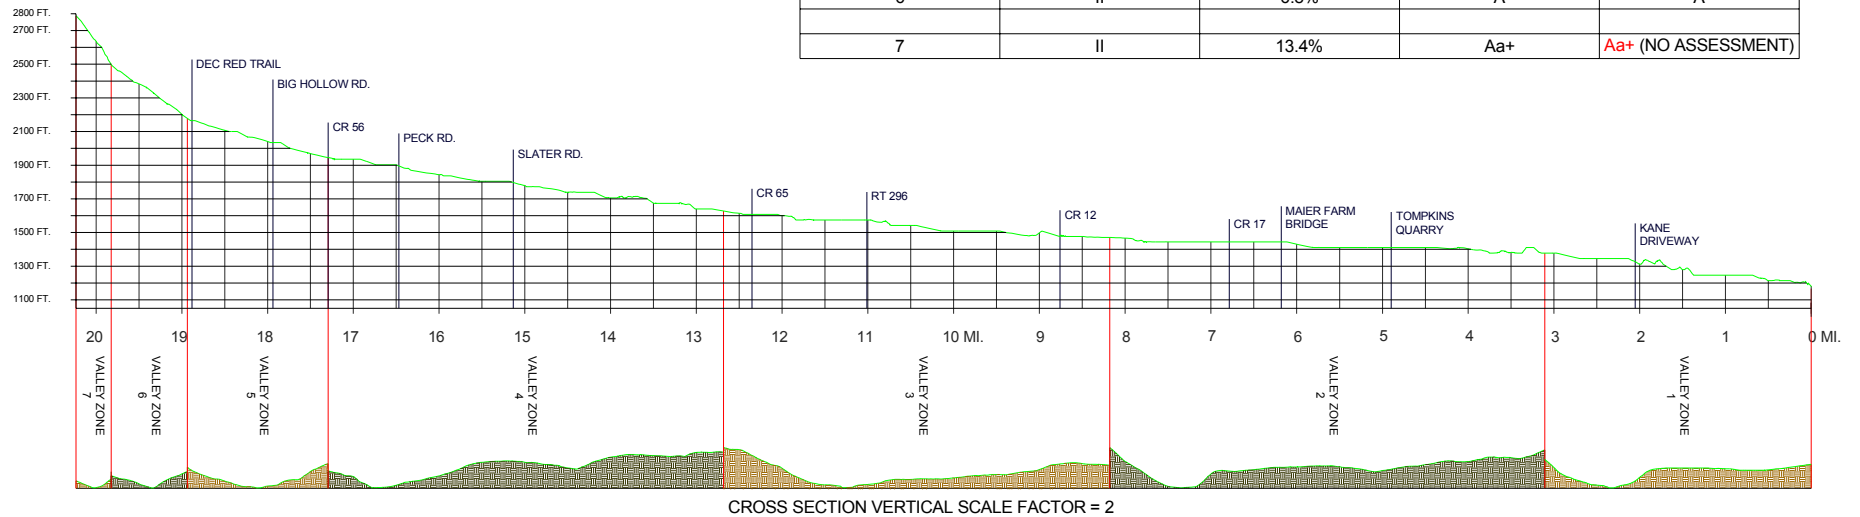
Figure V-12: Valley Zone delineation of the Batavia Kill watershed.

VALLEY PROFILE WITH REPRESENTATIVE CROSS SECTIONS

FOR EACH VALLEY ZONE

VALLEY ZONE	VALLEY TYPE	VALLEY SLOPE	TYPICAL STREAM TYPES	STREAM TYPES FOUND
1	V	1.2%	G, D, C	F, B, C
2	VIII	.3%	F, E, DA, D, C	F, C
3	V	.7%	G, D, C	B, C
4	V	1.3%	G, D, C	B, C
5	V	2.7%	G, D, C	B, F
6	II	6.8%	A	A
7	II	13.4%	Aa+	Aa+ (NO ASSESSMENT)

Rosgen (1996) identifies ten different valley types based on slope, confinement, sediment supply and whether the soils are colluvial, alluvial and/or glacial. While classification of the watershed based on valley types is somewhat broad, it can provide one variable by which stream managers can focus on typical stream form and function. An understanding of the valley form can assist stream managers in evaluating stream processes, as well as interpretation of channel resilience and recovery potential. To begin the analysis of valley morphology in the Batavia Kill basin, a digital terrain model of the watershed was created. A profile was then extracted from the model to illustrate the slope characteristics of the valley floor. In general, as shown on **Map IV-6**, the Batavia Kill Watershed is characterized by steep slopes and moderate to narrow valley widths. Approximately 80 percent of the land area in the watershed exceeds 10% slope. Seven general valley zones were identified from the valley profile on the basis of dominant slope characteristics (**Figure V-12**). The

seven zones, labeled "Valley Zone 1 - 7" starting with "Valley Zone 1" at the mouth, were then cross sectioned to illustrate the shape and grade of the valley slopes.

Valley Zone 1 extends from the mouth of the Batavia Kill at the Schoharie, to just over three miles up the valley. The overall land form slope of the zone was found to be approximately 1.2%. The slope and cross sectional characteristics of Valley Zone 1 suggest a type V valley. A type V valley is characterized by alluvial terraces, well-developed floodplains and a broad valley floor. Valley Zone 1 with a slope of 1.2% would typically support stream types F, E, D, and C.

Valley Zone 2 extends from the upper extent of Valley Zone 1 to about 8.25 miles up the valley from the mouth. The overall land form slope of this zone is approximately 0.3%. Valley Zone 2 is a type VIII valley, characterized by alluvial terraces, well-developed floodplains and a broad valley floor. The stream types commonly found in valley type VIII with this slope are F, E, D, DA and C.

Valley Zone 3 extends from the upper extent of Valley Zone 2 to just under 12.75 miles up the watershed. The overall land form slope of the zone is approximately 0.7%. Valley Zone 3 is a type V valley, characterized by a wide, "u"-shaped valley trough, lateral and terminal moraines, floodplains, and alluvial terraces. Stream types commonly found in this valley zone are G, D and C.

Valley Zone 4 extends from the upper extent of Valley Zone 3 to just over 17.25 miles up the valley. The overall land form slope of the zone is approximately 1.3%. Valley Zone 4 is a type V valley, characterized by a wide, "u"-shaped valley trough, lateral and terminal moraines, floodplains, and alluvial terraces. Stream types commonly found in this valley zone are G, D and C.

Valley Zone 5 extends from the upper extent of Valley Zone 4 to just under 19 miles up the valley. The overall land form slope of the zone is approximately 2.7%. Valley Zone 5 is a type V valley, characterized by a wide, "u"-shaped valley trough, lateral and terminal moraines, floodplains, and alluvial terraces. Stream types commonly found in this valley zone are G, D and C.

Valley Zone 6 extends from the upper extent of Valley Zone 5 to just over 19.75 miles up the valley. The overall landform slope of the zone is approximately 6.8%. Valley Zone 6 is a type I valley, characterized by "v"-shaped side slopes, high vertical relief, steep glacial scour lands. The stream type most commonly found in this valley type, with such elevation relief, is the type A stream.

Valley Zone 7 extends from the upper extent of Valley Zone 6 to the upper most reaches of the valley. The overall land form slope of the zone is approximately 13.4%. Valley Zone 7 is a type I valley, characterized by "v"-shaped side slopes, high vertical relief, and steep glacial scour lands. The stream type commonly found in valleys with slopes greater than 10% are the Aa+ streams.

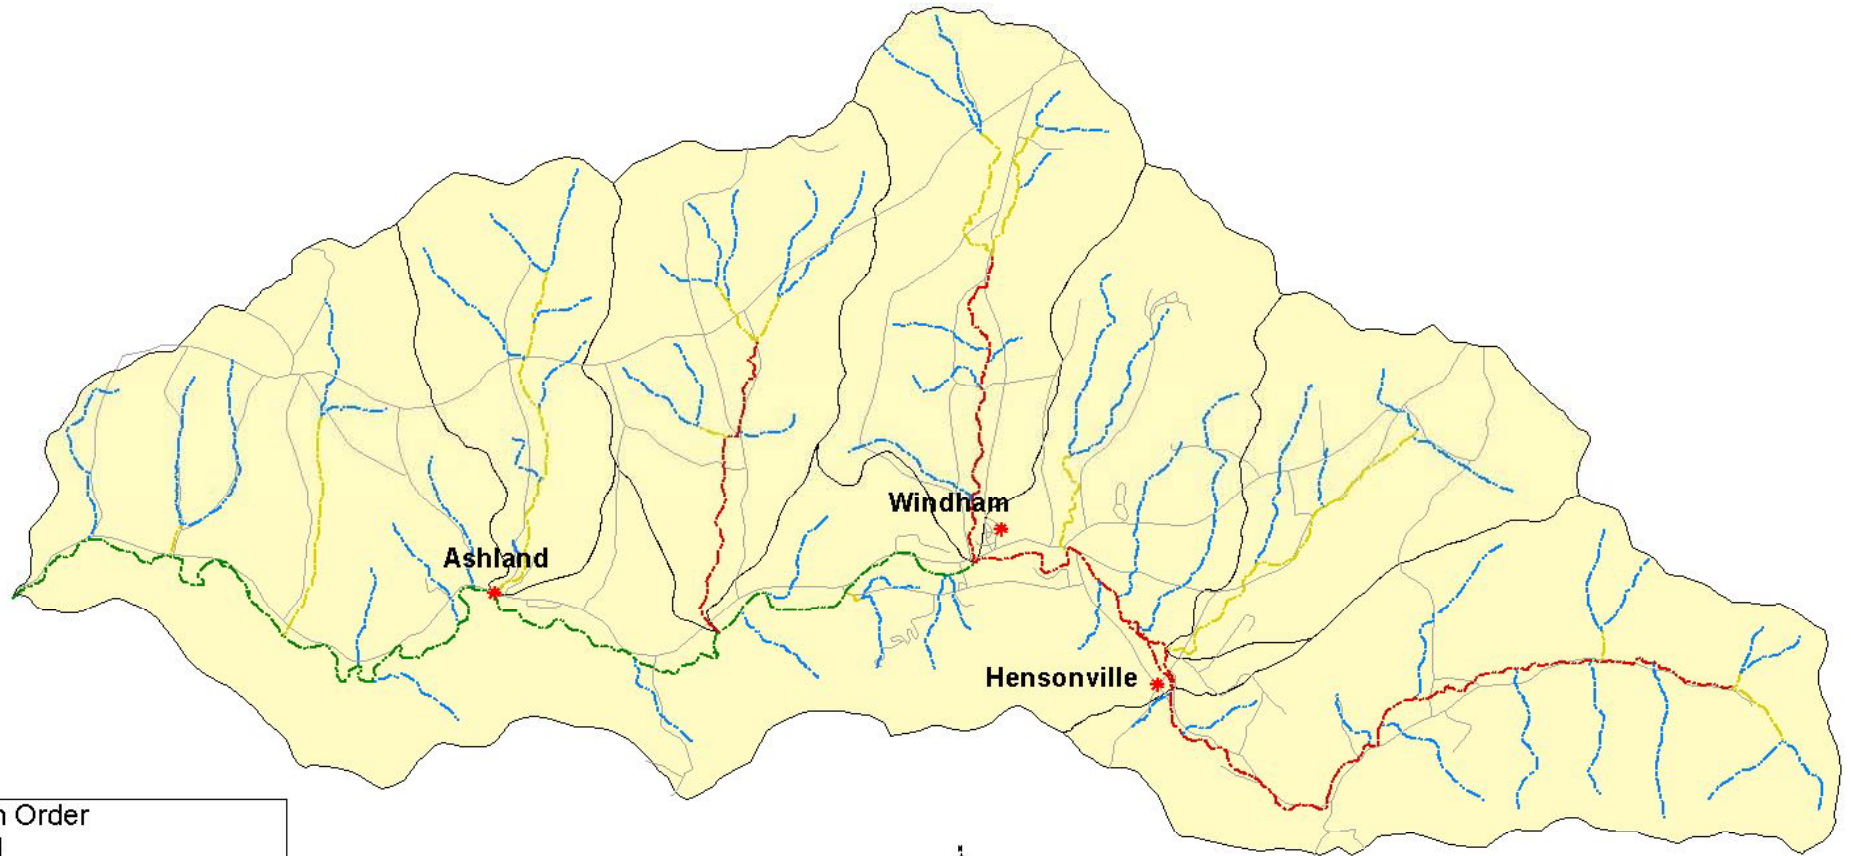
Map V-1
Greene County Soil & Water Conservation District
Batavia Kill Stream Corridor Management Plan

In the Batavia Kill watershed, the GCSWCD examined the stream order classification using the methodology developed by A.H. Strahler in 1957 (Okanagan University, 2000). Using only those stream segments as identified on USGS (7.5 minute 1:24000) topographical maps for the watershed, the GCSWCD evaluated the stream ordering of the entire Batavia Kill watershed. The stream order characteristics of the Batavia Kill are presented in Table V-1, and **Map V-1**. Based on the application of the stream order classification system in various watersheds, researchers have observed a number of morphometric relationships which are commonly known as the Laws of Drainage Composition.

**Batavia Kill Watershed
Stream Order**

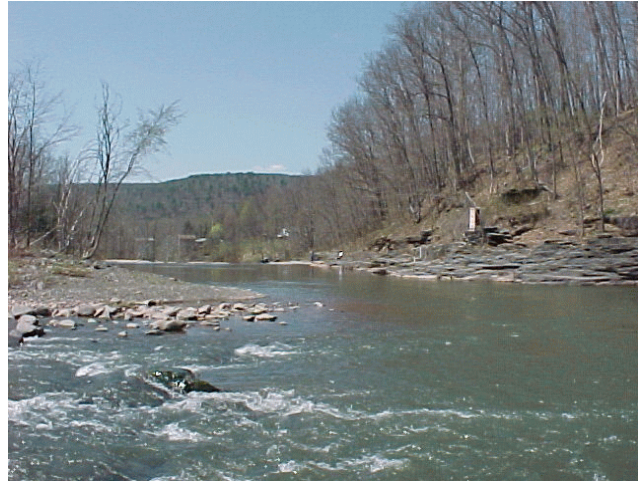
Figure V-13: Image of USGS gage at Red Falls.

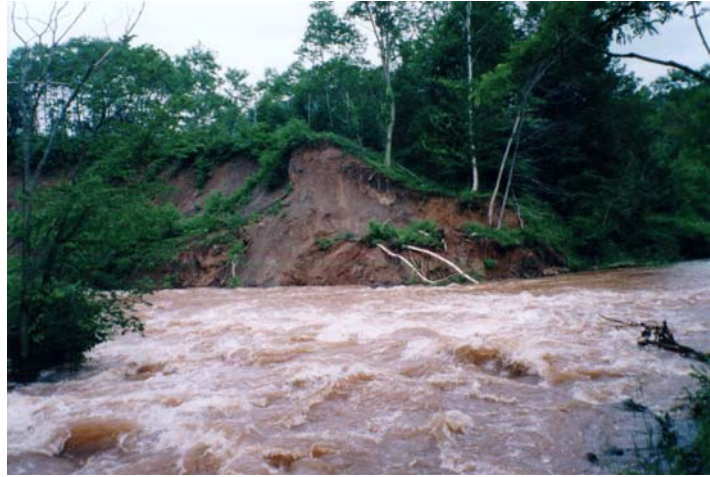
Figure V-14: Monitoring site above Red Falls during bankfull event.

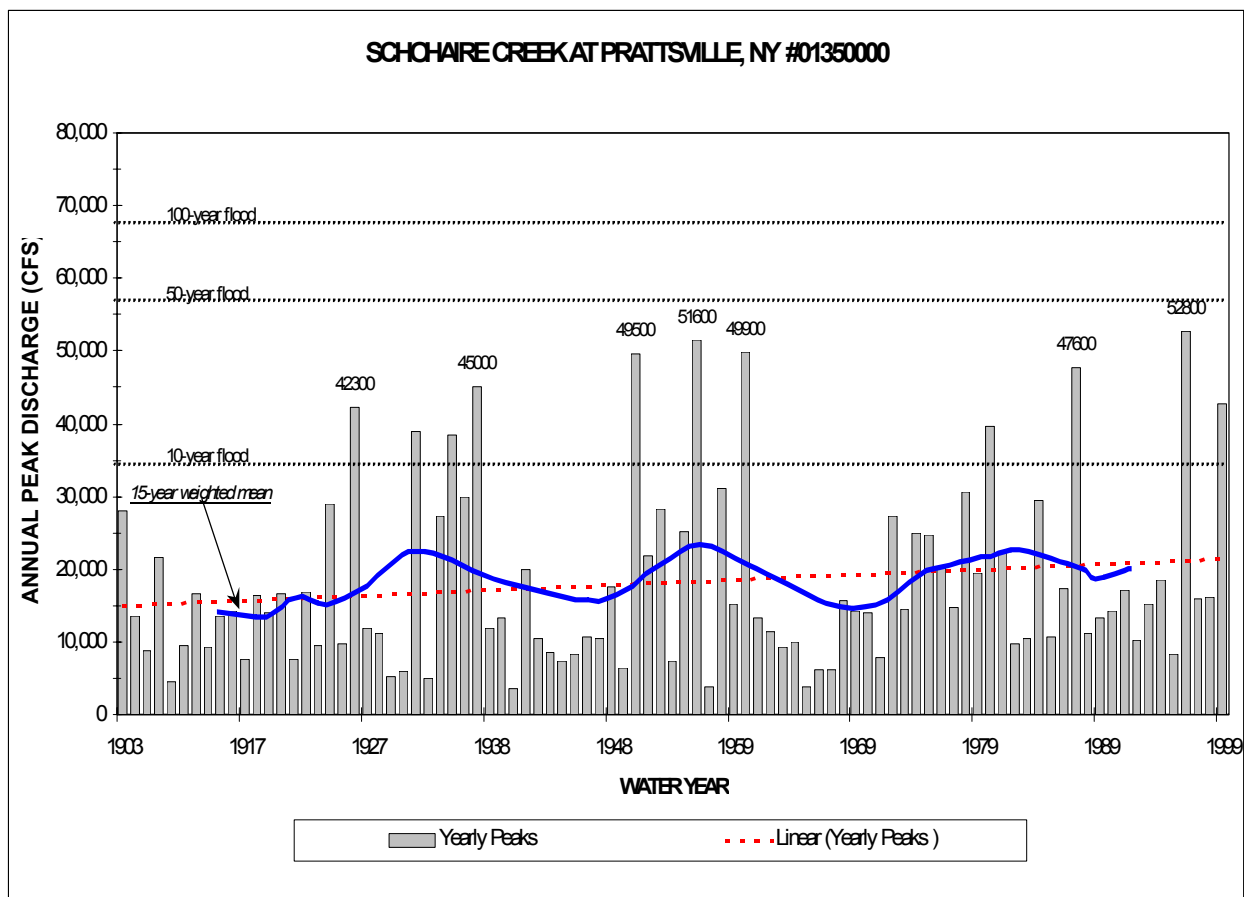
As shown in **Figure V-15**, the analysis completed by the GCSWCD was consistent with the findings of the USGS. The analysis indicated that the watershed was characterized by cycles of wetter and dryer periods. The axes represent the year of the storms occurrence and the peak discharge associated with them. Long-term discharge estimates for the frequencies of 10, 50, and 100 year storms are presented to show the magnitude of the flood events.

Figure V-15: Schoharie Creek historic yearly peak discharges.

The implications of the cyclic weighted average trend and the linear increase in average peak flow has tremendous importance in the management of the Batavia Kill. The cycle represented on the graph confirms trends in peak storm flow with approximately 20-25 years occurring between peaks. By forecasting the result forward, it can be determined that we are currently in a period of increased peak flow. Implications of this analysis can be applied to trends in erosion processes, floodplain function, as well as used to make management decisions regarding elements such as installation and construction of projects. The effects of land use and projected changes within the basin can also be used for planning the future use management of the Batavia Kill resource.

The frequency of events exceeding bankfull is consistent with the cyclic pattern in long term peak discharges discussed earlier (**Figure V-15**). The high number of bankfull events, and the magnitude of the flood associated with tropical storm Floyd, are both assumed to have been a primary factor in the excessive rates of stream instability observed during the project period.

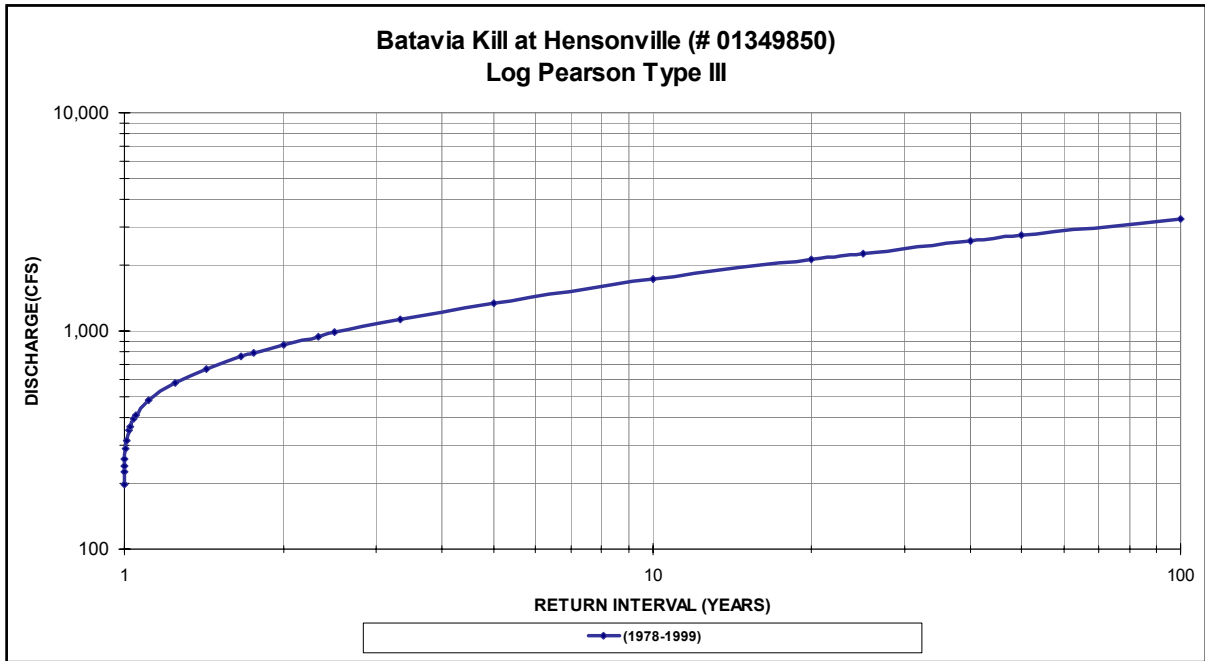
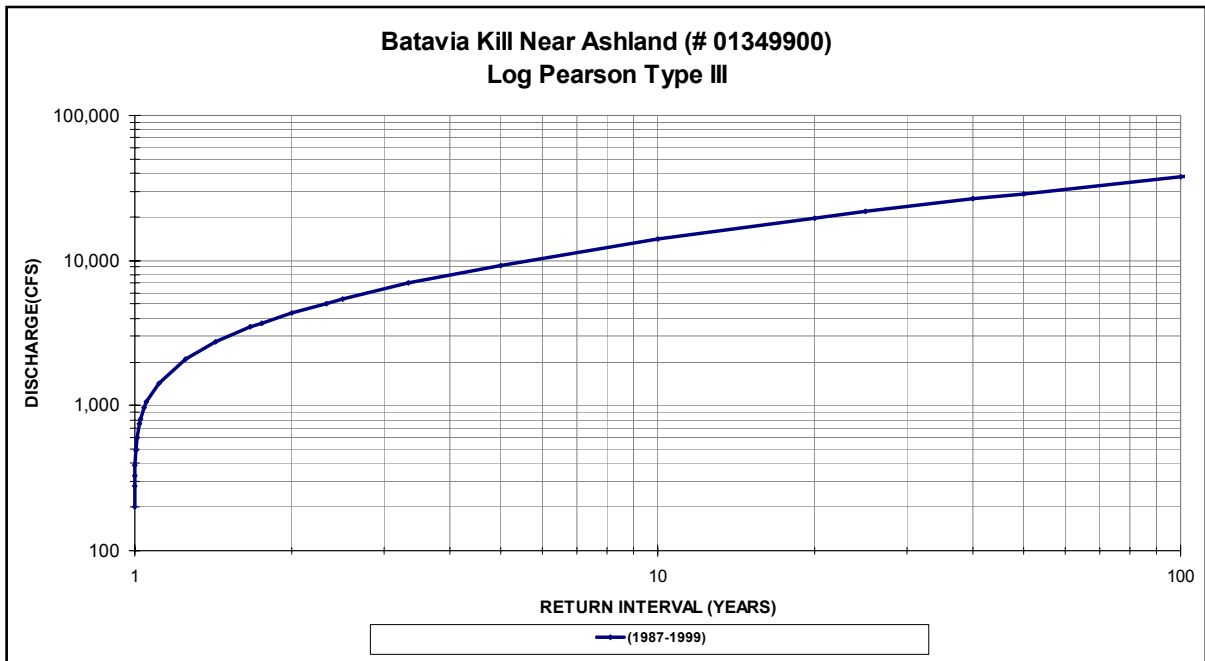
Figure IV-16: Flood frequency curves for Hensonville and Ashland USGS stream gages.

near Ashland #01349900 has recently established 10 years of consecutive record for analysis, but caution must be used in its applications due to effects of flow trends presented in **Figure V-15**, as well as implications of flood retention structures located in the watershed. Flood Frequency Curves for the Ashland and Hensonville gages are shown in **Figure IV-16**.

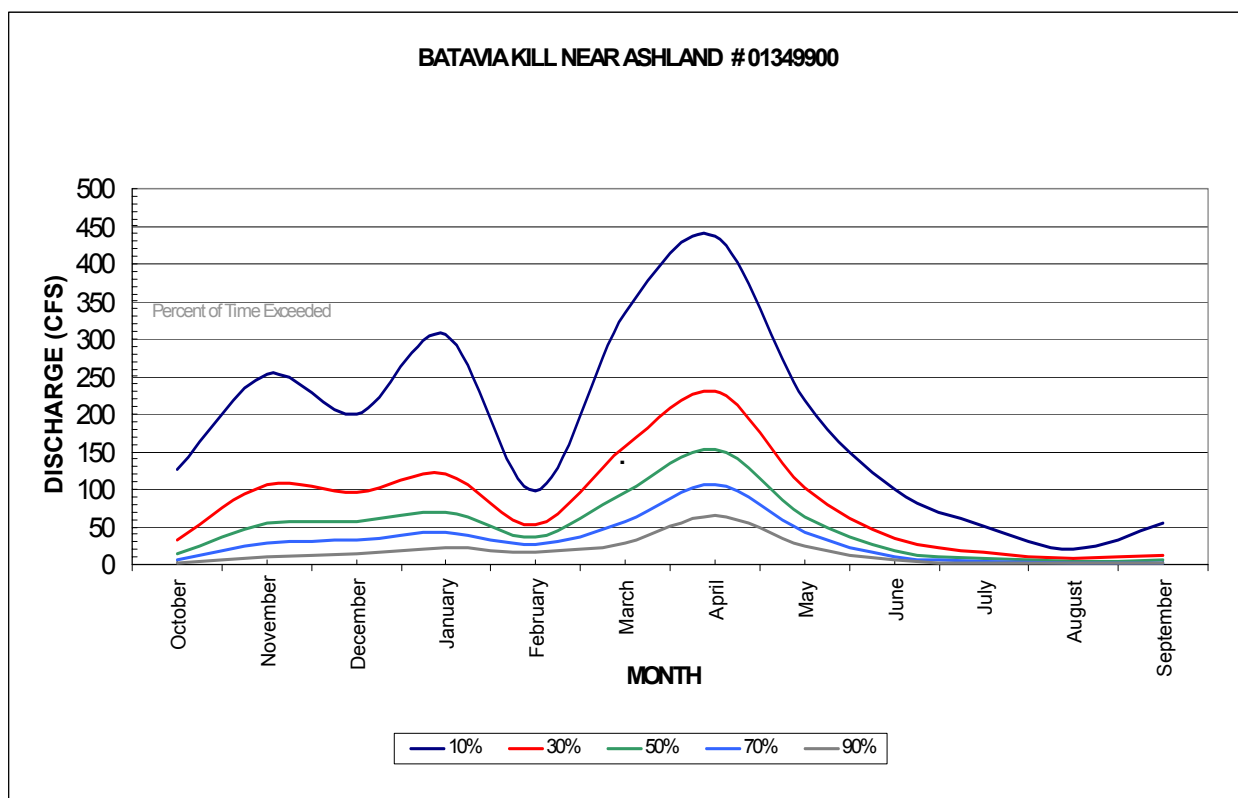
Seasonal distributions of flow are also important for planning and management decisions. For example, knowledge of when a specific stream system experiences various levels of flow, can allow stream managers to schedule restoration efforts for intervals when the probability analysis indicates low flow conditions can be expected. Using the USGS gage near Ashland, the GCSWCD examined the seasonal flow variability on the Batavia Kill. As shown in **Figure V-17** below, the Batavia Kill is characterized by a spike in the average discharge in the springtime, with runoff during April producing an average flow of over 155 cfs.

The months of July and August represent the summer low flows where the mean daily averages are only 4-8 cfs. The analysis also indicates smaller peaks in daily discharge in November and January. The November peak is likely associated with late fall storms, often related to the remnants of hurricanes. While the GCSWCD did not correlate the discharge data with either precipitation or daily watershed temperatures, it is thought that the January peak represents the “January Thaw”.

Figure V-17: Monthly probability curve for Near Ashland gage.

On the Batavia Kill, water withdrawals at Windham Mountain are regulated and monitored by NYSDEC. Water withdrawals for snow making occurs between November through March. Ski Windham maintains a stream gage approximately ½ mile down stream from their water intake structure, and the ski slope's permit with NYSDEC allows for water withdrawals only when stream flows exceed 7 cfs. Again, while the GCSWCD did not correlate the data used to examine seasonal flow variability with the rate and amount of water withdrawals at Windham mountain, the reduction of flow during February as shown in **Figure V-17** may be impacted by these withdrawals.

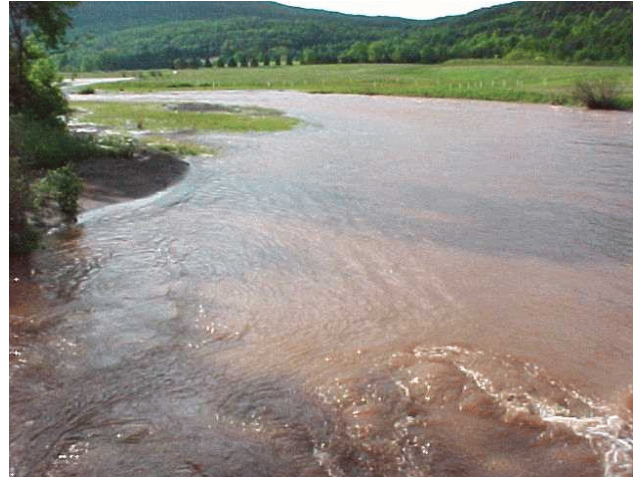
Figure V-18: Batavia Kill at Maier Farm at bankfull stage 1 day after tropical storm Floyd Sept. 1999.

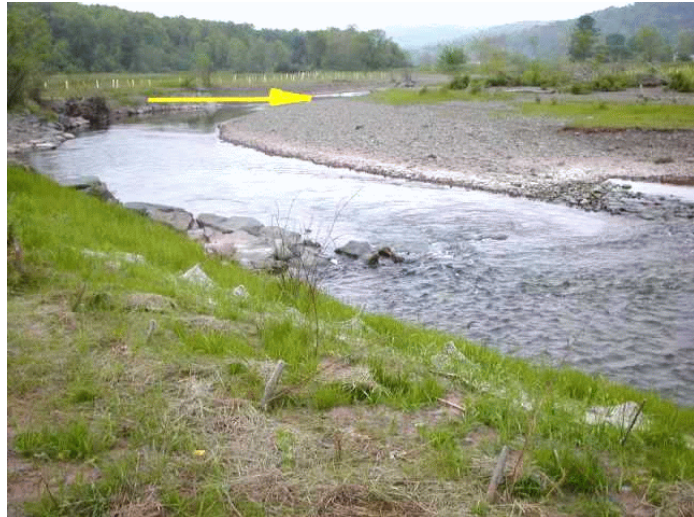
Figure V-19: On stable stream reaches, the top elevation of depositional features such as this point bar are good bankfull indicators.

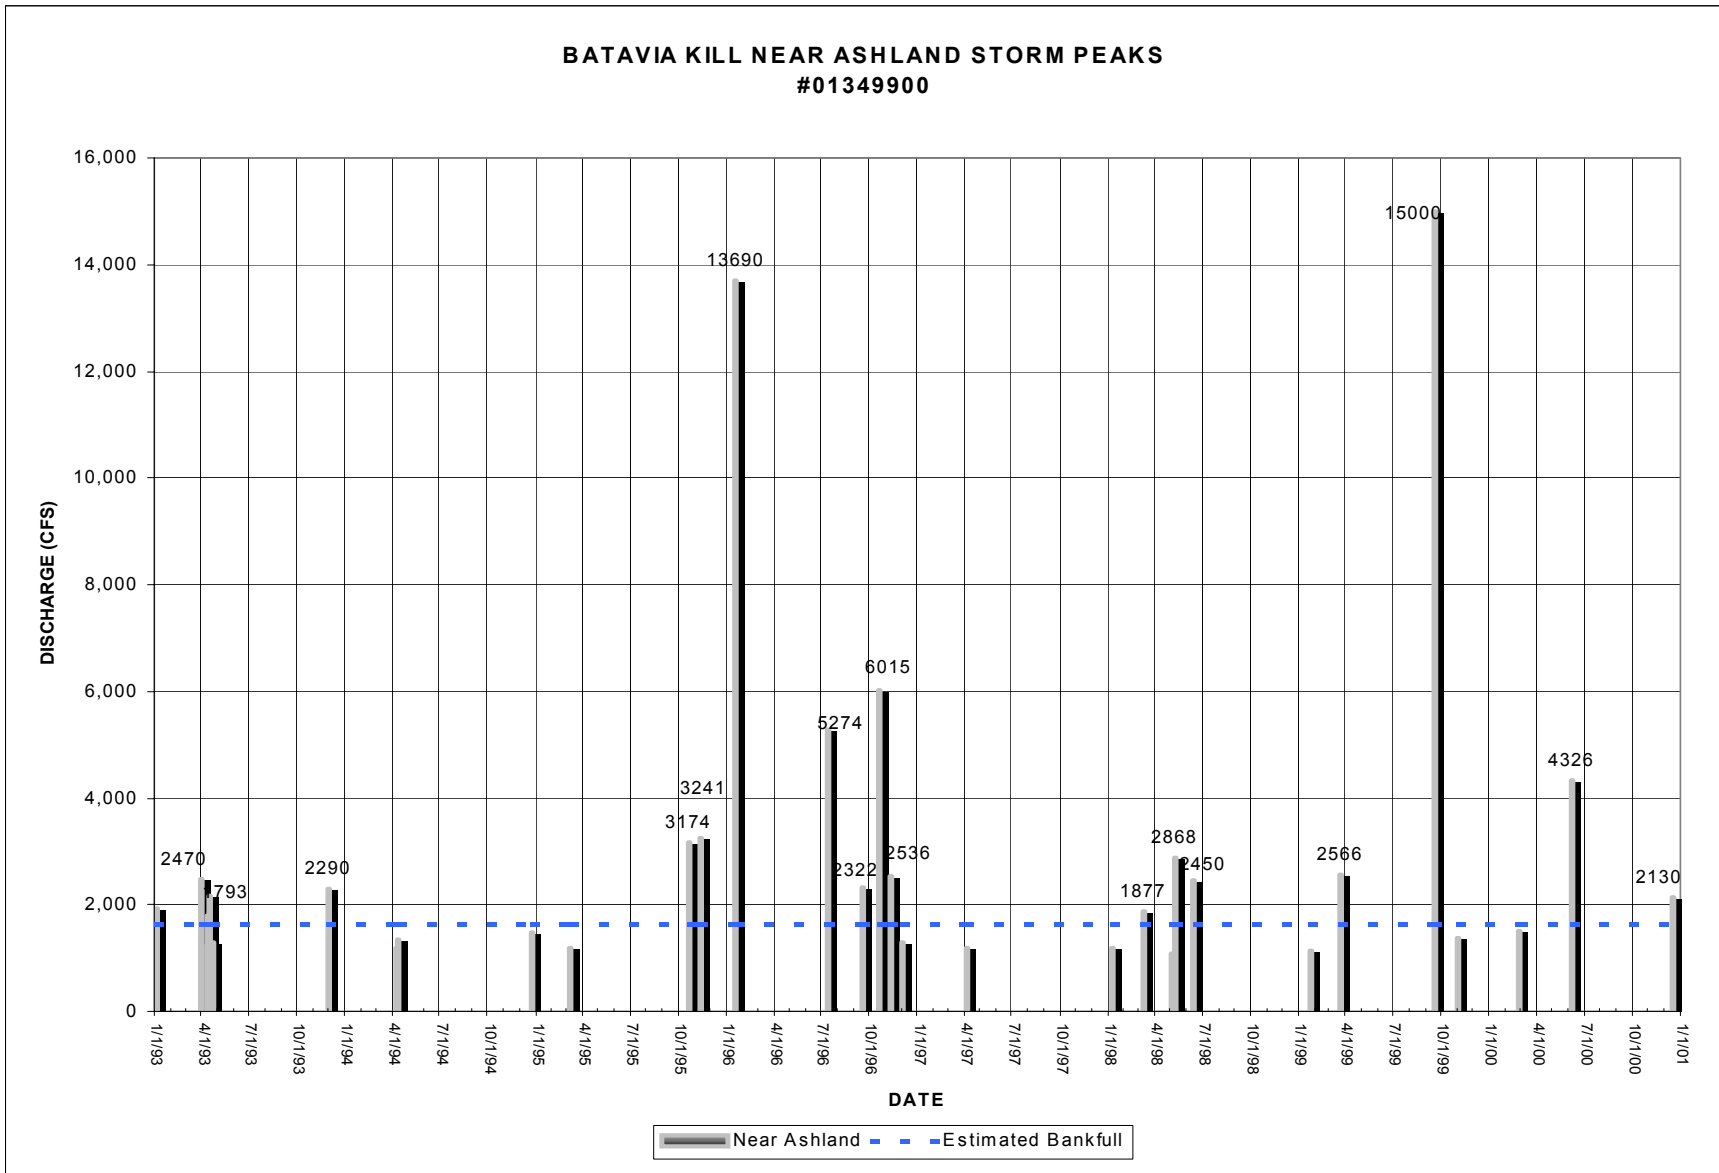
Figure V-20 summarizes the frequency of bankfull events during the period that the GCSWCD has been monitoring stream instability on the Batavia Kill. Using data from the Ashland stream gage, the GCSWCD wanted to determine how many times the stream discharge had met or exceeded the bankfull stage (1000 cfs at Ashland gage). In January 1996, a mid-winter flood occurred in the basin with the flood peak exceeding 13000 cfs. During that year, 4 additional flow events exceeded the bankfull discharge. When the period of stream monitoring conducted by the GCSWCD is evaluated (1997 - 2001), it can be seen that 7 bankfull or greater events (blue line) have occurred. This excludes tropical storm Floyd in September 1999 when the peak discharge was over 15,000 cfs.

Figure V-20: Batavia Kill storm events over 1000cfs at Ashland, 1993-2001.

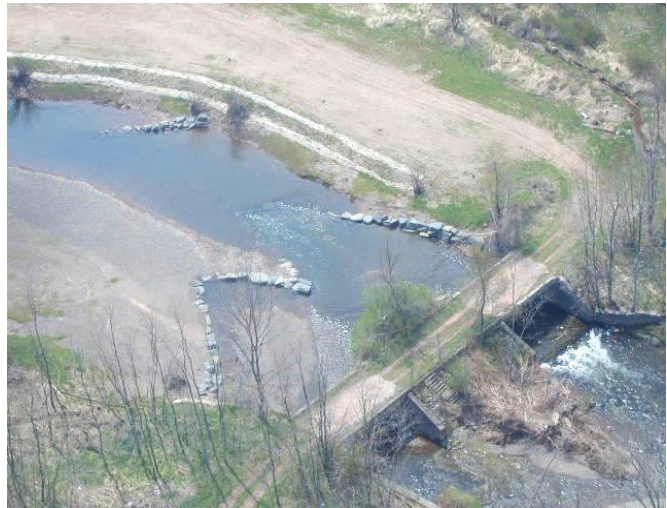
Figure V-21: Private bridge at Maier Farm demonstration project site.

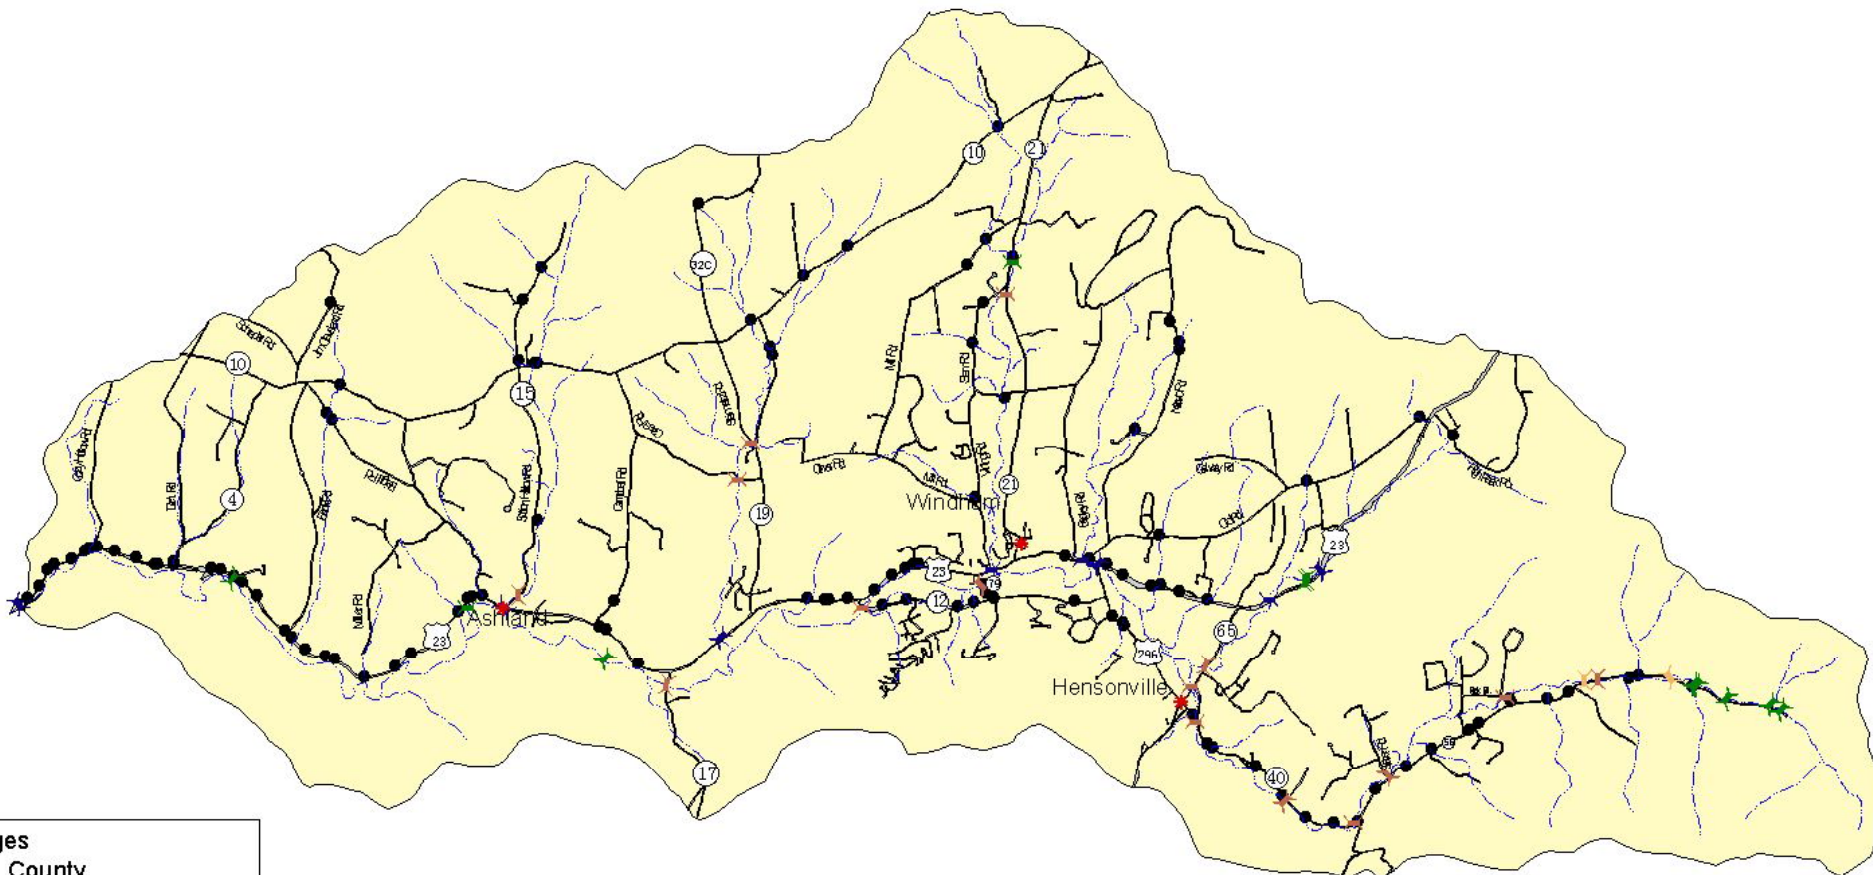
Map V-2
Greene County Soil & Water Conservation District
Batavia Kill Stream Management Plan

The locations of all the structures were logged in the field using GPS technology, and information on the structure including structure ID number, road name, stream name, size, etc., was collected and associated with the location point. The 1 meter accuracy of the located structures is adequate for the purposes of this SMP. The data was imported into a database that can be used in multiple software applications and the bridges/culverts were mapped in ArcView (**Map V-2**).

**Batavia Kill Watershed
Infrastructure**

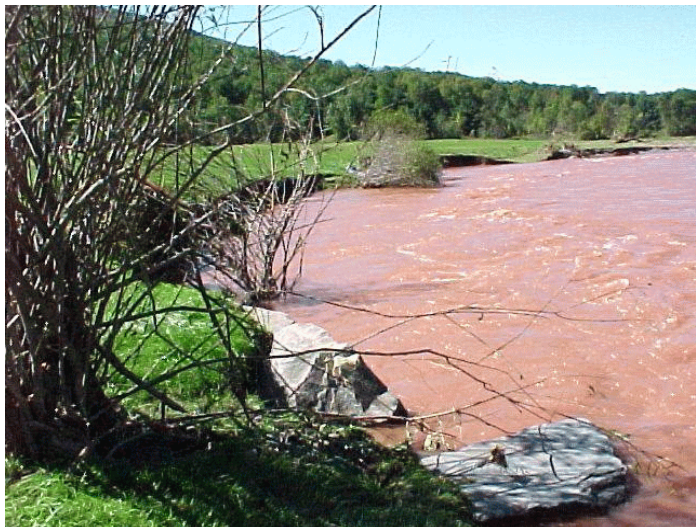
Figure V-22: The Batavia Kill at just below bankfull stage 2 days after the tropical storm Floyd flood event.

After the flood associated with tropical storm Floyd in September 1999, the GCSWCD was able to observe the impact of the flood control structures on stream discharge. The peak discharge associated with the flood occurred on the Batavia Kill somewhere between 10:00 and 11:00 PM on Thursday, September 16th. Since the flood stage exceeded the staff plate elevations at key gages on the Batavia Kill it is not possible to pin down the exact time. When the GCSWCD arrived in the watershed early the following morning, the stream had receded to the point where it was mostly within the channel, and at just over the bankfull stage. The GCSWCD continues to make daily observations of the stream, and by late in the day on Saturday, September 18th, the discharge was still running slightly below bankfull. By Tuesday September 21st, the discharge had dropped to approximately $\frac{1}{2}$ of the bankfull discharge, and by one week after the flood, the stream stage was still higher than other streams in the watershed.

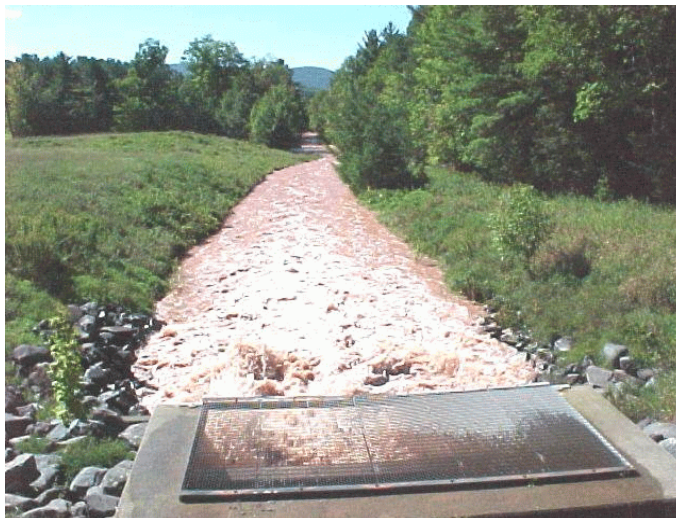
Figure V-24 shows water release downstream of the C.D. Lane Park structure outlet during the recession of flow following the Tropical Storm Floyd event in September of 1999. It is clear from this image that the release is laden with suspended load. It is this suspended sediment that is currently the primary limiting factor of the value of the Batavia Kill resource and the focus of the pilot project.

Figure V-24: Discharge from the C.D.Lane dam spillway 2 days after tropical Storm Floyd.
