New York State
Department of Environmental Conservation

Division of Water

**30 Year Trends
in Water Quality of
Rivers and Streams
in
New York State**

Based on Macroinvertebrate Data
1972 - 2002

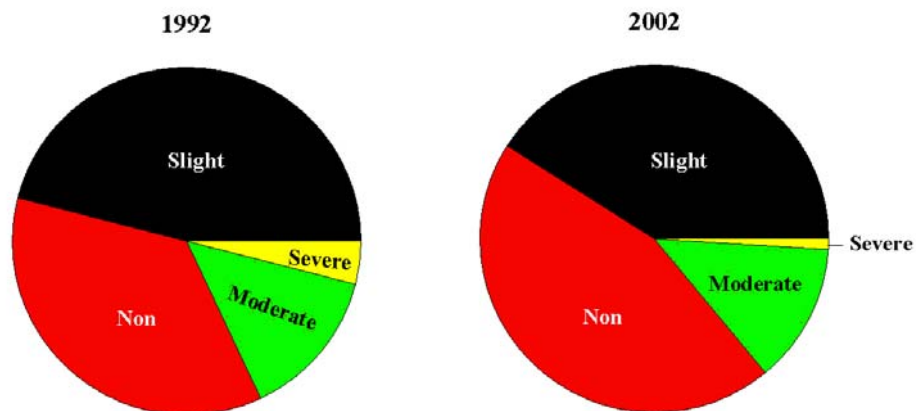
Figure 0-1. Assessed water quality at all sites, 1992 and 2002.

The 1992 water quality assessments showed 36% of sites as non-impacted, 46% slightly impacted, 14% moderately impacted, and 4% severely impacted.

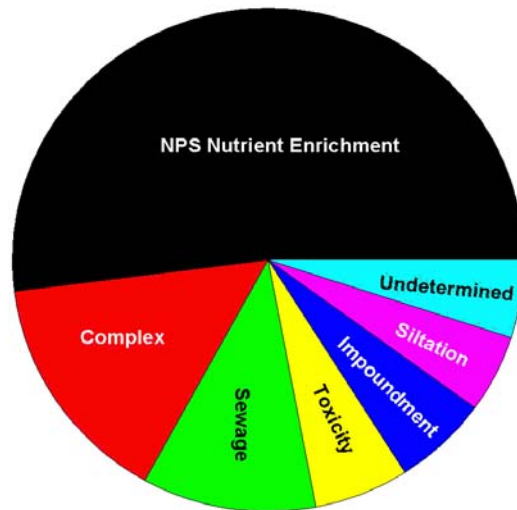
Figure 0-2. Causes of impact at impacted sites.

The probable causes of impairment are dominated by nonpoint source nutrient enrichment, affecting 52% of the currently assessed sites other than non-impacted sites. Other causes are: 15% complex (municipal/industrial inputs), 11% organic wastes (sewage and animal wastes), 6% toxicity, 6% impoundment, 5% siltation, and 5% undetermined (Figure 0-2). These probable causes of impairment were determined by Impact Source Determination, a method using faunal models empirically derived from macroinvertebrate data, first developed and applied by the Stream Biomonitoring Unit in 1994 and published in the scientific literature in 2002. Because the method was developed in 1994, no trend comparisons can be made to determine changes in causes of impact.

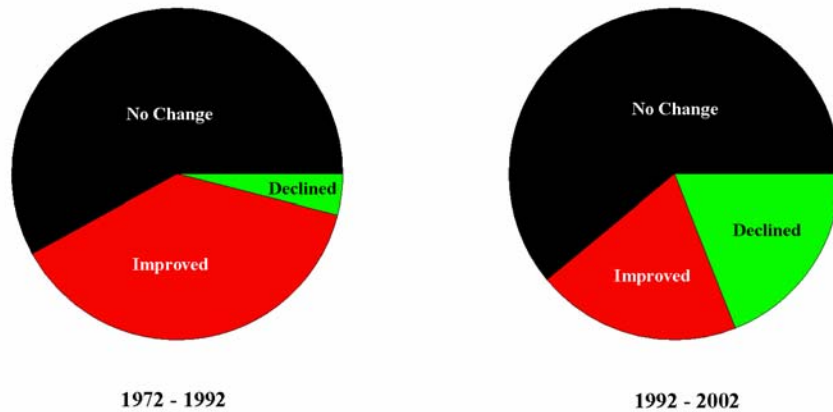
Figure 0-3. Water quality trends, 1972-1992 and 1992-2002.

Water quality trends were determined by comparing assessments at the 278 temporal trends sites before and after 1992. Some of these comparisons are based on a limited number of site visits, and are considered provisional, subject to further monitoring and verification. The breakdown of trends for the 1992-2002 period is: 20% improved, 19% declined, and 61% showing no change. This represents a substantial change compared to trends observed in 1992, specifically an increase in the category of declined water quality (Figure 0-3). Of the improved sites, most (64%) were attributable to improved treatment or elimination of municipal and/or industrial inputs.

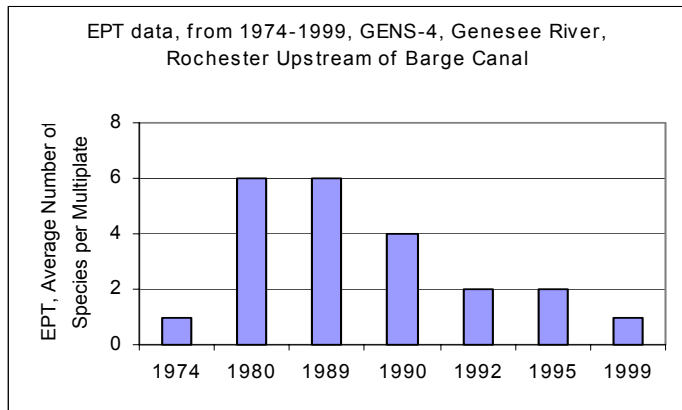
Figure 0-4. Clean-water mayflies, stoneflies, and caddisflies (EPT) in the Genesee River at Rochester, 1974-1999.

of the Gates-Chili-Ogden Sewage Treatment Plant. The number of EPT species (mayflies, stoneflies, and caddisflies) illustrated this change, but these numbers returned to 1974 levels in 1999 (Figure 0-4), and water quality was assessed as severely impacted. This situation is likely to be reversed, since as of late 1999, all Monroe County wastewater treatment facilities now discharge into Lake Ontario.

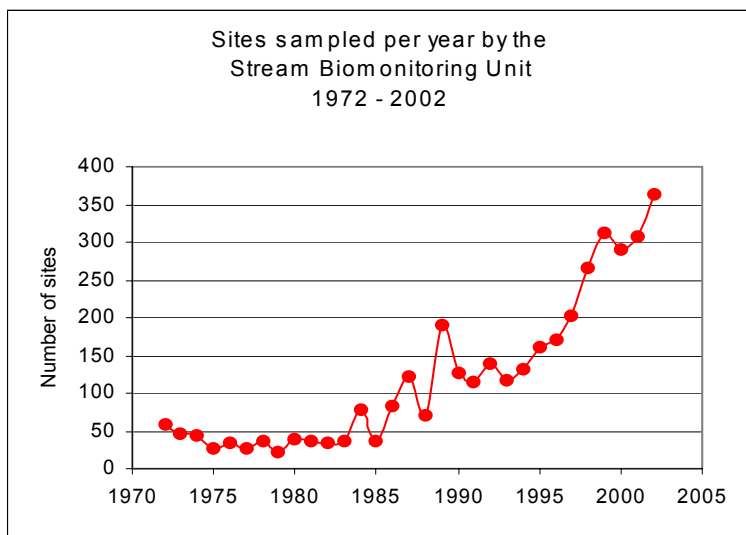
Figure 0-5. Sites sampled per year by the Stream Biomonitoring Unit, 1972-2002.

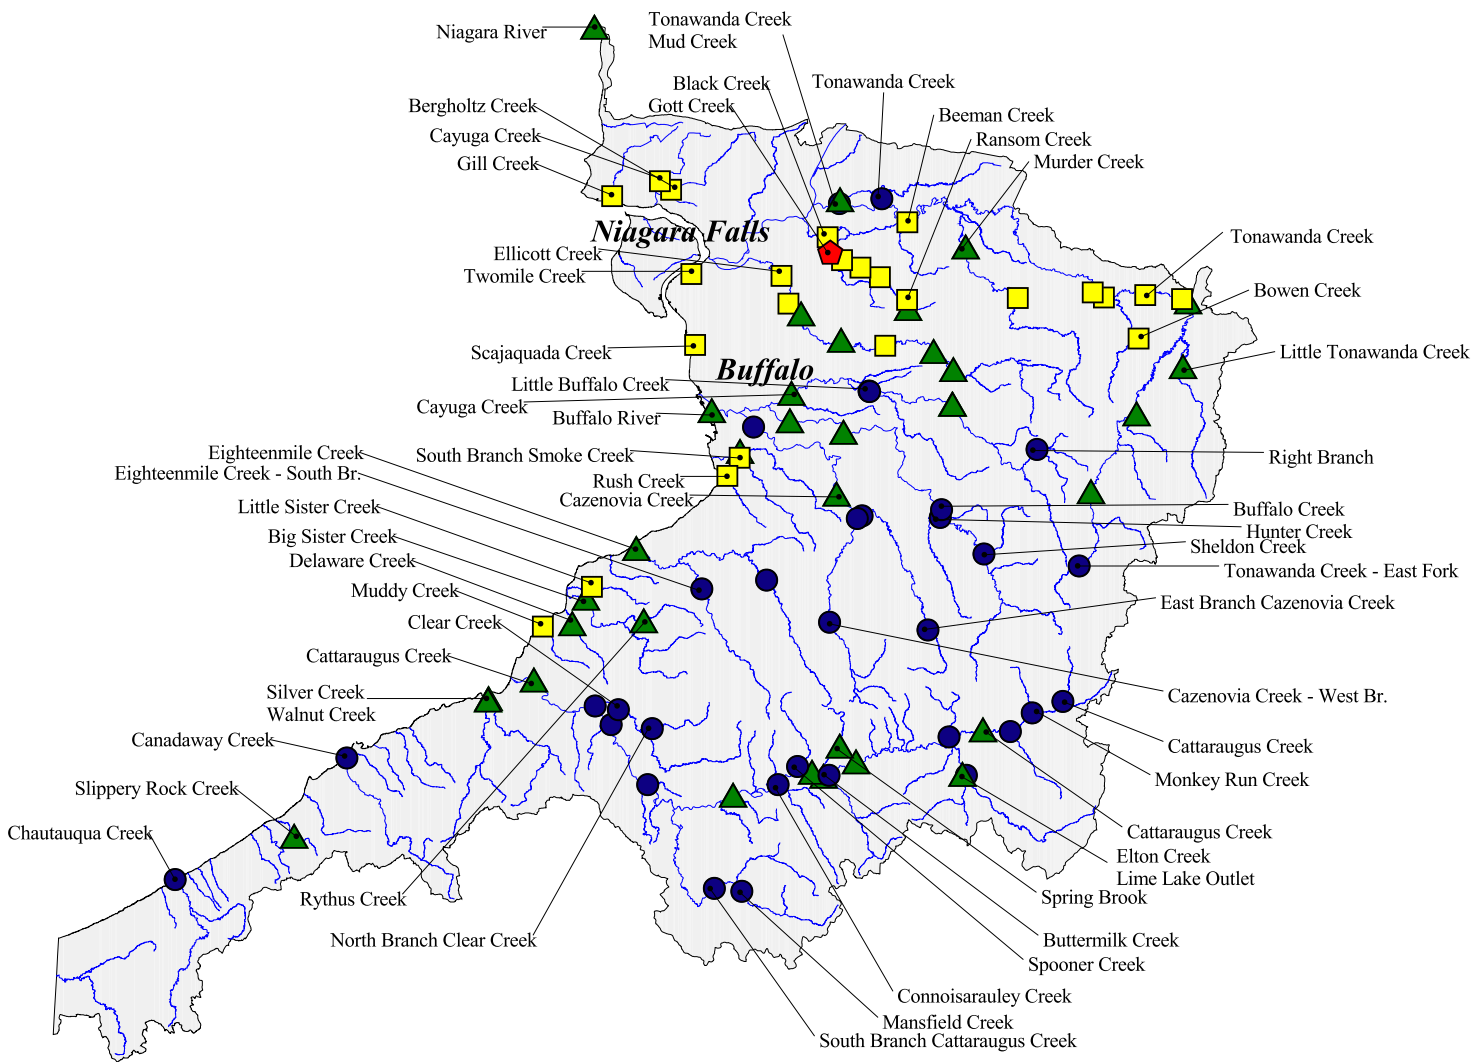
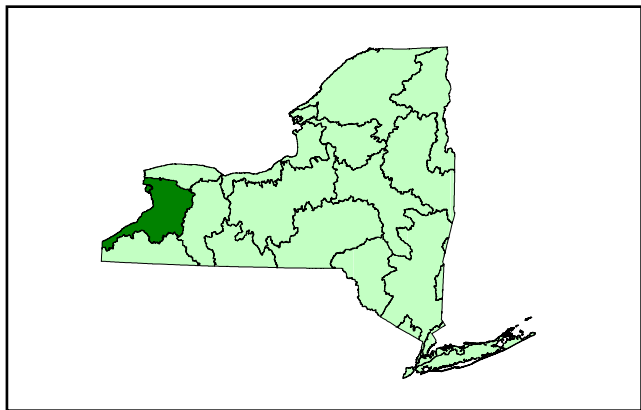
Lake Erie & Niagara River Drainage Basin

Water Quality Assessment based on Resident Macroinvertebrates

- non-impacted
- ▲ slightly impacted
- moderately impacted
- ◆ severely impacted

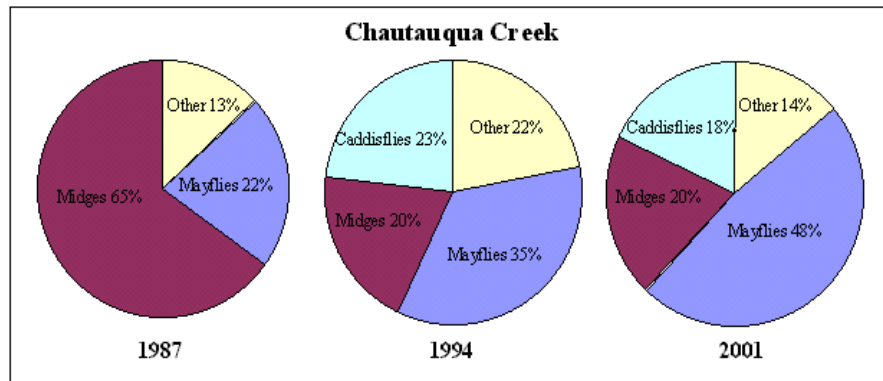
Figure 1-2. Faunal changes in Chautauqua Creek, 1987-2001.

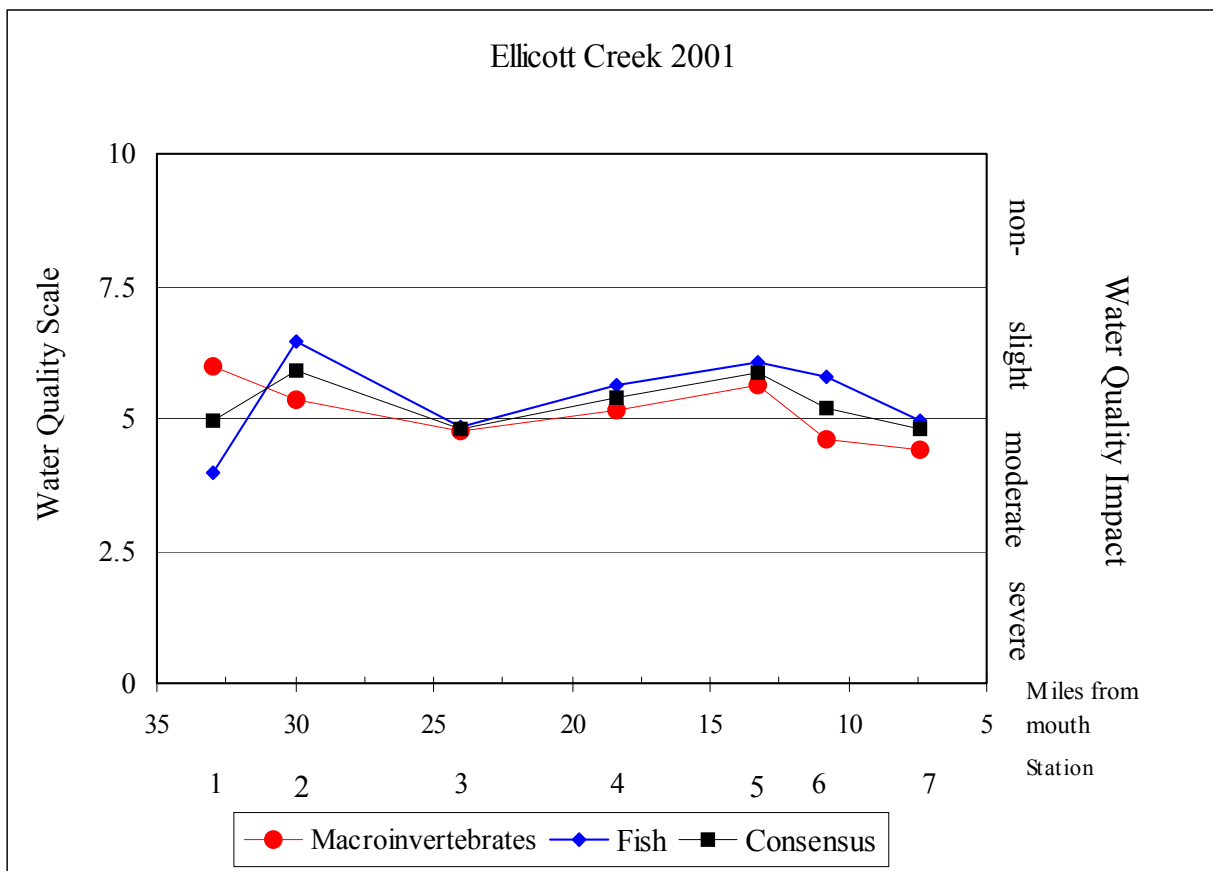
Figure 1-3. Ellicott Creek water quality as determined by macroinvertebrate and fish sampling, 2001.

Water quality in Ellicott Creek has ranged between slightly and moderately impacted. Most of the impact is in the lower portion of the creek in Amherst. A site upstream of Bowmansville was assessed as moderately impacted in the 2001 sampling, but poor habitat may be partially responsible for that determination. The Sheridan Avenue site between Williamsville and Amherst was clearly moderately impacted in the 1993 and 1994 samplings, and again in 2001. The sampling in 2000, a high-flow year, yielded only slight impact at this site, with 2 species of mayflies found. Nonpoint source runoff is considered to be the major cause of impact, with municipal/industrial inputs indicated for the lower portion of the stream. Fish collections by Doug Carlson (NYSDEC Fisheries) at 7 sites in 2001 showed similar trends as the macroinvertebrates (Figure 1-3).

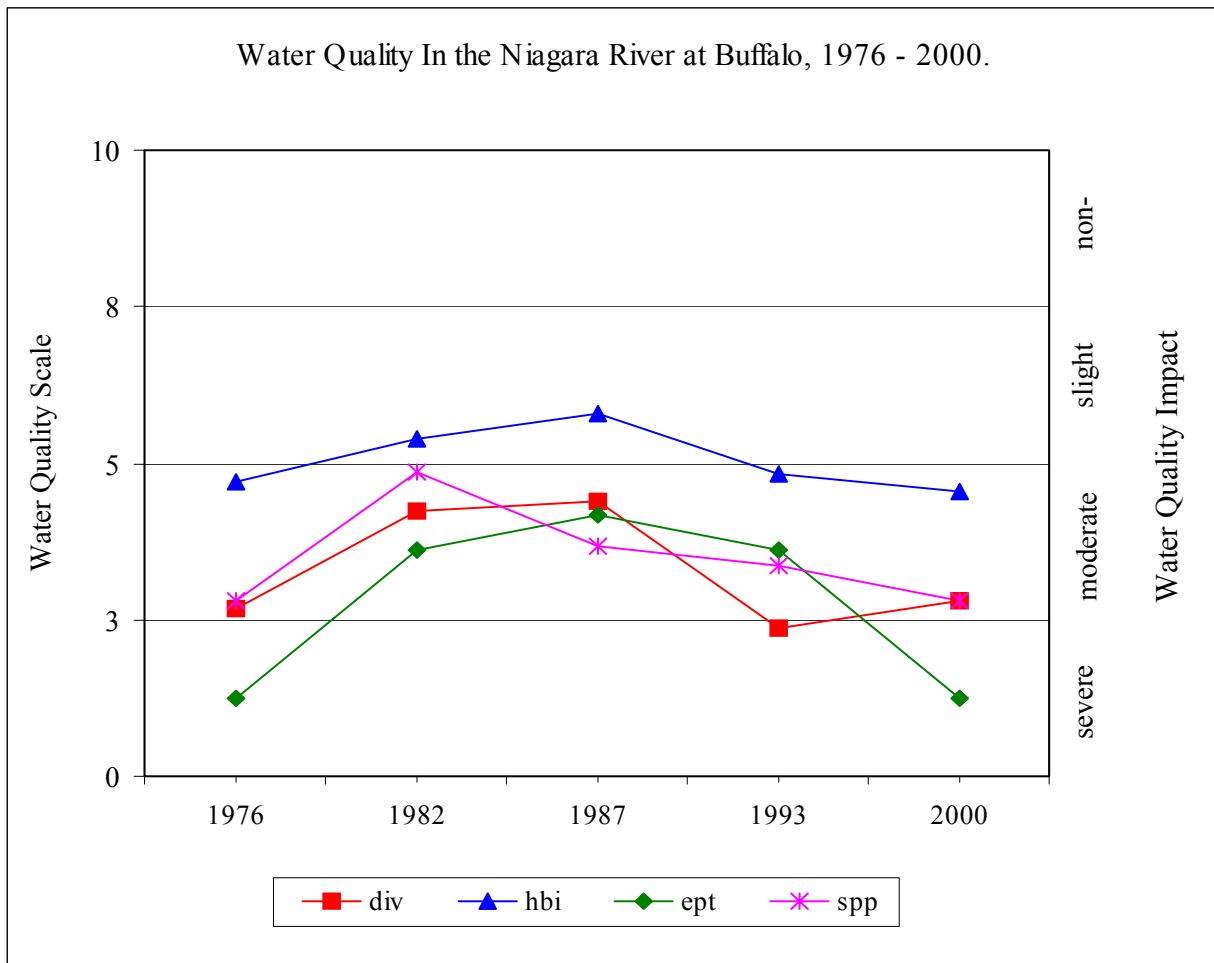
Figure 1-4. Water quality in the Niagara River at Buffalo, 1976-2000. DIV= species diversity, SPP= species richness, HBI= Hilsenhoff biotic index, EPT= richness of mayflies, stoneflies, and caddisflies,

The Niagara River site in Buffalo was assessed as moderately impacted, based on macroinvertebrate multiplate sampling in 2000. The fauna was very limited, consisting mostly of midges, worms, and scuds. The results represent a decline from conditions documented in 1982-1993; the fauna sampled in 2000 was similar to that sampled in 1976 (Figure 1-4). No cause is

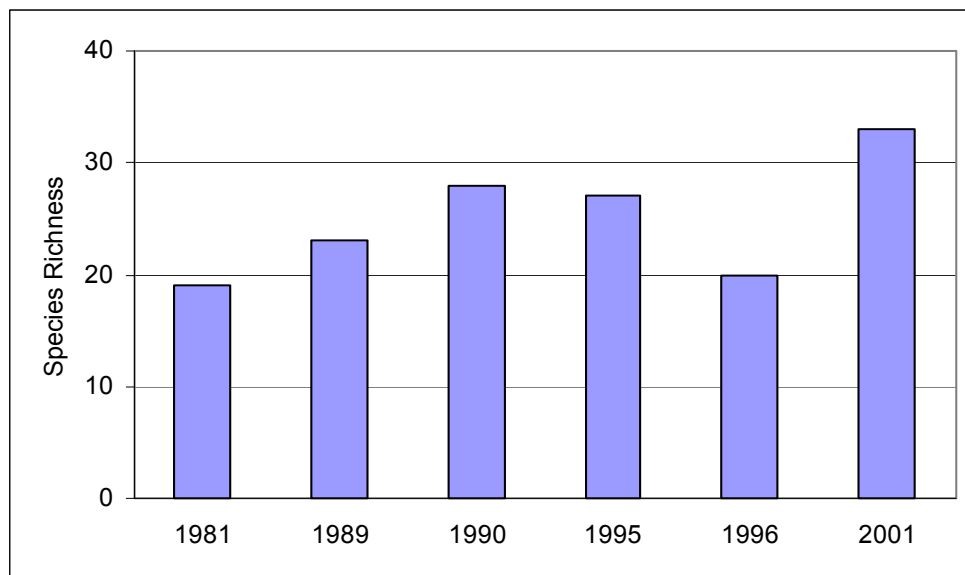
Figure 2-1. Species richness in the Allegheny River at Mill Grove, 1981-2001.

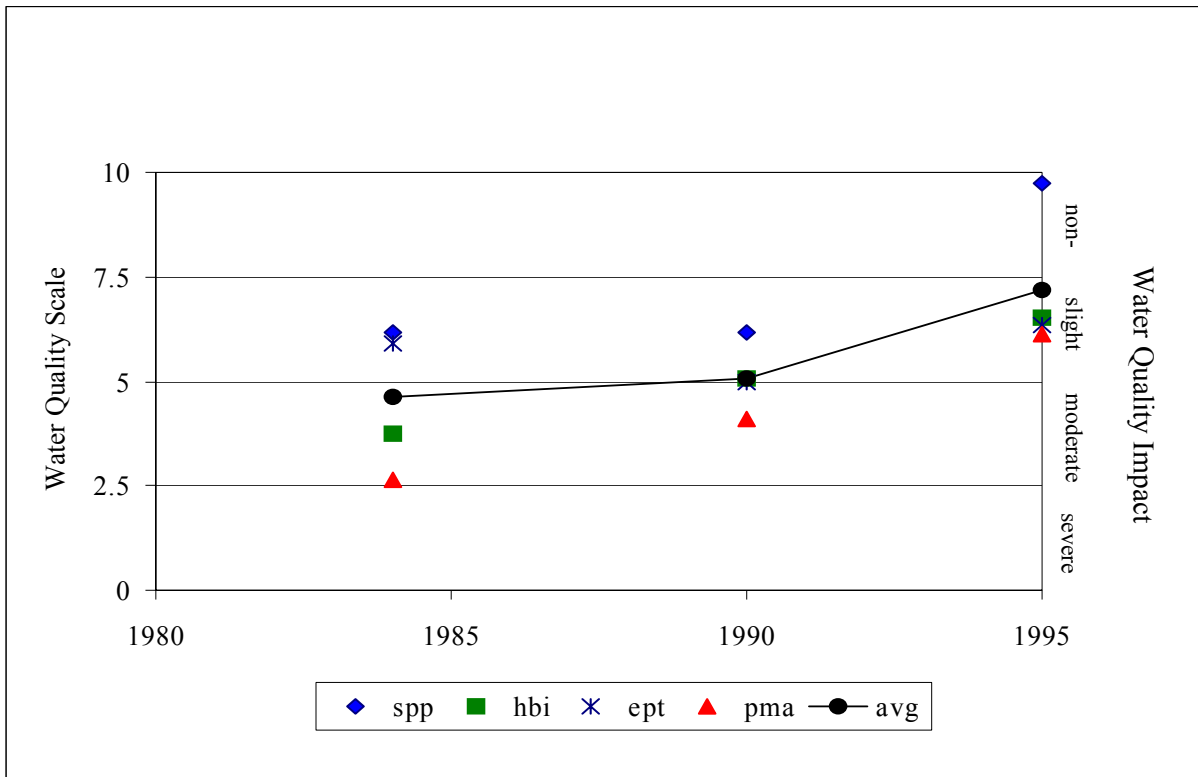
Figure 2-2. Water quality in Little Genesee Creek, 1984-1995. SPP= species richness, HBI= Hilsenhoff biotic index, EPT= richness of mayflies, stoneflies, and caddisflies, PMA- Percent Model Affinity, AVG= Biological Assessment Profile value.

Water quality at Bolivar was determined in 1995 to be slightly impacted, an improvement from 1984 and 1990, when moderate impact was caused by the Bolivar (V) Sewage Treatment Plant. A new treatment plant was built in 1991, with activated sludge treatment. The improvement is illustrated by the decline in the percent contribution of sewage-tolerant worms, which declined from 70% in 1984 to 2% in 1995 (Figure 2-2). At the town of Little Genesee, water quality has been assessed as slightly impacted for all years. The impact may represent residual effects from Bolivar, in addition to nonpoint source nutrient enrichment from the golf course immediately upstream. A site at Bowler, near the mouth, was sampled in 2001, and was determined to be non-impacted.

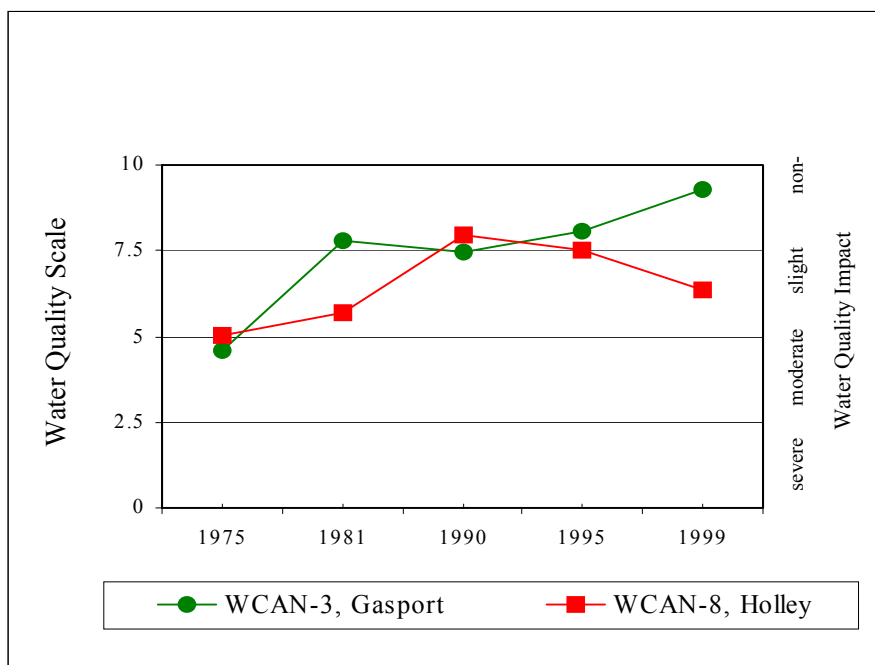
Figure 3-1. Water quality in the Western Barge Canal at Gasport and Holley, 1975-1999.

Monitoring of the Western Barge Canal has been focused on sites at Gasport and Holley. These sites have been monitored in 1975, 1981, 1990, 1995, and 1999. The Gasport site is currently assessed as non-impacted, representing an improvement compared to previous assessments. This site exhibited moderate impact in 1975 sampling, and has improved steadily since, displaying faunas of several species of mayflies and caddisflies.

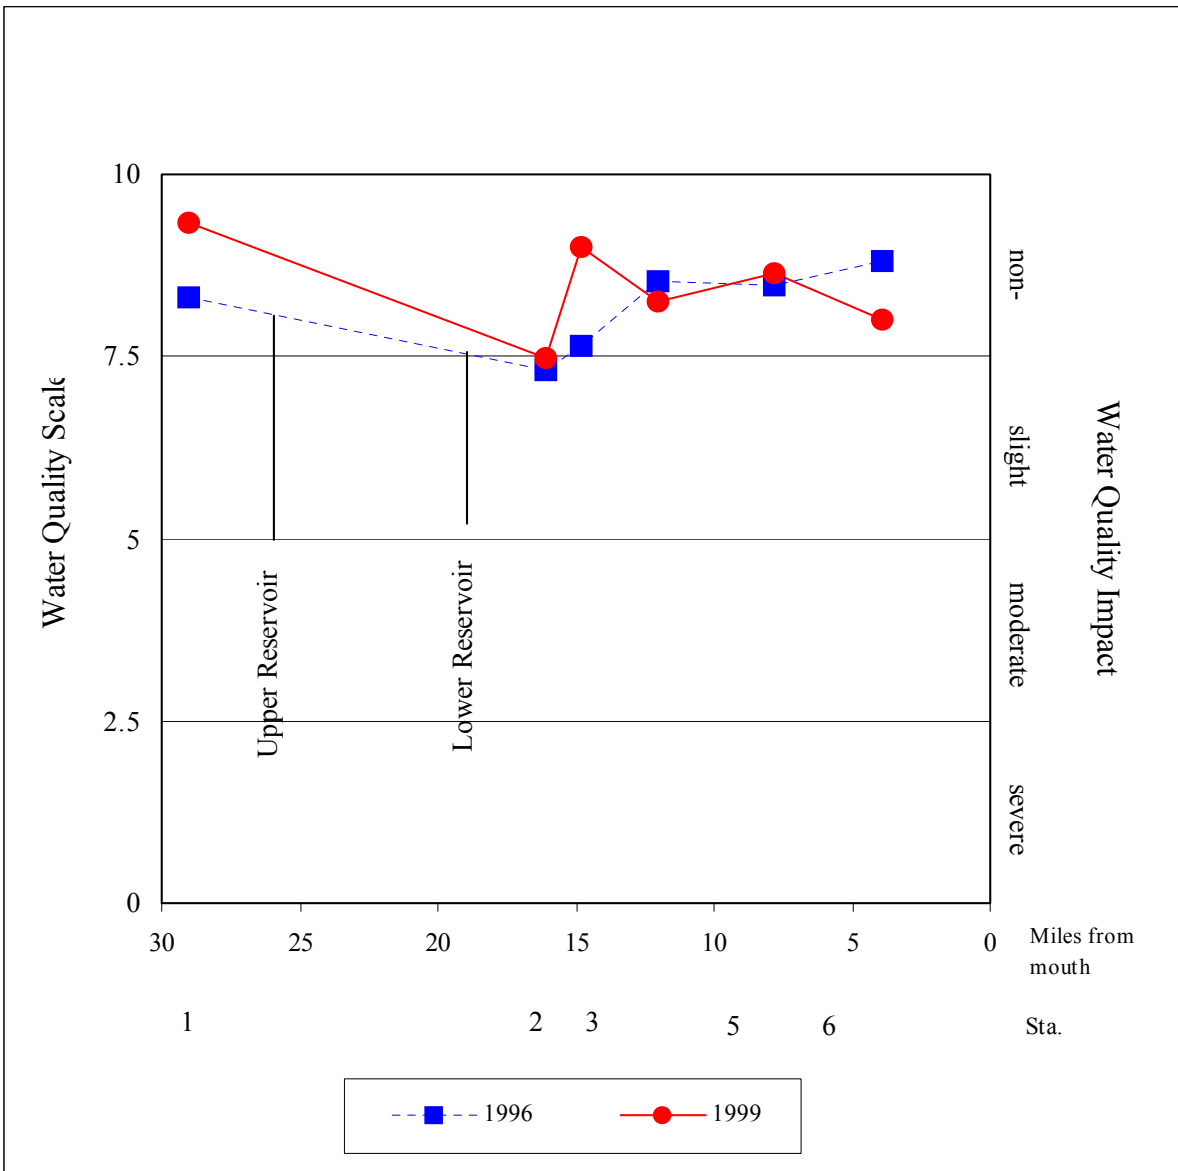
Figure 3-4. Salmon River water quality, 1996 and 1999.

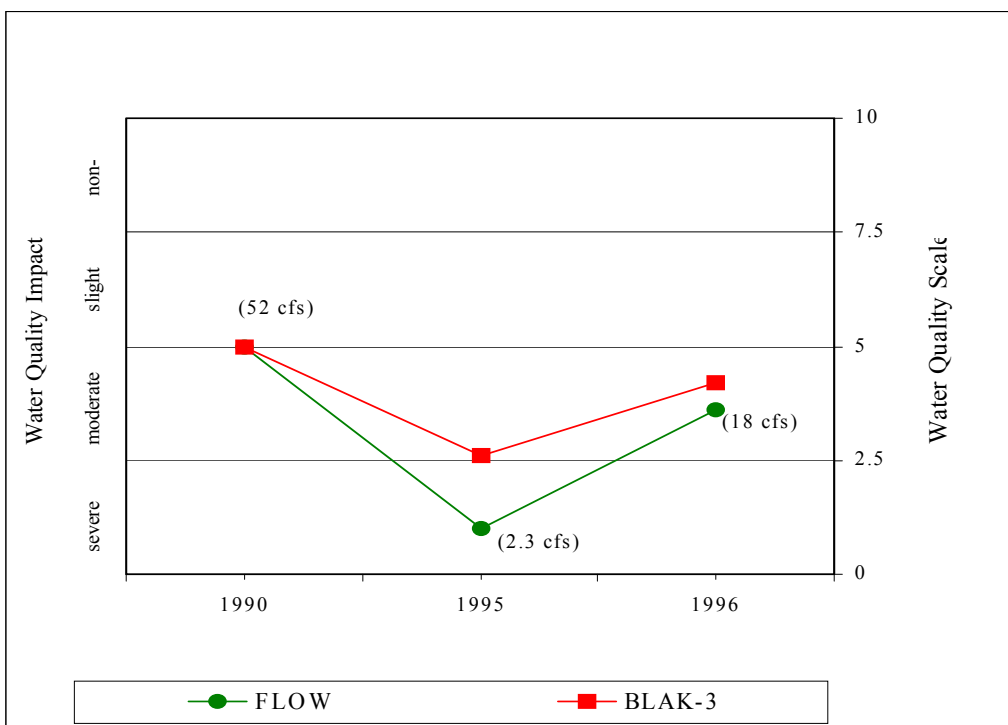
Figure 4-1. Biological Assessment Profile of index values, Black Creek at Churchville, 1990-1996, and flow at Churchville during these years. Flow values are of average 7-day low flow period during the 2-month period prior to invertebrate sampling, derived from values from the USGS gage at Churchville.

In a 1996 macroinvertebrate study sampling 6 Black Creek sites from above Byron to Chili Center, water quality assessments ranged from slightly to moderately impacted. Moderate impacts were observed downstream of the discharges of the South Byron (V) Sewage Treatment Plant and the Churchville (V) Sewage Treatment Plant. The South Byron site was also assessed as moderately impacted in

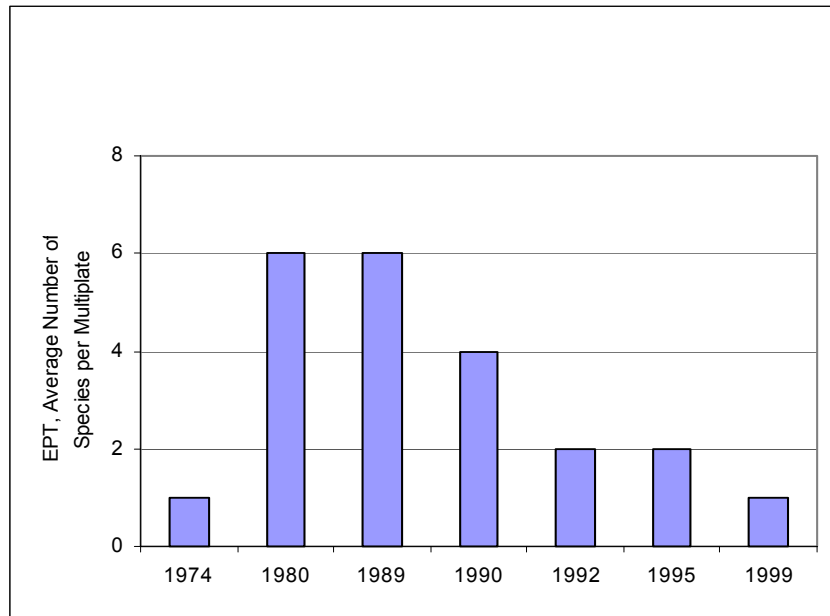
Figure 4-2. Genesee River at Rochester, upstream of Barge Canal. EPT data (species of sensitive mayflies, stoneflies, and caddisflies), 1974-1999.

The Genesee River entering Rochester upstream of the canal junction exhibited a substantial decline in water quality from 1989 to 1999. During the 1980's this site showed greatly improved water quality following the 1977 upgrade of the Gates-Chili-Ogden Sewage Treatment Plant. The number of EPT (mayflies, stoneflies, and caddisflies) illustrated this change, but these numbers

returned to 1974 levels (Figure 4-2) in 1999, and water quality is assessed as severely impacted. This situation is likely to be reversed, as all Monroe County wastewater treatment facilities discharge into Lake Ontario, as of late 1999. Resampling of this reach is planned for 2004. The Genesee River near the mouth currently exhibits good water quality, being assessed as slightly impacted in 1995 and 1999. The 1992 assessment of slight impact was considered somewhat inflated by high flows, but improvement now is verified at this site.

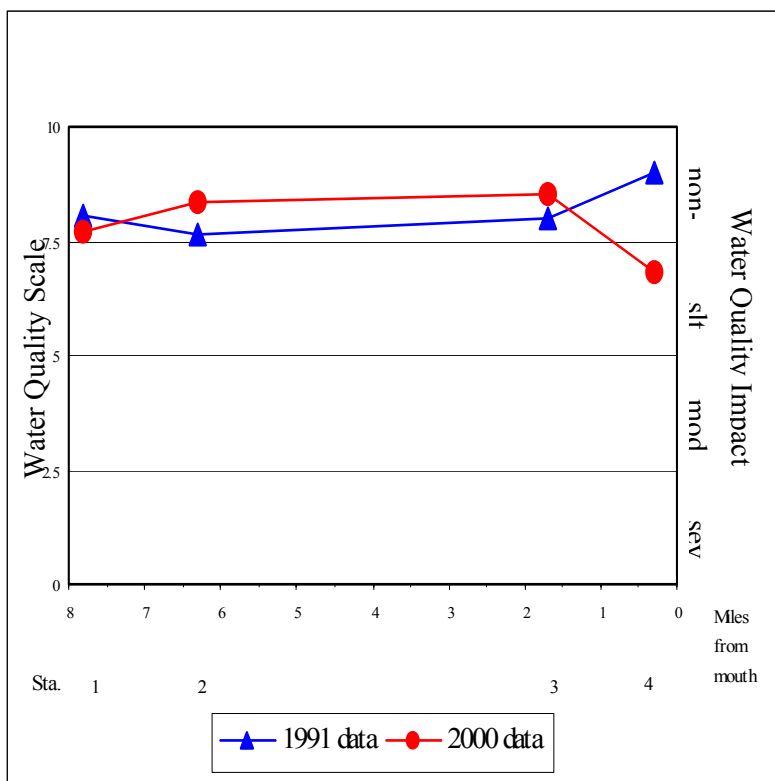
Figure 4-3. Water quality in Knight Creek, 1991 and 2000.

Knight Creek was sampled from Allentown to Scio in 1991 and 2000. The 1991 survey documented non-impacted conditions at all four sites. The 2000 survey showed the upper three sites to be non-impacted, but the Scio site showed slight impact, from nonpoint source nutrient additions (Figure 4-3). Similar conditions at this site were also documented in 1999 sampling .

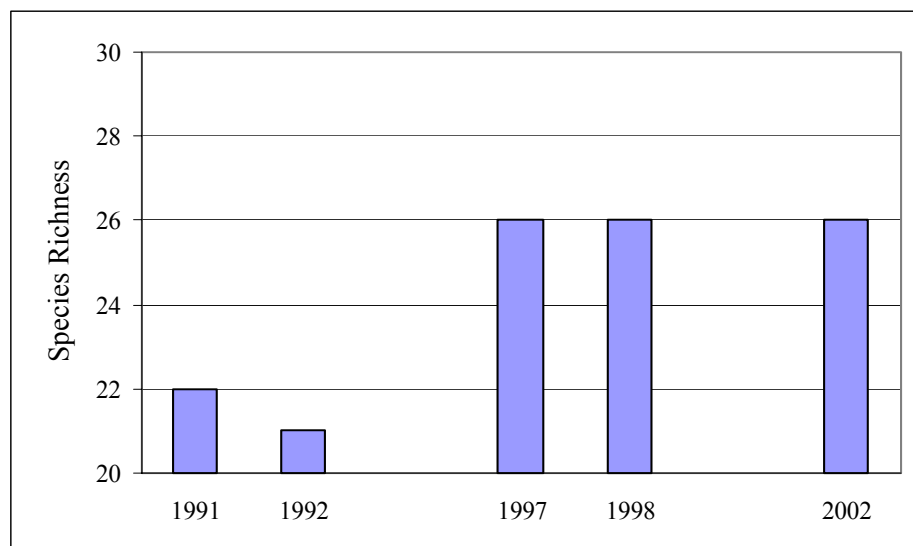
Figure 5-1. Species richness trends in Canacadea Creek at Hornell, 1991-2002.

Improved water quality is indicated for Canacadea Creek at Hornell. Water quality was assessed as moderately impacted in 1991 and 1992. Species richness was low (Figure 5-1) and the impact on the fauna was thought to be toxic in nature. Crayfish collected in 1991 contained elevated levels of mercury and

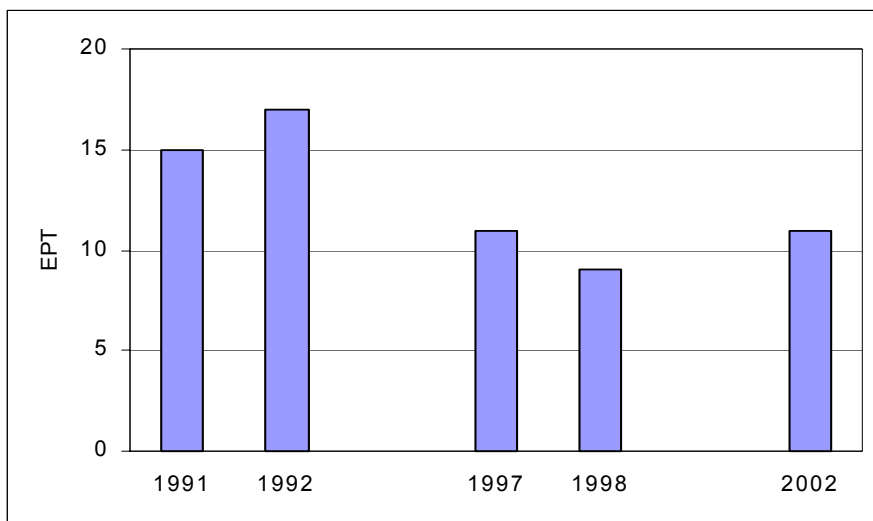
Figure 5-2. EPT trends (species of sensitive mayflies, stoneflies, and caddisflies) in Canisteo River at Derby Switch, 1991-2002.

Water quality in the Canisteo River currently ranges from non-impacted to moderately impacted. A small segment of moderate impact still exists downstream of the Hornell (C) Water Pollution Control Facility discharge, similar to the results of 1988 survey. Water quality from downstream of Canisteo to Cameron is assessed as slightly impacted, primarily by nutrient enrichment and siltation.

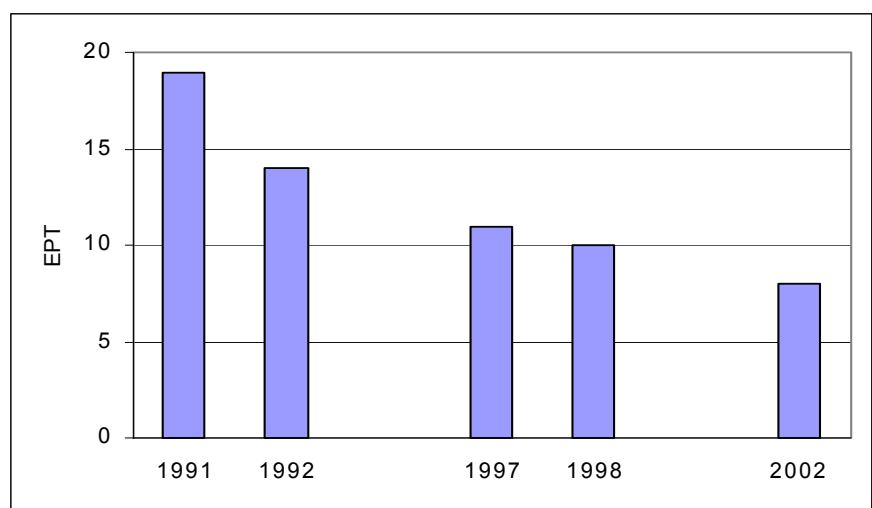
Figure 5-3. EPT trends (species of sensitive mayflies, stoneflies, and caddisflies) in Tioga River at Presho, 1991-2002.

The site at the Presho-Lindley bridge has shown an apparent decline in water quality from 1991 to 2002. The site was sampled in 1991, 1992, 1997, 1998, and 2002, and the number of species of EPT has steadily declined over those years (Figure 5-3). Water quality was assessed as non-impacted in 1991 and 1992, and slightly impacted in 1997, 1998, and 2002. Hellgrammites continue to be numerous at this site. Hellgrammites collected in 1992 had high body burdens of cobalt, manganese, and nickel. ISD denotes siltation as the primary stressor, although this needs verification. The river originates in Pennsylvania.

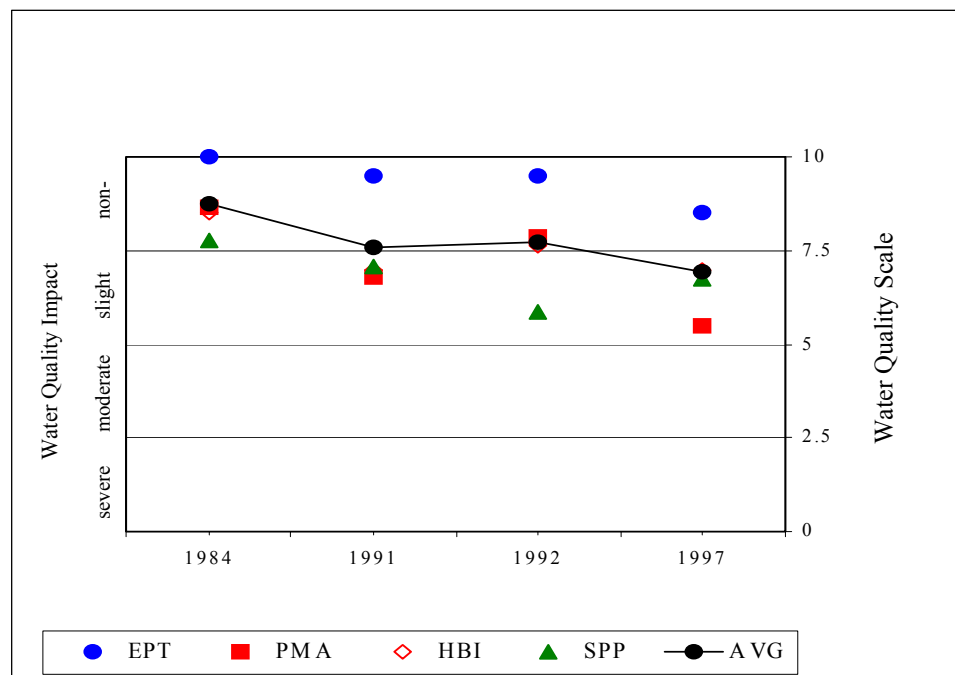
Figure 6-1. Susquehanna River below Owego, 1984-1997, showing declining water quality. SPP= species richness, HBI= Hilsenhoff biotic index, EPT= richness of mayflies, stoneflies, and caddisflies, PMA- Percent Model Affinity, AVG= Biological Assessment Profile value.

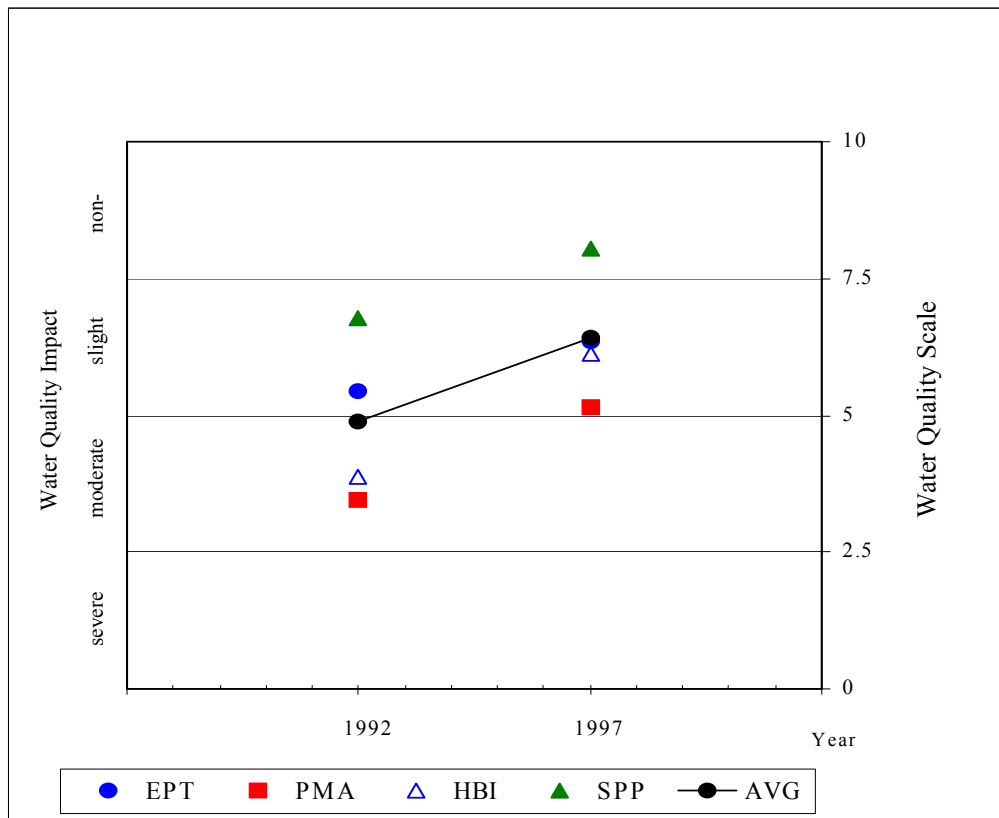
Figure 6-2. Tioughnioga River below Cortland (C) Wastewater Treatment Facility, 1992 and 1997. SPP= species richness, HBI= Hilsenhoff biotic index, EPT= richness of mayflies, stoneflies, and caddisflies, PMA- Percent Model Affinity, AVG= Biological Assessment Profile value.

Mayflies, stoneflies, caddisflies, and riffle beetles were found at this site in 1997, a substantial improvement over 1992 samples, when caddisflies, stoneflies, and riffle beetles were eliminated from the benthic fauna. Improvement is attributable to the 1995 change in sewage treatment process at the Cortland (C) Wastewater Treatment Facility.

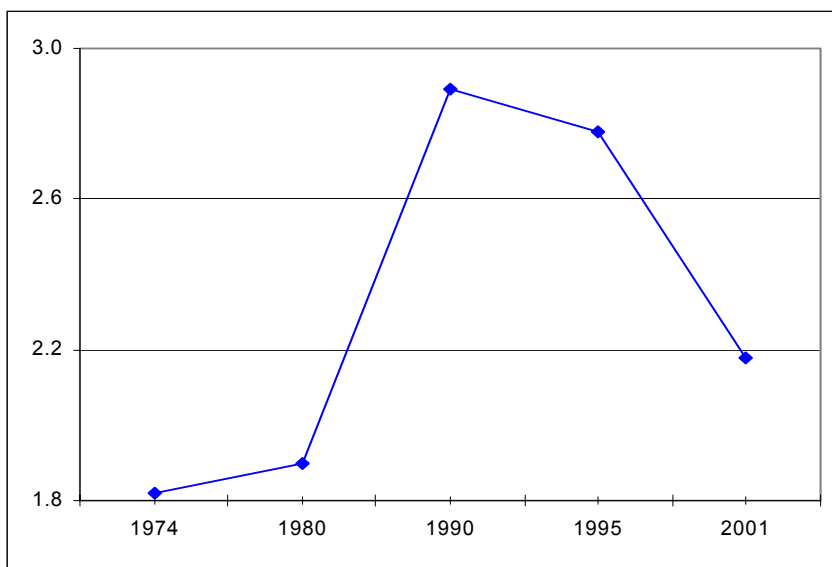
Figure 7-1. Species diversity in the Central Barge Canal below Clyde, 1974-2001.

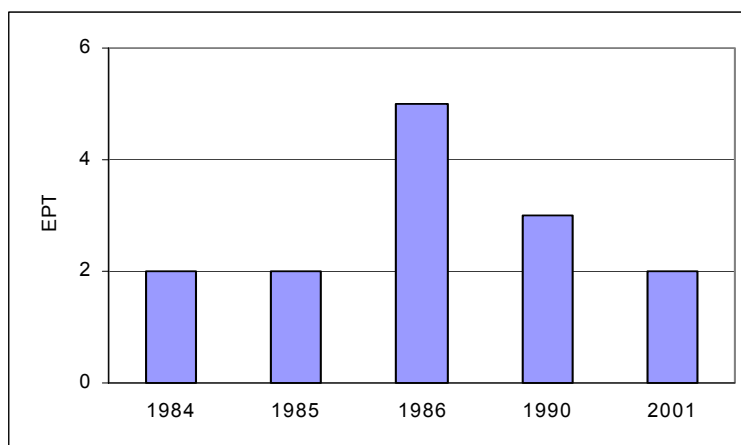
Figure 7-2. EPT trends (sensitive mayflies, stoneflies, and caddisflies), Canandaigua Outlet, Canandaigua, 1984-2001.

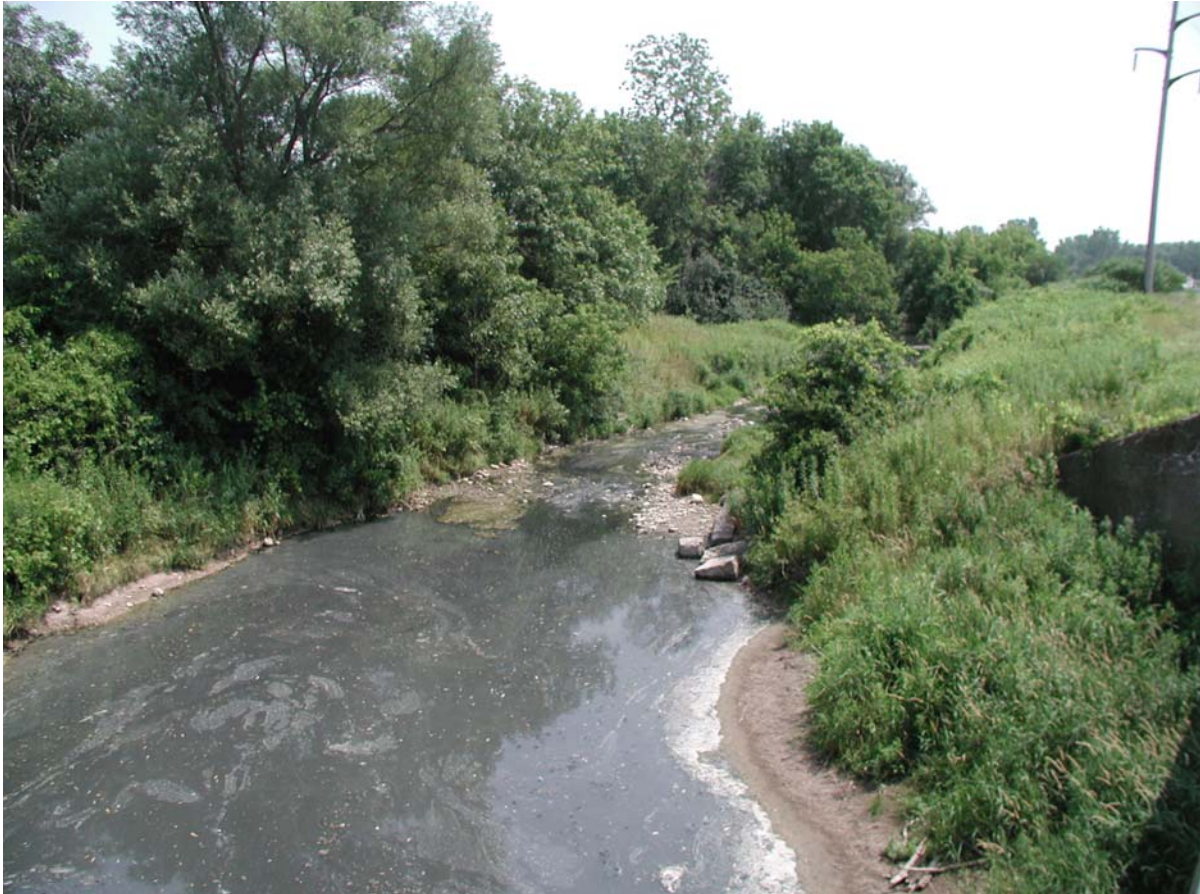
Figure 7-3. Crane Brook near Montezuma, 2002.

Severe impact was documented in Crane Brook near Montezuma in 2002 macroinvertebrate sampling. A potato processing plant discharge was the cause of the impact. Specific conductance at the site was 6979 $\mu\text{mhos/cm}$, and dissolved oxygen was 0.8 mg/l. Upstream of this site, water quality was assessed as slightly impacted by nonpoint source nutrient enrichment. This problem is expected to be remediated in the near future.

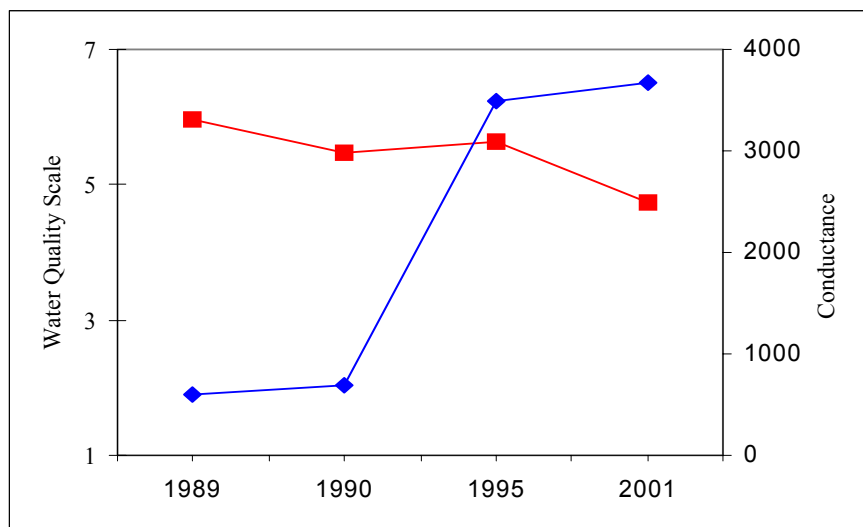
Figure 7-4. Water quality (red) vs. conductance (blue) in upper Onondaga Creek at Cardiff, 1989-2001.

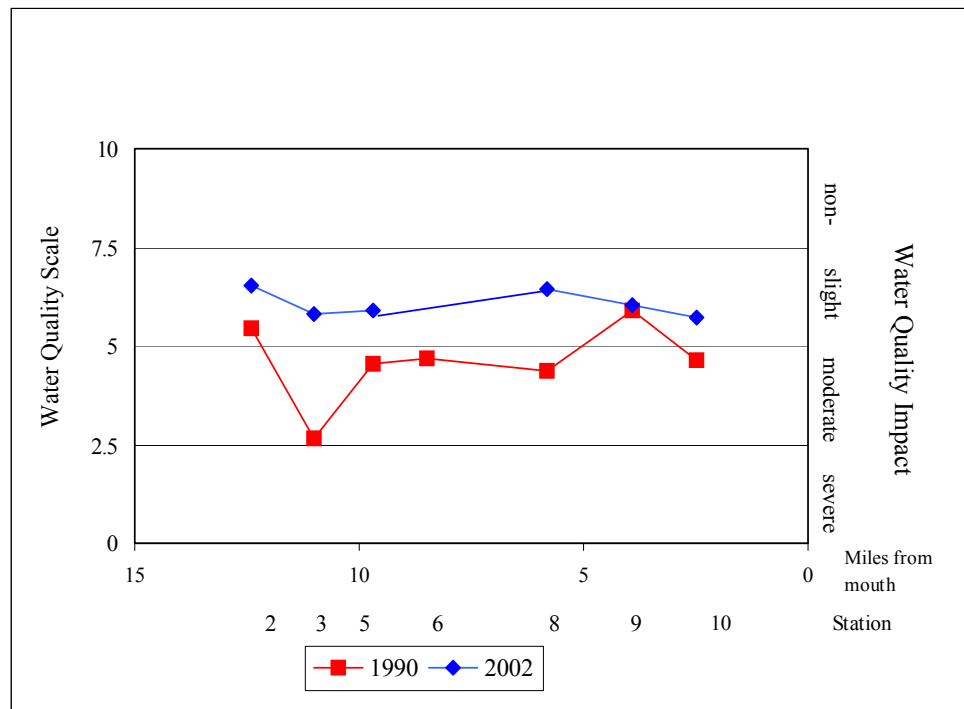
Figure 7-5. Water quality in Owasco Outlet, Auburn to North Port Byron, 1990 and 2002.

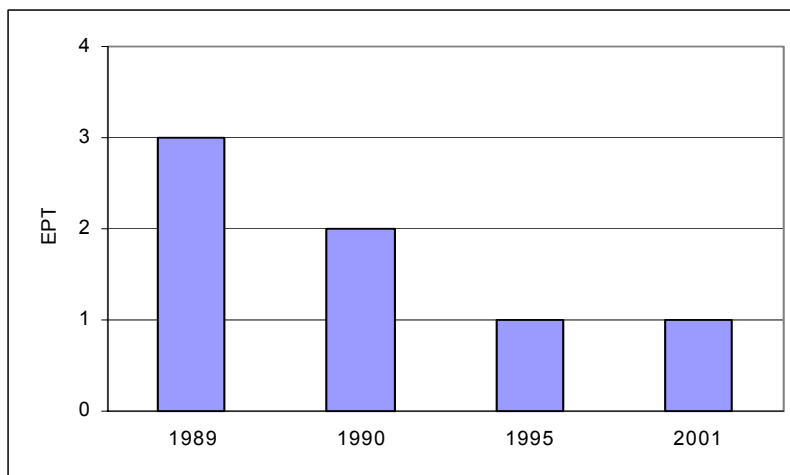
Figure 7-7. EPT trends (sensitive mayflies, stoneflies, and caddisflies), Seneca River at Jacks Reef, 1989-2001.

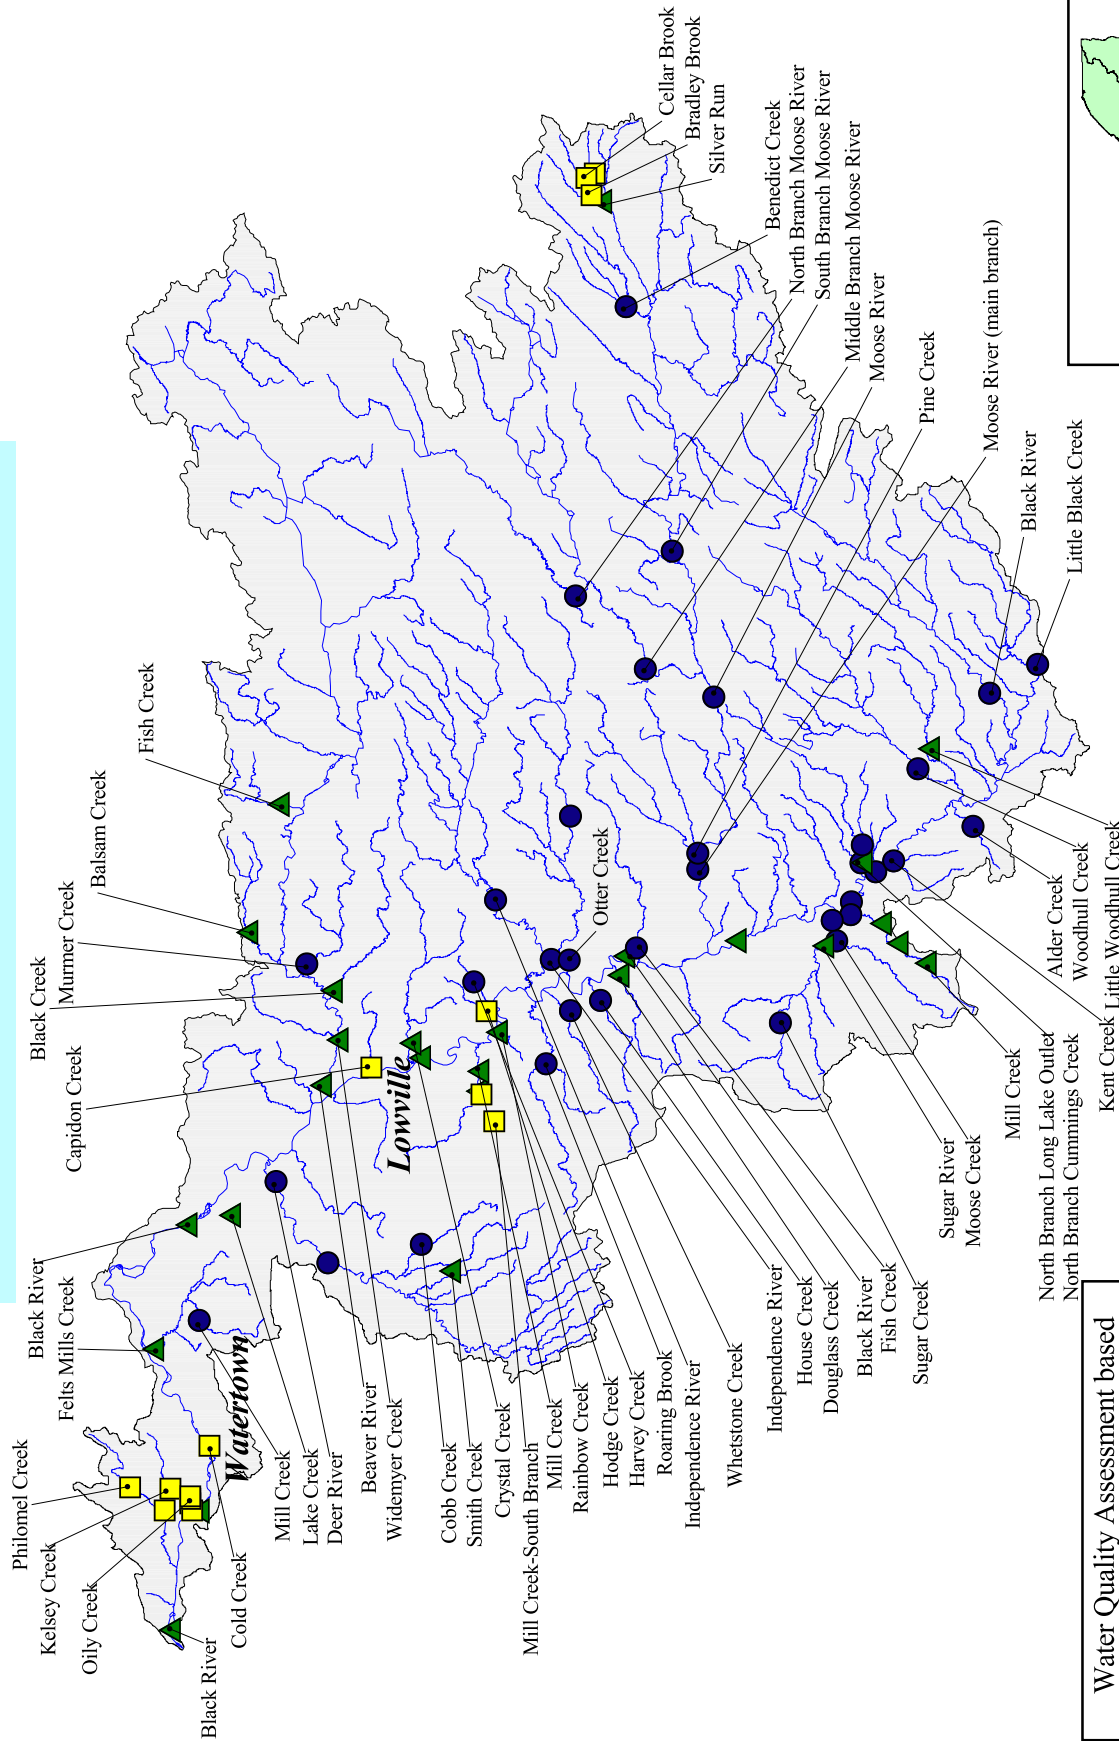
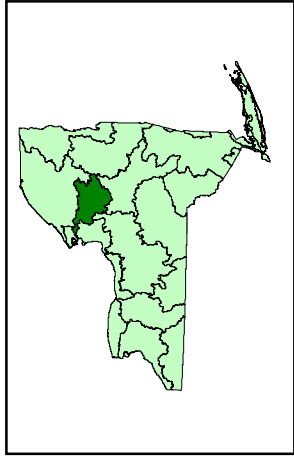
Black River Drainage Basin

Water Quality Assessment based on Resident Macroinvertebrates

BLACK RIVER DRAINAGE BASIN SAMPLING SITES, 1972-2002
