New York State
Department of Environmental Conservation

Division of Water

**30 Year Trends
in Water Quality of
Rivers and Streams
in
New York State**

Based on Macroinvertebrate Data
1972 - 2002

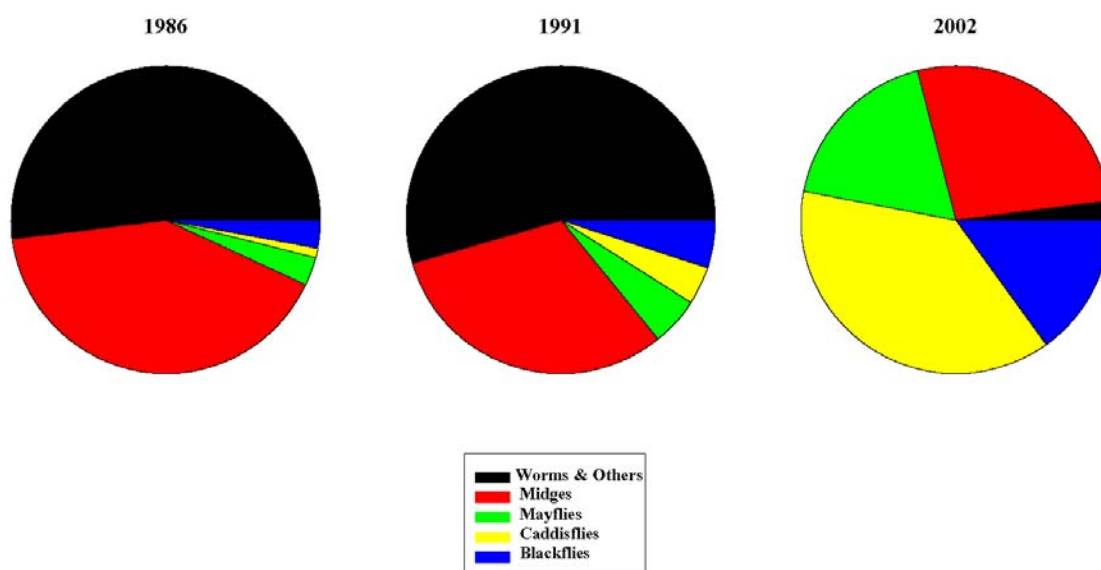
Figure 8-1. Changes in macroinvertebrate community composition, Black River at Greig, 1986-2002.

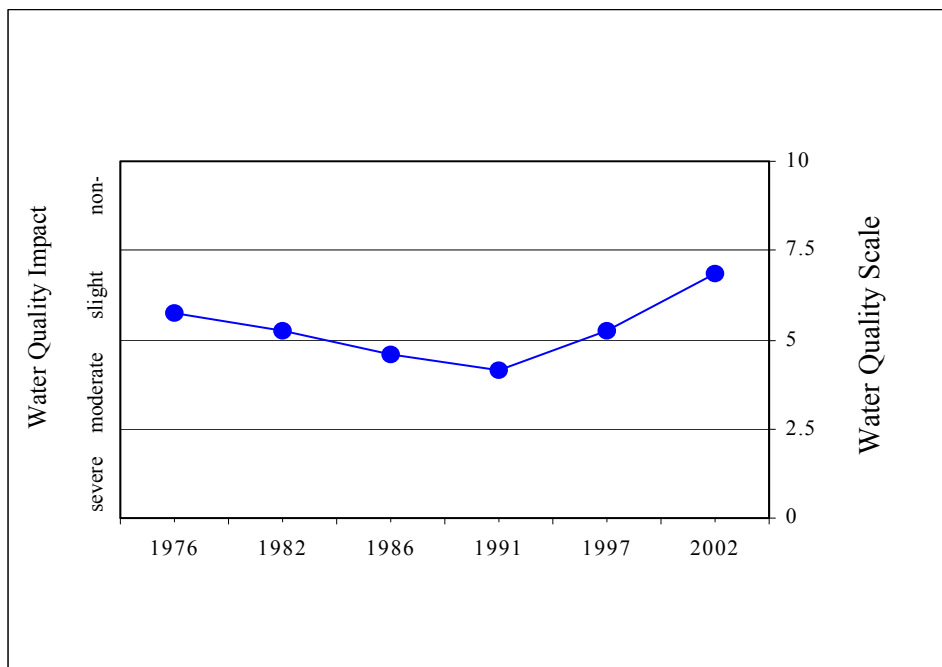
Figure 8-2. Water quality trends in the Black River below Dexter, 1975-2002.

Water quality in the Black River at Dexter has shown substantial improvement in recent years (Figure 8-2). This site exhibited moderately impacted water quality in 1986 and 1991 multiplate sampling. High numbers of tolerant midges and worms clearly reflected organic inputs. In 1992, the Dexter (V) Sewage Treatment Plant completed a substantial upgrade, resulting in a much cleaner effluent.

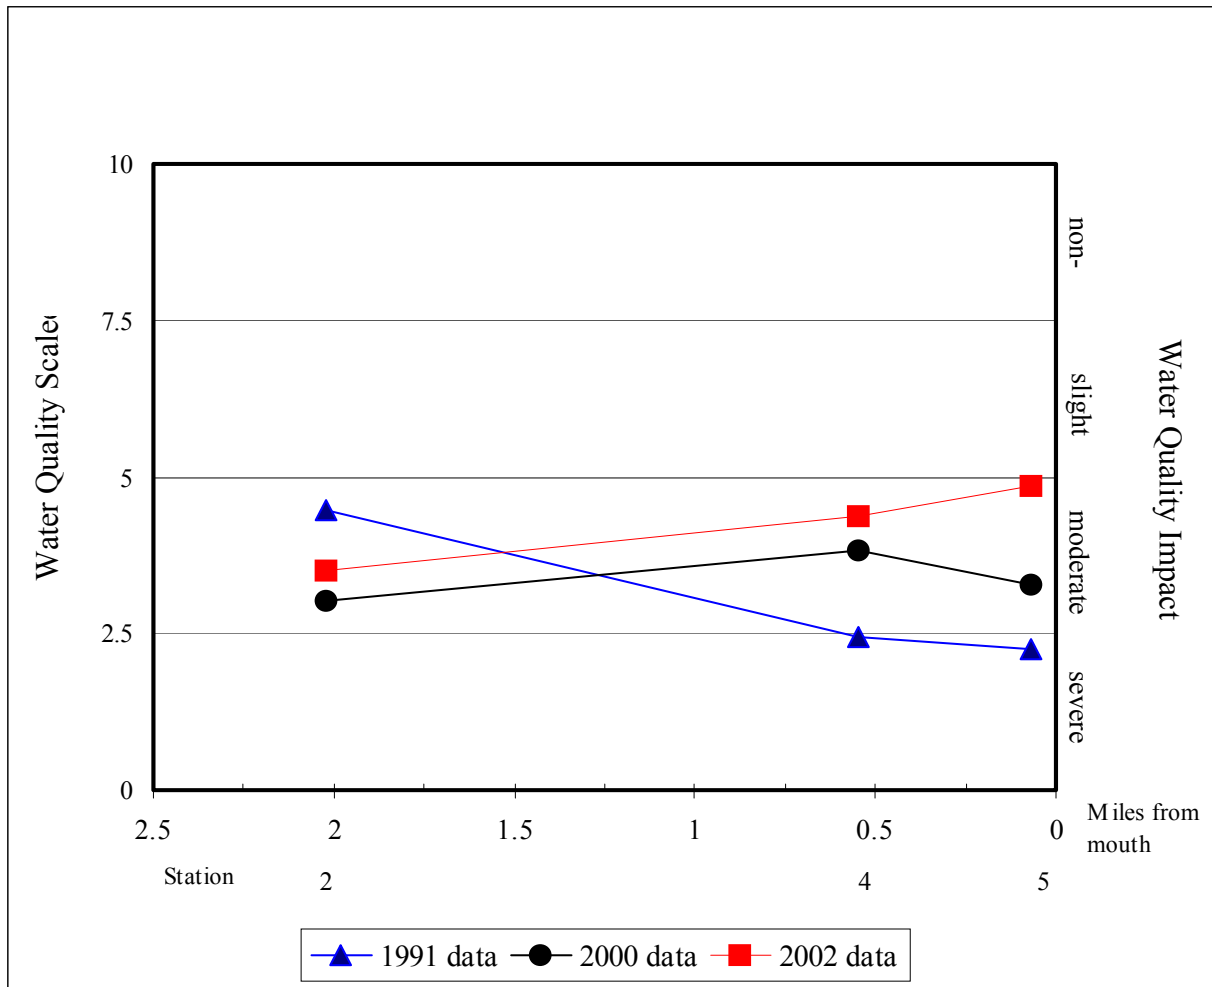
Figure 8-3. Water quality trends in Kelsey Creek, 1991-2002.

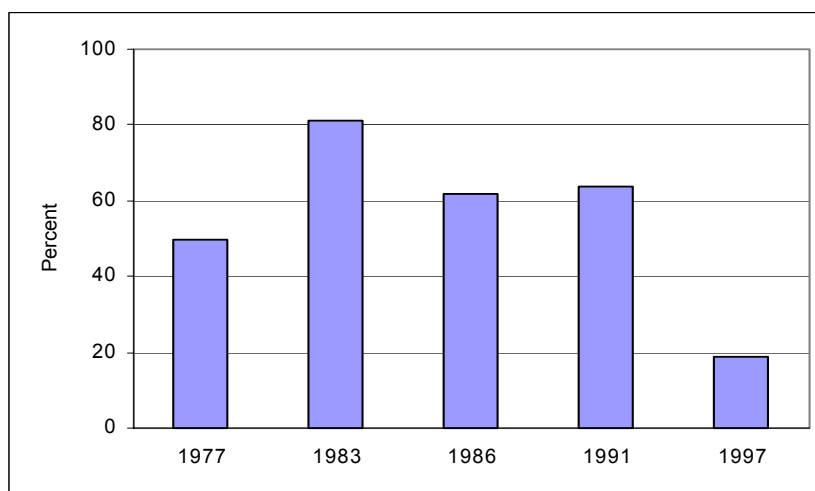
Figure 9-1. Percent contribution of tolerant worms in samples from the Grass River at Massena Center, 1977-1997.

Water quality in the Grass River continues to be slightly impacted downstream of Massena Center. Multiplate samples were collected from this site in 1977, 1983, 1986, 1991, and 1997. Although the assessment has not changed since 1991, slight improvement appears to have occurred, indicated by a reduction in the percentage contribution of tolerant worms (Figure 9-1).

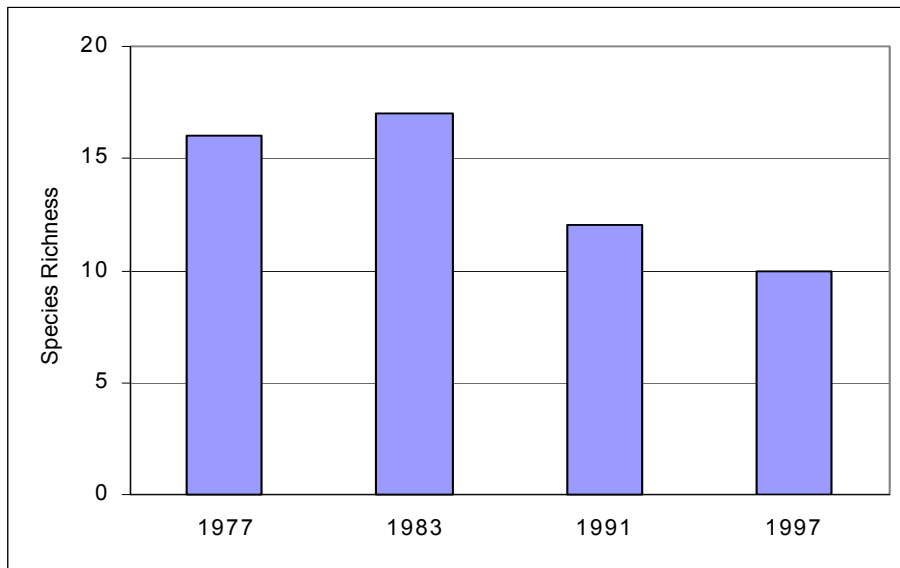
Figure 9-2. Species richness in the St. Lawrence River at Point Vivian, 1977-1997.

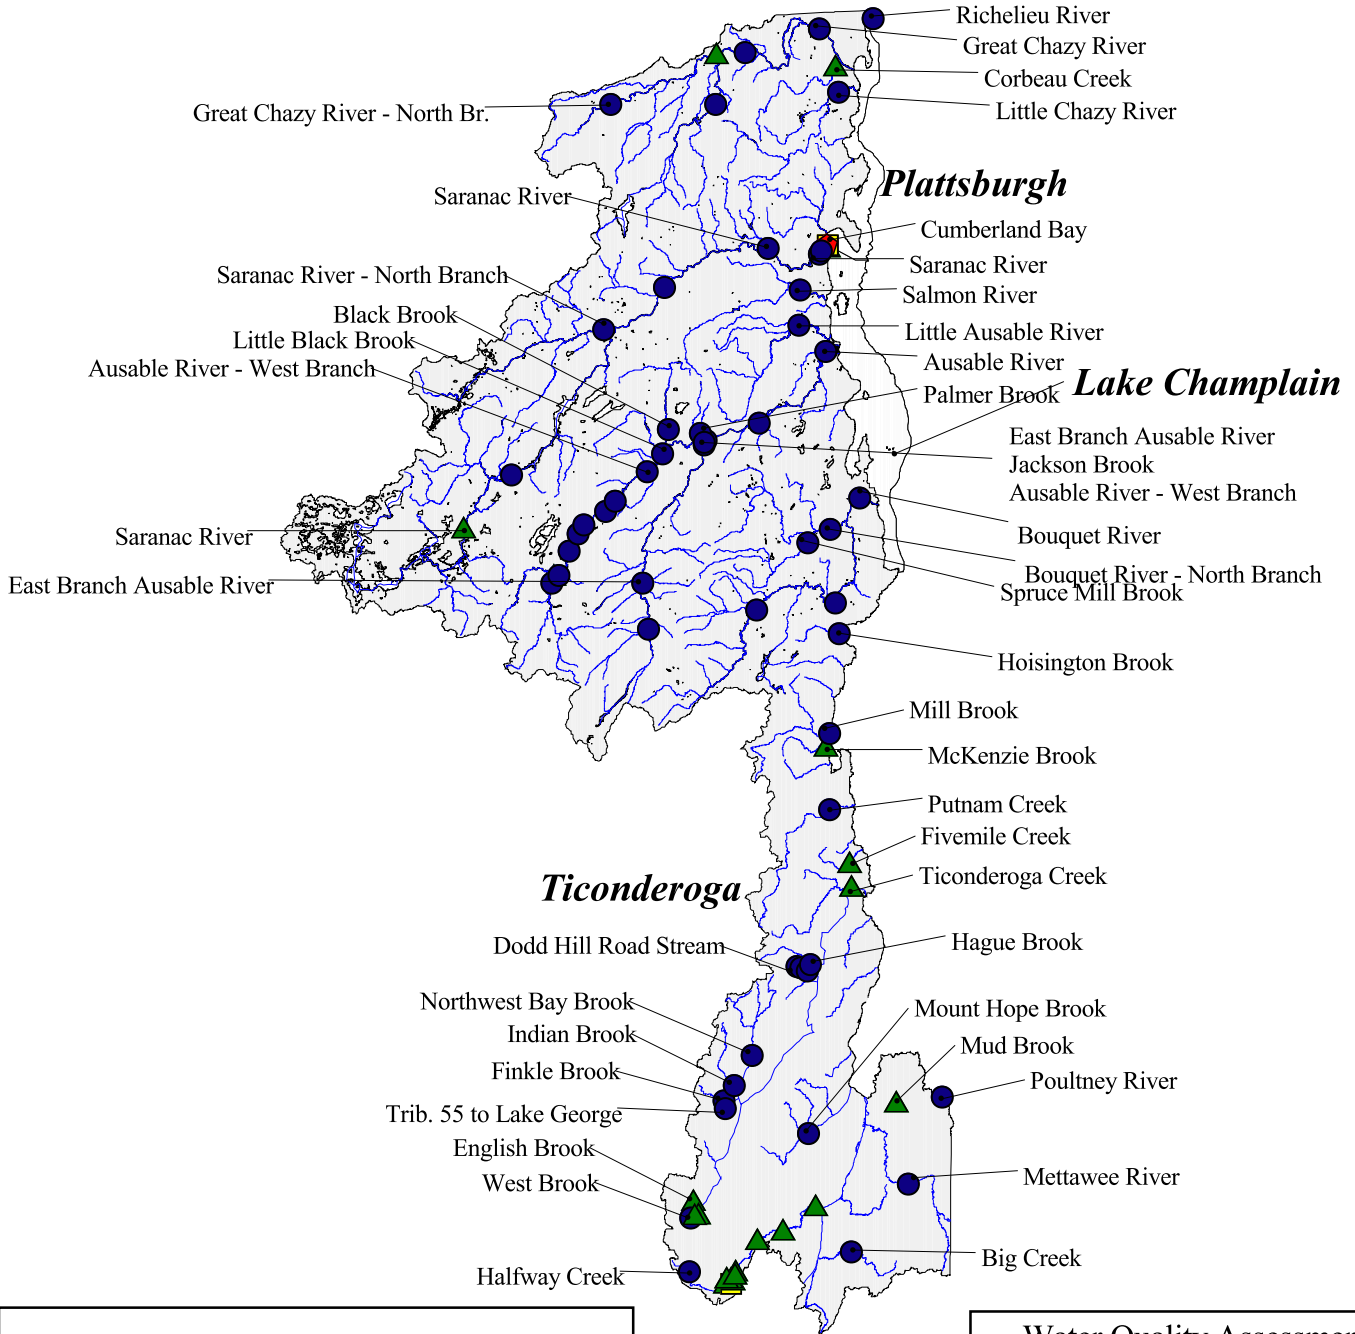
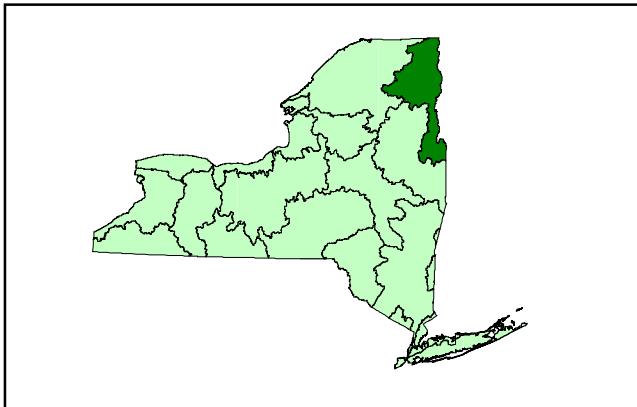
Lake Champlain Drainage Basin

LAKE CHAMPLAIN DRAINAGE BASIN SAMPLING SITES, 1972-2002

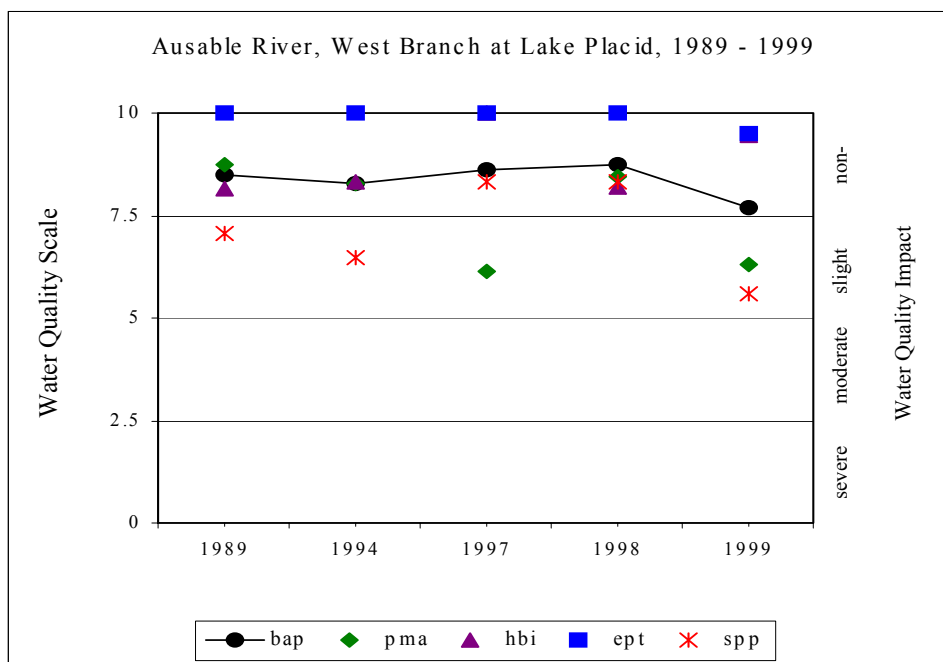
Figure 10-1. Water quality in the West Branch Ausable River at Lake Placid, 1989-1999. SPP= species richness, HBI= Hilsenhoff biotic index, EPT= richness of mayflies, stoneflies, and caddisflies, PMA- Percent Model Affinity, BAP= Biological Assessment Profile value

Water quality in the West Branch Ausable River also remains non-impacted (Figure 10-1). Recent sampling includes macroinvertebrate sampling at Haselton and Au Sable Forks in 1998 and at Lake Placid in 1999. Water quality was clearly non-impacted, with mayflies, stoneflies, and caddisflies well-represented in both samplings. No

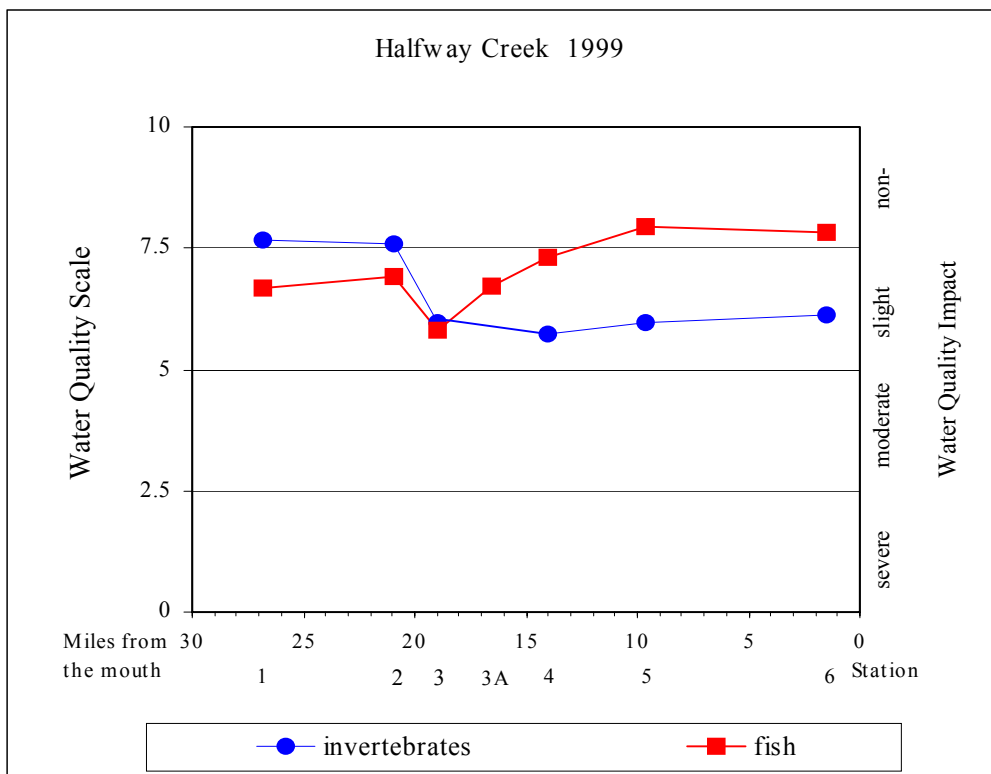
Figure 10-2. Water quality in Halfway Creek, Glens Falls to Fort Ann, 1999, as determined by macroinvertebrate sampling and fish sampling.

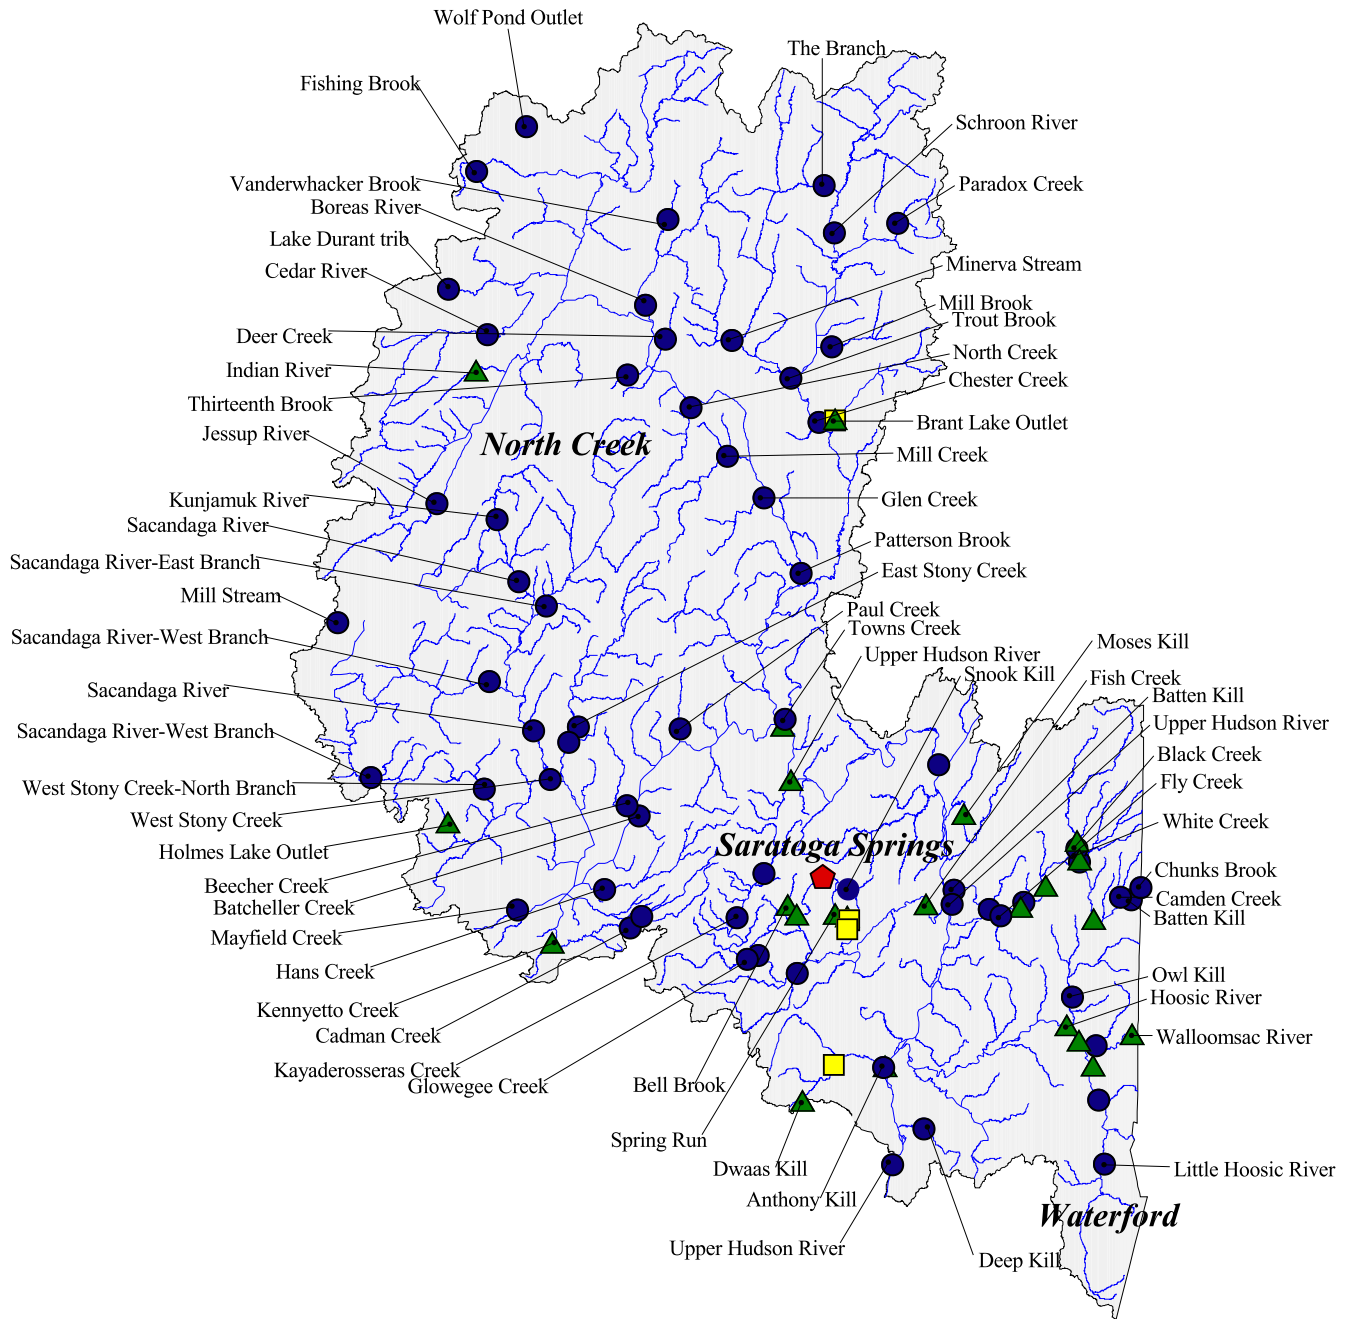
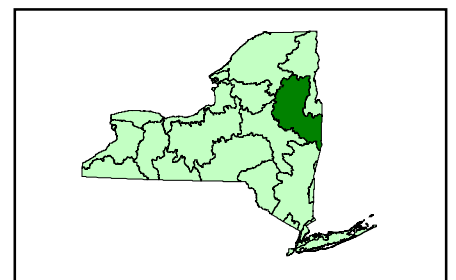
Upper Hudson River Drainage Basin

Water Quality Assessment based on Resident Macroinvertebrates

UPPER HUDSON RIVER DRAINAGE BASIN SAMPLING SITES, 1972-2002

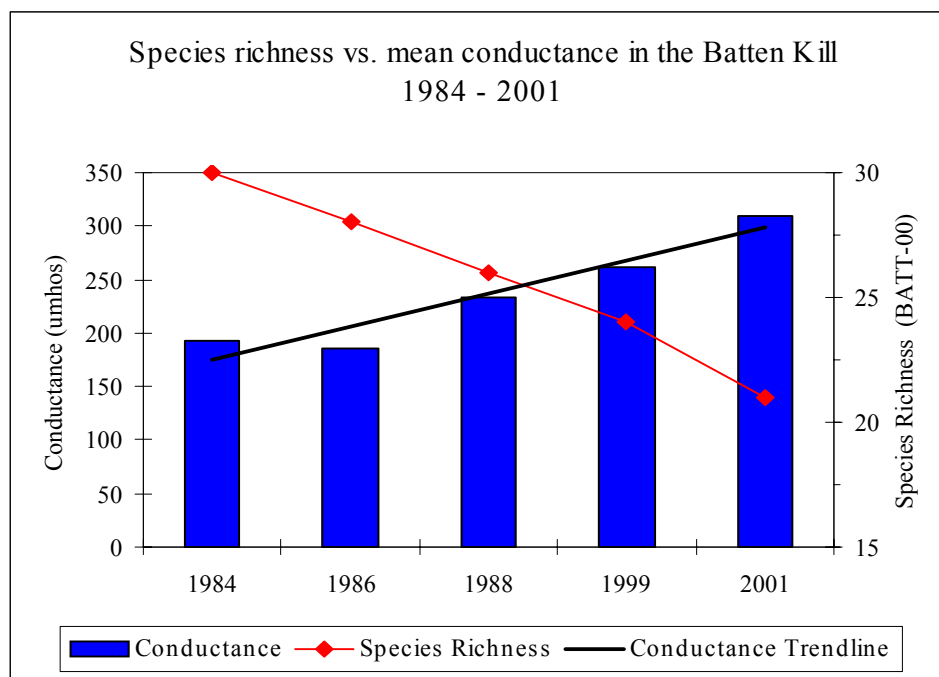
Figure 11-1. Species richness vs. mean conductance in the Batten Kill at Battenville, 1984-2001. Trendline for conductance ($r=0.91$) shown in black.

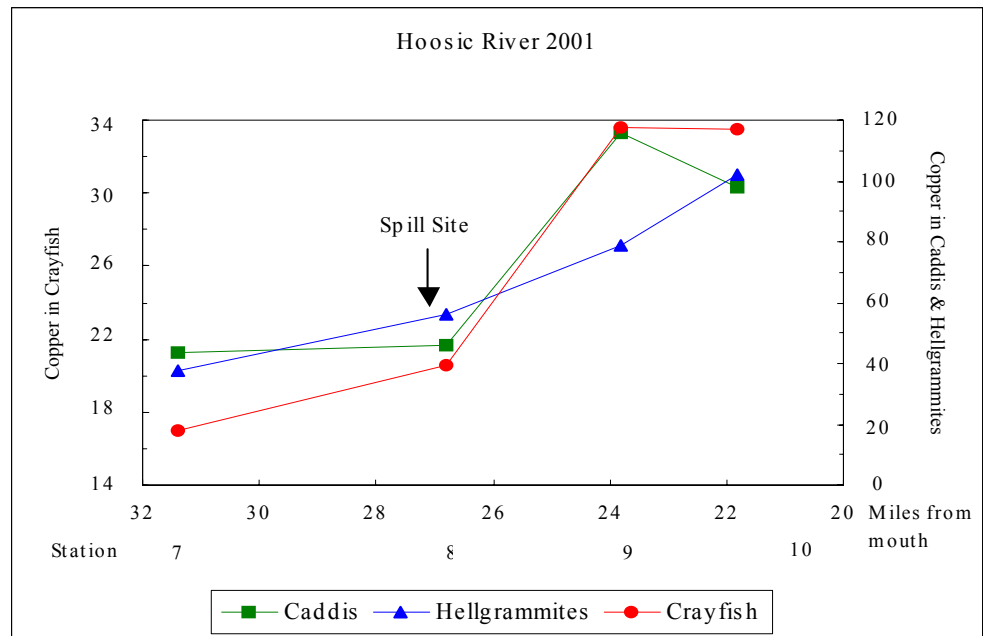
Figure 11-2. Copper levels in invertebrate tissues, Hoosic River, 2001, following a copper spill. The scale for crayfish is normalized to the scale for caddisflies and hellgrammites, based on levels of concern for each.

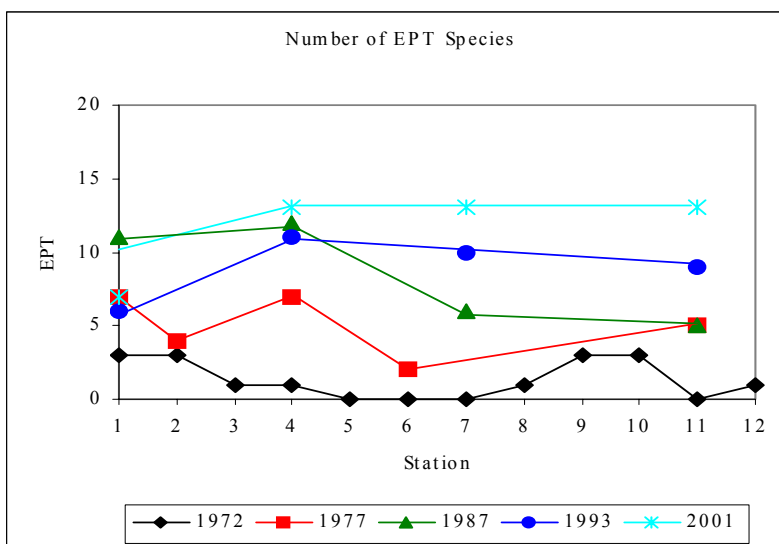
Figure 11-3. Water quality in the Upper Hudson River, Corinth to Waterford, 1972-2001, indicated by richness of clean-water mayflies, stoneflies and caddisflies (EPT).

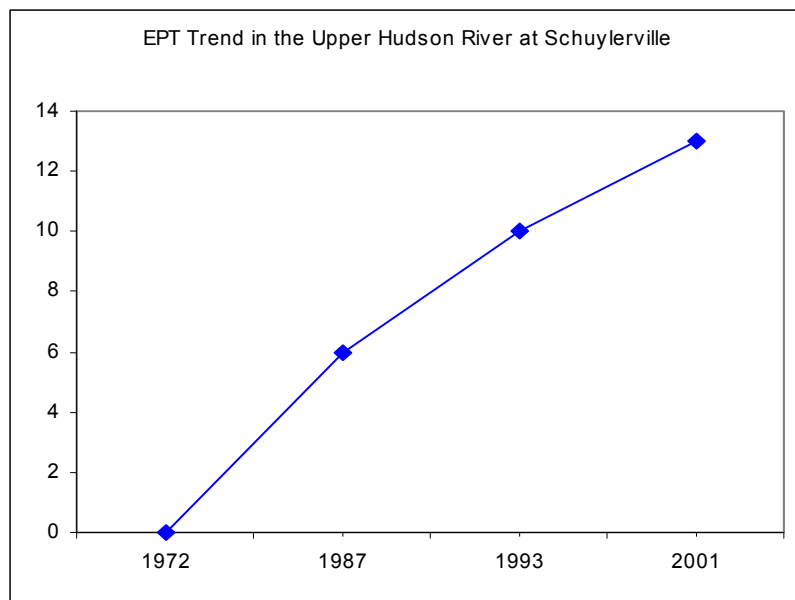
Figure 11-5. Clean-water mayflies, stoneflies, and caddisflies (EPT) in the Upper Hudson River at Schuylerville, 1972-2001.

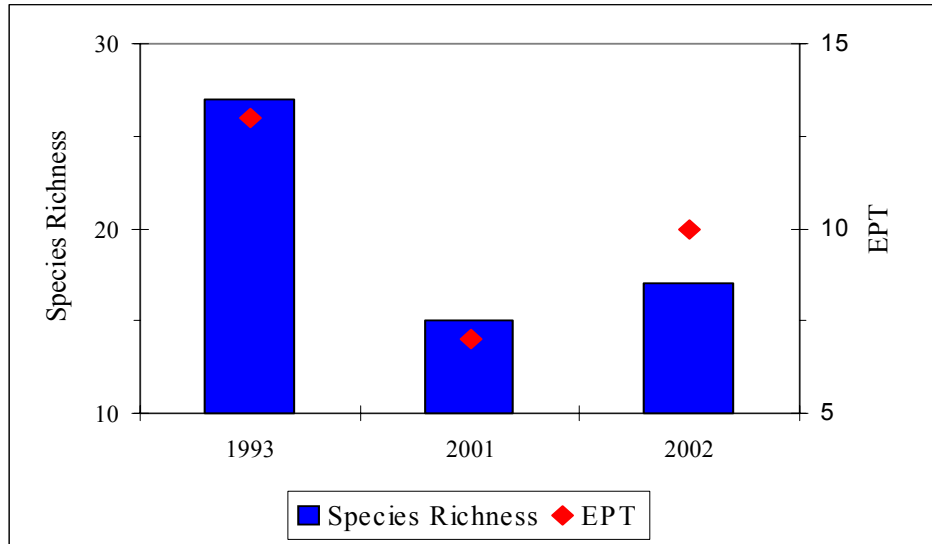
Figure 11-6. Declining species richness and EPT richness (clean-water mayflies, stoneflies, and caddisflies) in the Indian River, 1993-2001.

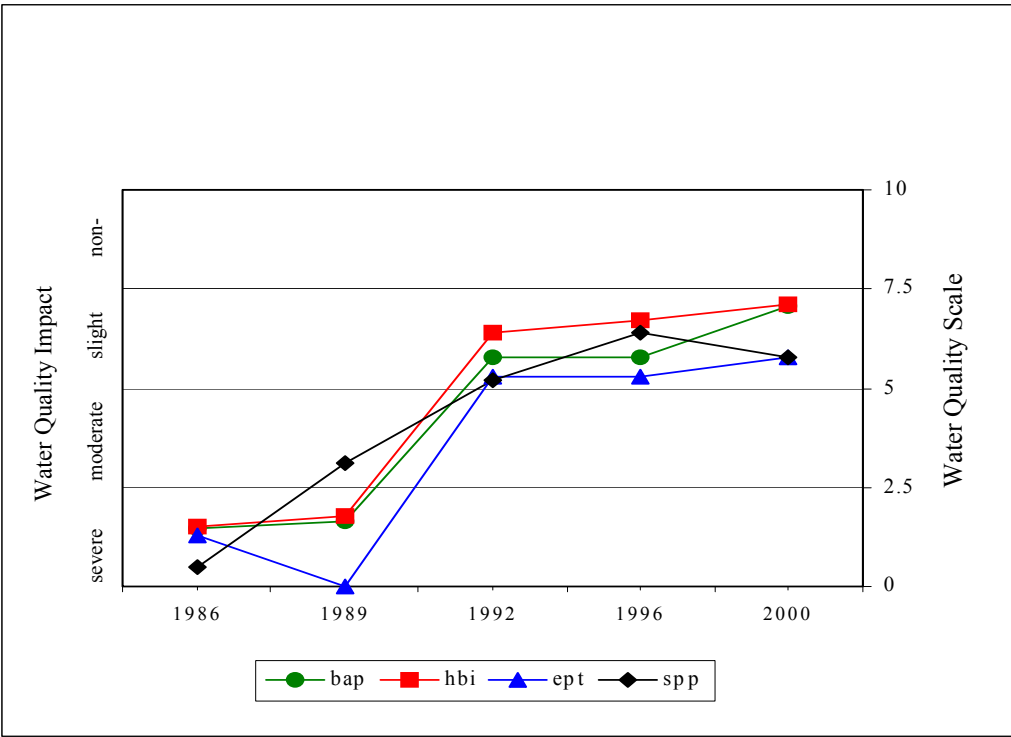
Figure 12-1. Water quality in Cayadutta Creek downstream of the Johnstown-Gloversville Wastewater Treatment Facility, 1986-2000. SPP= species richness, HBI= Hilsenhoff biotic index, EPT= richness of mayflies, stoneflies, and caddisflies, BAP= Biological Assessment Profile.

Current water quality in most of Cayadutta Creek is considered slightly impacted, with the exception of non-impacted water quality upstream of Gloversville. Ten sites from Gloversville to Fonda were sampled for macroinvertebrates in 1996. Water quality declined as the stream passed through Gloversville, due to multiple urban nonpoint sources. The discharge of the Gloversville-Johnstown Wastewater Treatment Facility had minimal impact on water quality. The site at Sammons ville was also sampled in 2000, and was determined to be slightly impacted. The macroinvertebrate community at the Sammons ville site was well-balanced and dominated by mayflies, with stoneflies and caddisflies also present. This site previously was assessed as slightly impacted in 1992 (Figure 12-1), reflecting greatly improved conditions following the upgrade of the wastewater treatment facility.

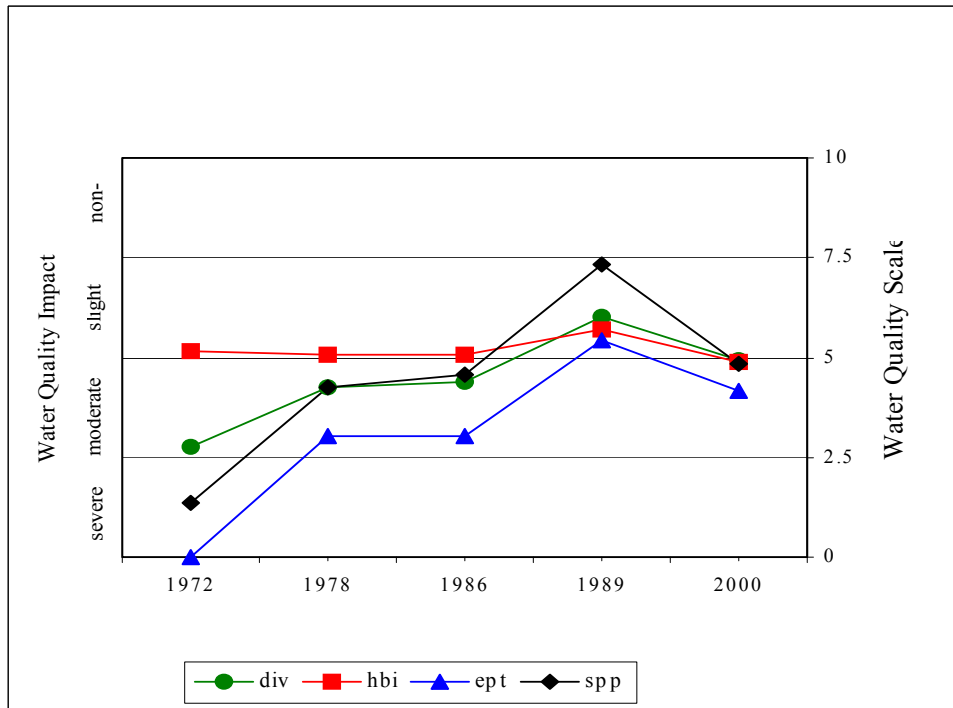
Figure 12-2. Water quality in the Mohawk River below Rome, 1972-2000. All indices are shown. SPP= species richness, HBI= Hilsenhoff biotic index, EPT= richness of mayflies, stoneflies, and caddisflies, PMA- Percent Model Affinity.

Water quality in the Mohawk River downstream of Rome (sampled at Chaminade Road, Oriskany) was assessed as moderately impacted, representing a decline compared to 1989 water quality, based on multiplate sampling in 2000. Current water quality is similar to that assessed in 1978 and 1986. (Figure 12-2)

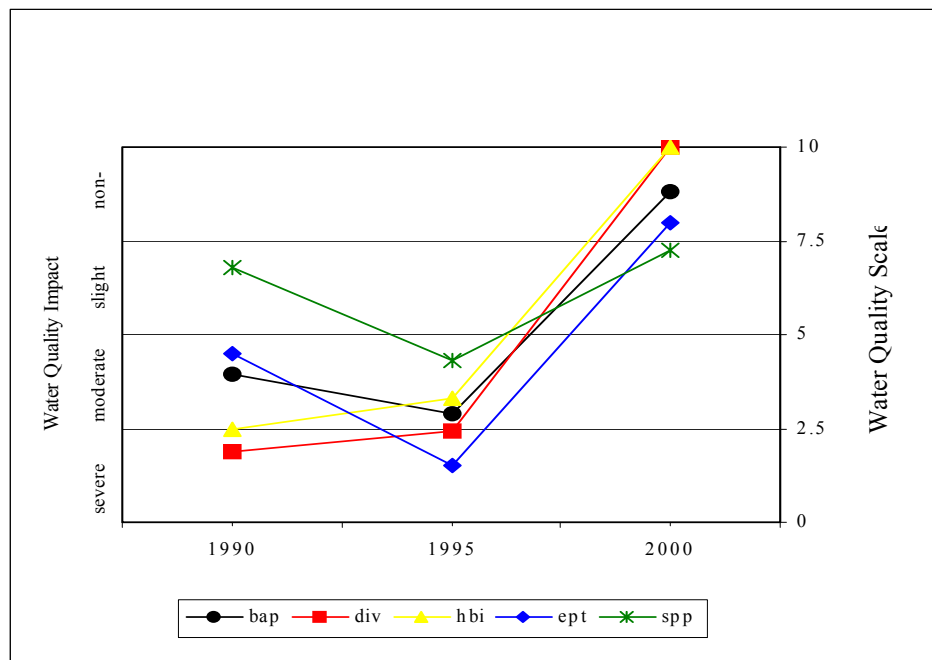
Figure 12-3. Water quality in the Mohawk River at Fonda, 1990-2000, showing all indices. SPP= species richness, HBI= Hilsenhoff biotic index, EPT= richness of mayflies, stoneflies, and caddisflies, PMA- Percent Model Affinity, BAP= Biological Assessment Profile value.

Water quality at Fonda was assessed as non-impacted, based on 2000 multiplate sampling. This represents a substantial improvement, compared to moderately impacted conditions at this site documented in 1990 and 1995 (Figure 12-3). Multiplate samples that were dominated by sewage-tolerant worms in 1990 and 1995 were dominated by midges and mayflies in 2000. One possible reason for improvement is greatly improved water quality in Cayadutta Creek, which joins the Mohawk River upstream of the Fonda sampling site, following the major 1991 upgrade of the Gloversville-Johnstown Wastewater Treatment Facility.

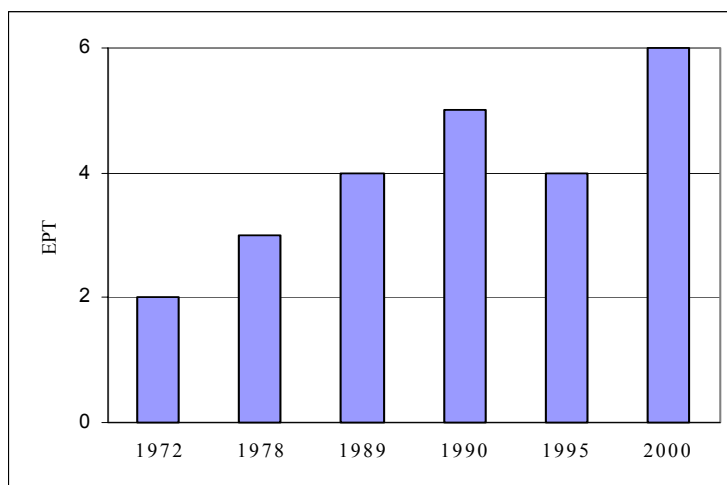
Figure 12-4. EPT trends (sensitive mayflies, stoneflies, and caddisflies) in the Mohawk River at Waterford, 1972-2000.

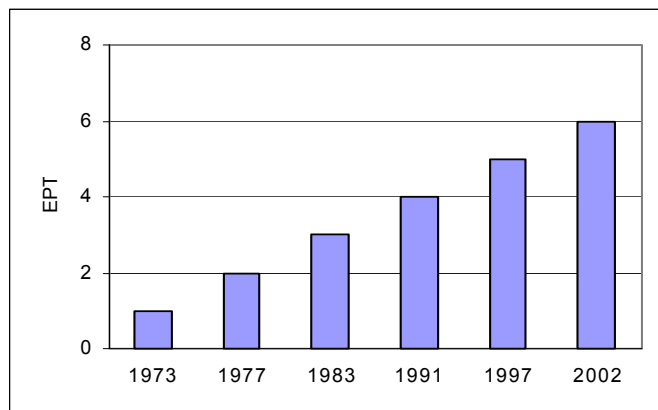
Figure 13-1. EPT trends (sensitive mayflies, stoneflies, and caddisflies) in the Hudson River at Troy, 1973-2002.

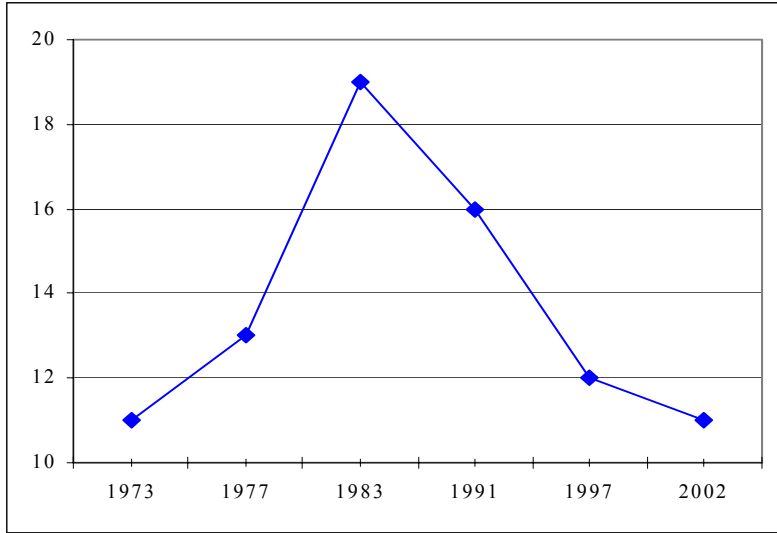
Figure 13-2. Species richness in the Hudson River below Albany, 1973-2002.

Water quality from Albany to Hudson showed an apparent decline from 1991 to 2002 (Figure 13-2). This reach was assessed as slightly impacted in 1991 multiplate sampling, and moderately impacted in the 1997 and 2002 multiplate samplings. This trend is unexplained. Ponar sampling at Glenmont in July, 1997, resulted in an assessment of moderate impact. Multiplate sampling at Castleton in 1997 and 2002 yielded assessments of moderately impacted water quality. Water

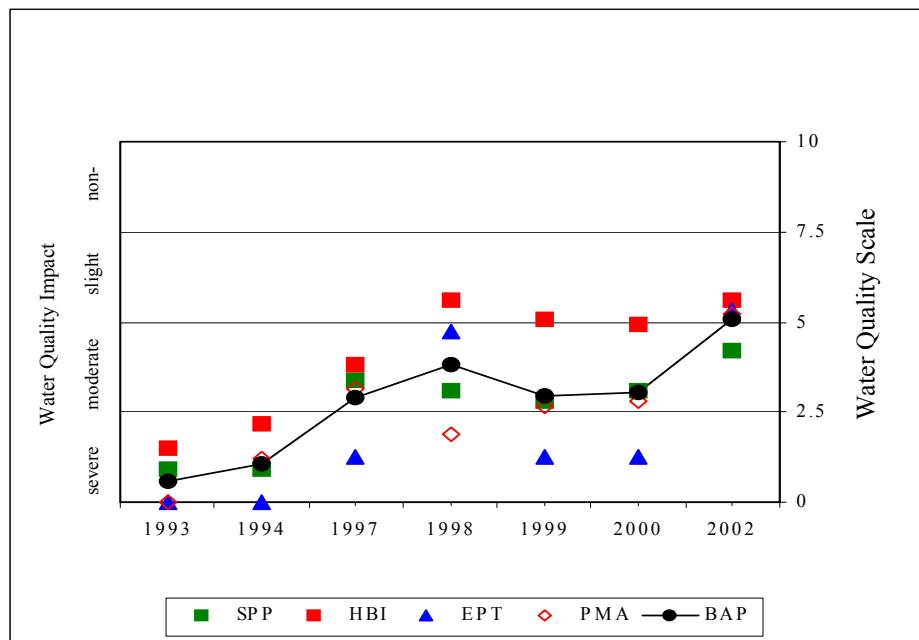
Figure 13-4. Water quality in Patroon Creek, 1993-2002. SPP= species richness, HBI= Hilsenhoff biotic index, EPT= richness of mayflies, stoneflies, and caddisflies, PMA- Percent Model Affinity, BAP= Biological Assessment Profile value.

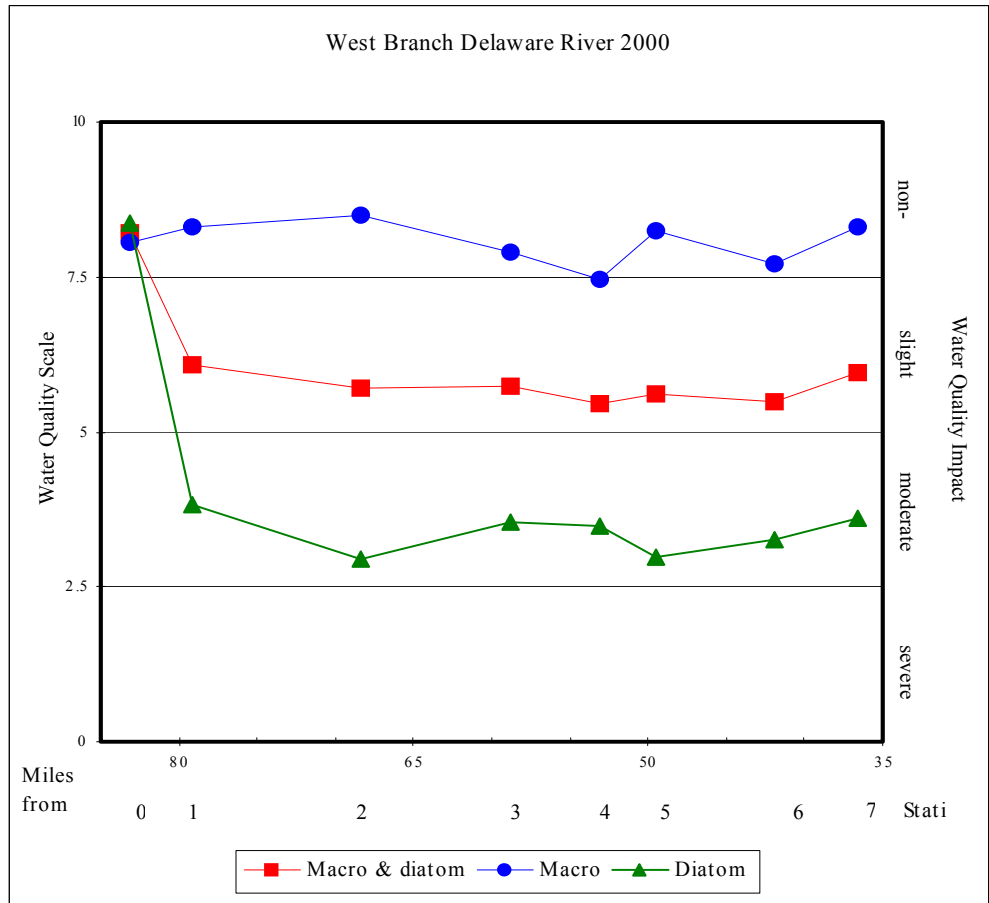
Figure 14-1. Water quality in the West Branch Delaware River, 2000, showing assessments of macroinvertebrates, diatoms, and combined assessments.

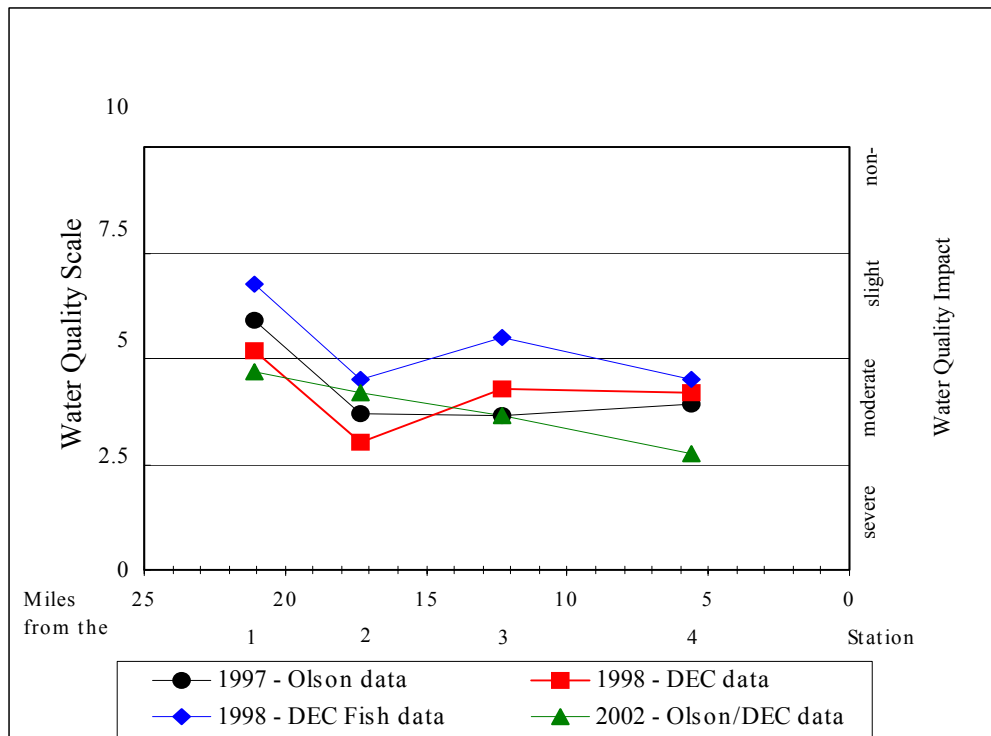
Figure 17-1. Water quality in the Bronx River, Valhalla to Bronx, as assessed by different studies.

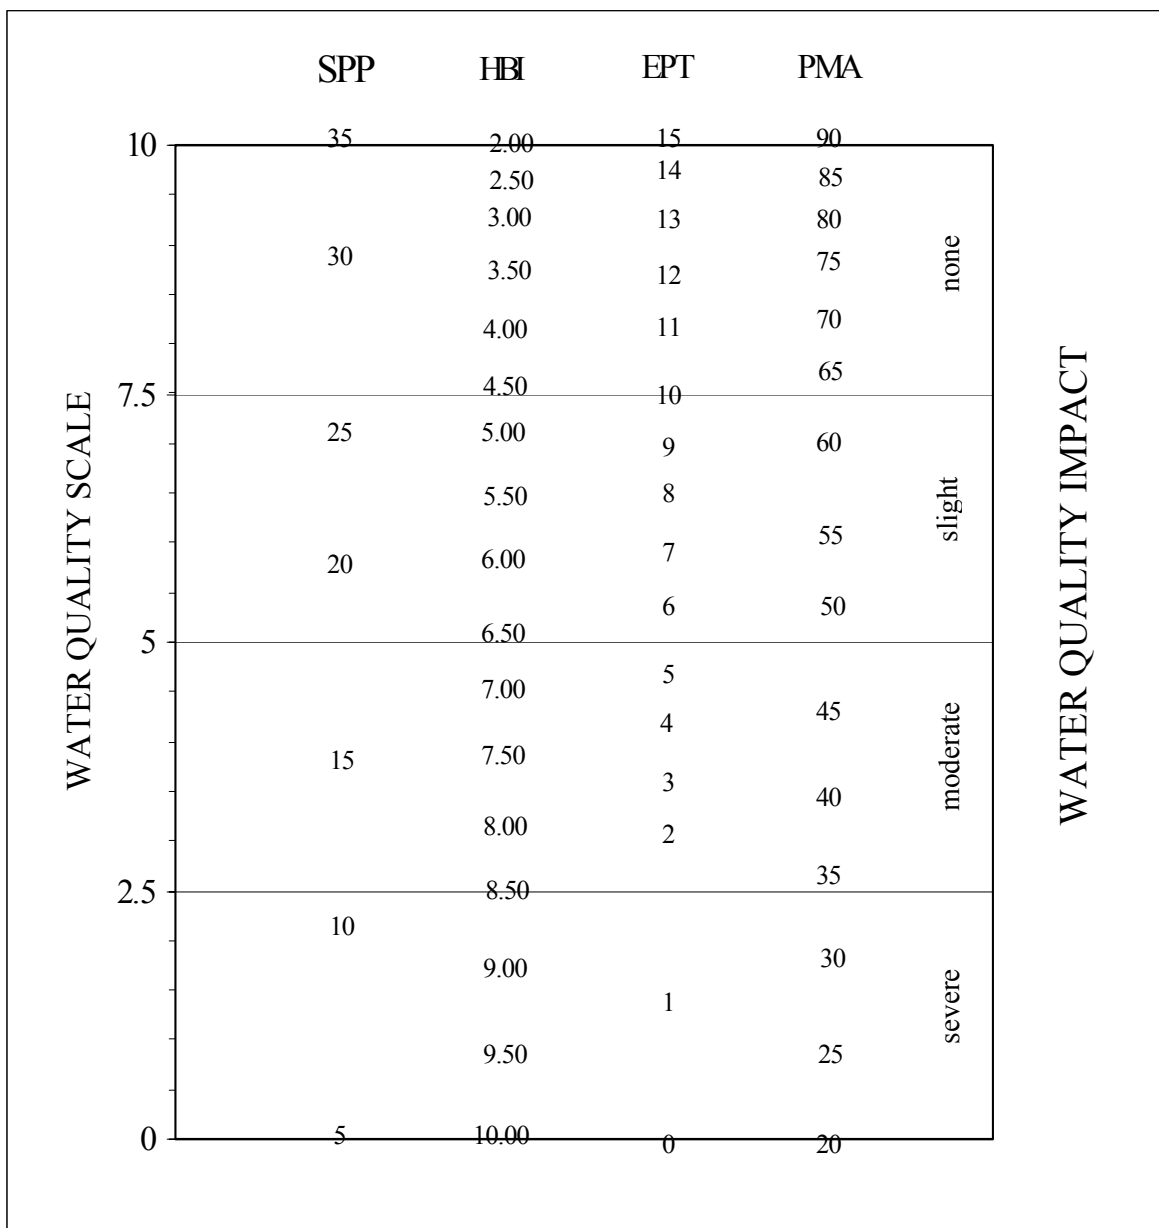
To plot survey data, each site is positioned on the x-axis according to river miles from the mouth, and the scaled values for the four indices are plotted on the common scale. The mean scale value of the four indices represents the assessed impact for each site.

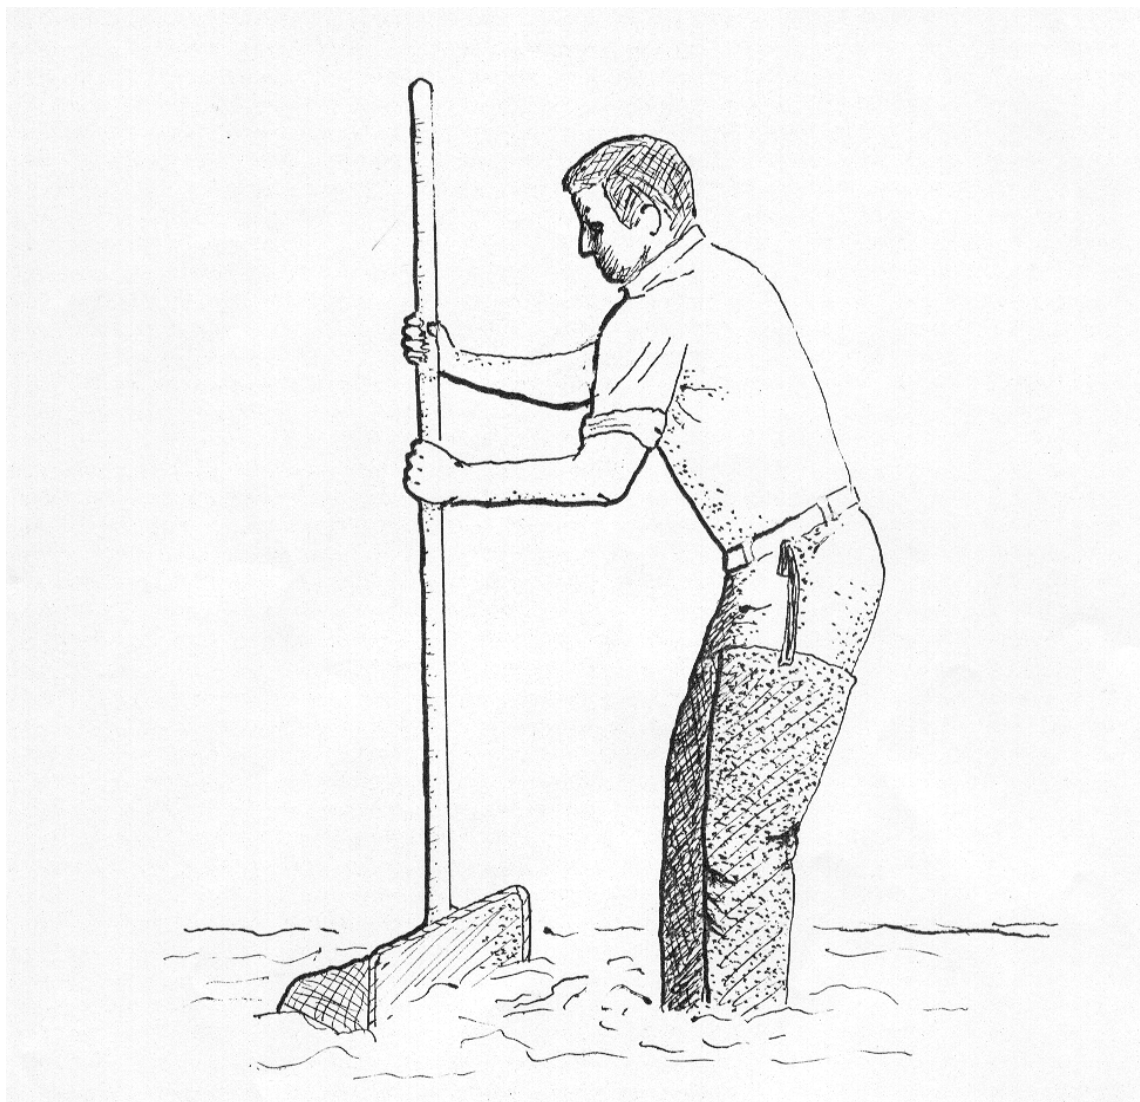
Appendix VI.
THE TRAVELING KICK SAMPLE

Rocks and sediment in the riffle are dislodged by foot upstream of a net; organisms dislodged are carried by the current into the net. Sampling is continued for five minutes, as the sampler gradually moves downstream to cover a distance of five meters.

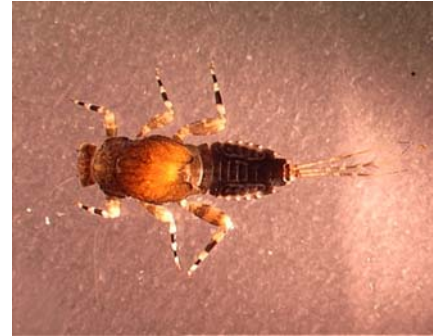
MAYFLIES

Mayfly nymphs are often the most numerous organisms found in clean streams. They are sensitive to most types of pollution, including low dissolved oxygen (less than 5 ppm), chlorine, ammonia, metals, pesticides, and acidity. Most mayflies are found clinging to the undersides of rocks.

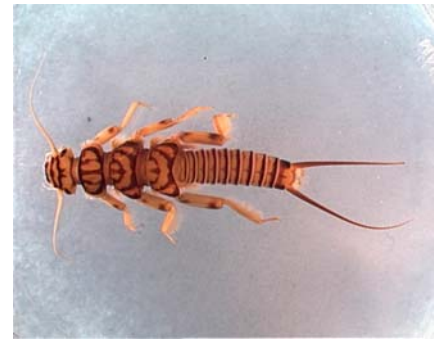
STONEFLIES

Stonefly nymphs are mostly limited to cool, well-oxygenated streams. They are sensitive to most of the same pollutants as mayflies, except acidity. They are usually much less numerous than mayflies. The presence of even a few stoneflies in a stream suggests that good water quality has been maintained for several months.

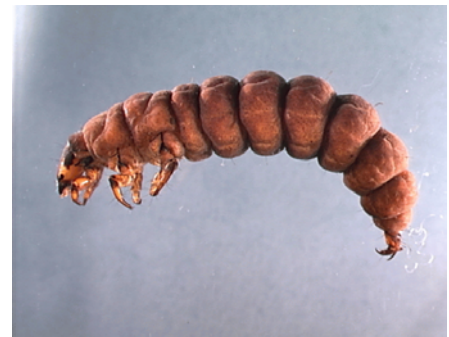
CADDISFLIES

Caddisfly larvae often build a portable case of sand, stones, sticks, or other debris. Many caddisfly larvae are sensitive to pollution, although a few are tolerant. One family spins nets to catch drifting plankton, and is often numerous in nutrient-enriched stream segments.

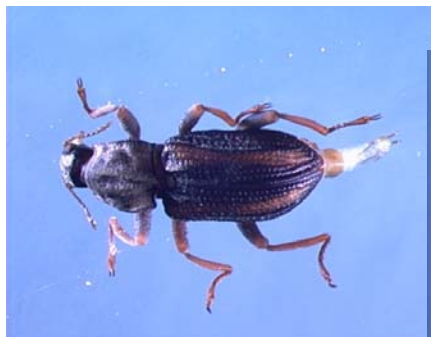
BEETLES

The most common **beetles** in streams are riffle beetles and water pennies. Most of these require a swift current and an adequate supply of oxygen, and are generally considered clean-water indicators.

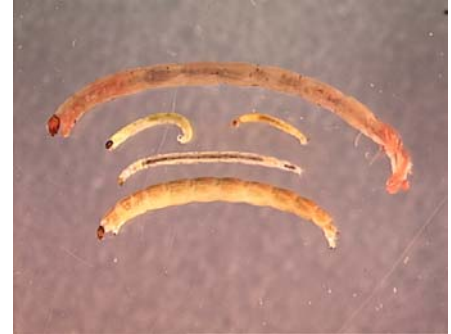
MIDGES

Midges are the most common aquatic flies. The larvae occur in almost any aquatic situation. Many species are very tolerant to pollution. Large, red midge larvae called “bloodworms” indicate organic enrichment. Other midge larvae filter plankton, indicating nutrient enrichment when numerous.

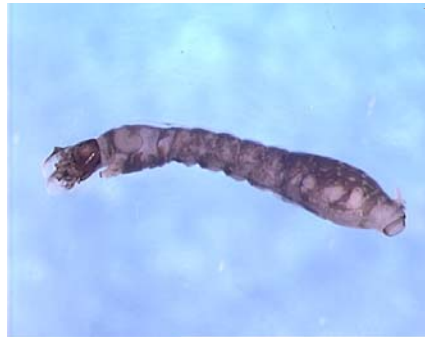
BLACK FLIES

Black fly larvae have specialized structures for filtering plankton and bacteria from the water, and require a strong current. Some species are tolerant of organic enrichment and toxic contaminants, while others are intolerant of pollutants.

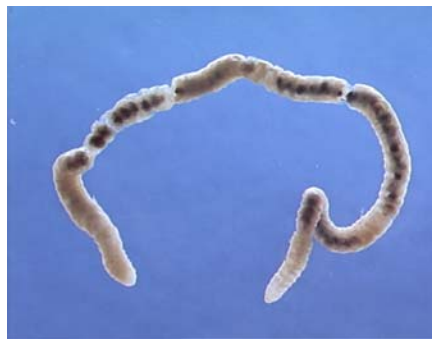
WORMS

The segmented **worms** include the leeches and the small aquatic earthworms. The latter are more common, though usually unnoticed. They burrow in the substrate and feed on bacteria in the sediment. They can thrive under conditions of severe pollution and very low oxygen levels, and are thus valuable pollution indicators. Many leeches are also tolerant of poor water quality.
