New York State
Department of Environmental Conservation

Division of Water

**30 Year Trends
in Water Quality of
Rivers and Streams
in
New York State**

Based on Macroinvertebrate Data
1972 - 2002

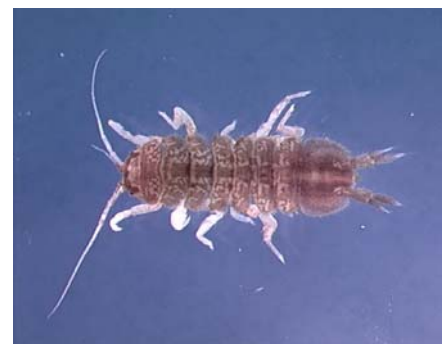
SOWBUGS

Aquatic **sowbugs** are crustaceans that are often numerous in situations of high organic content and low oxygen levels. They are classic indicators of sewage pollution, and can also thrive in toxic situations.
